The test results obtained at Lister and Treves Houses indicate that there is significant deterioration to the various elements.

Project LISTER & TREVES HSES.

Date _____
Report No 14093

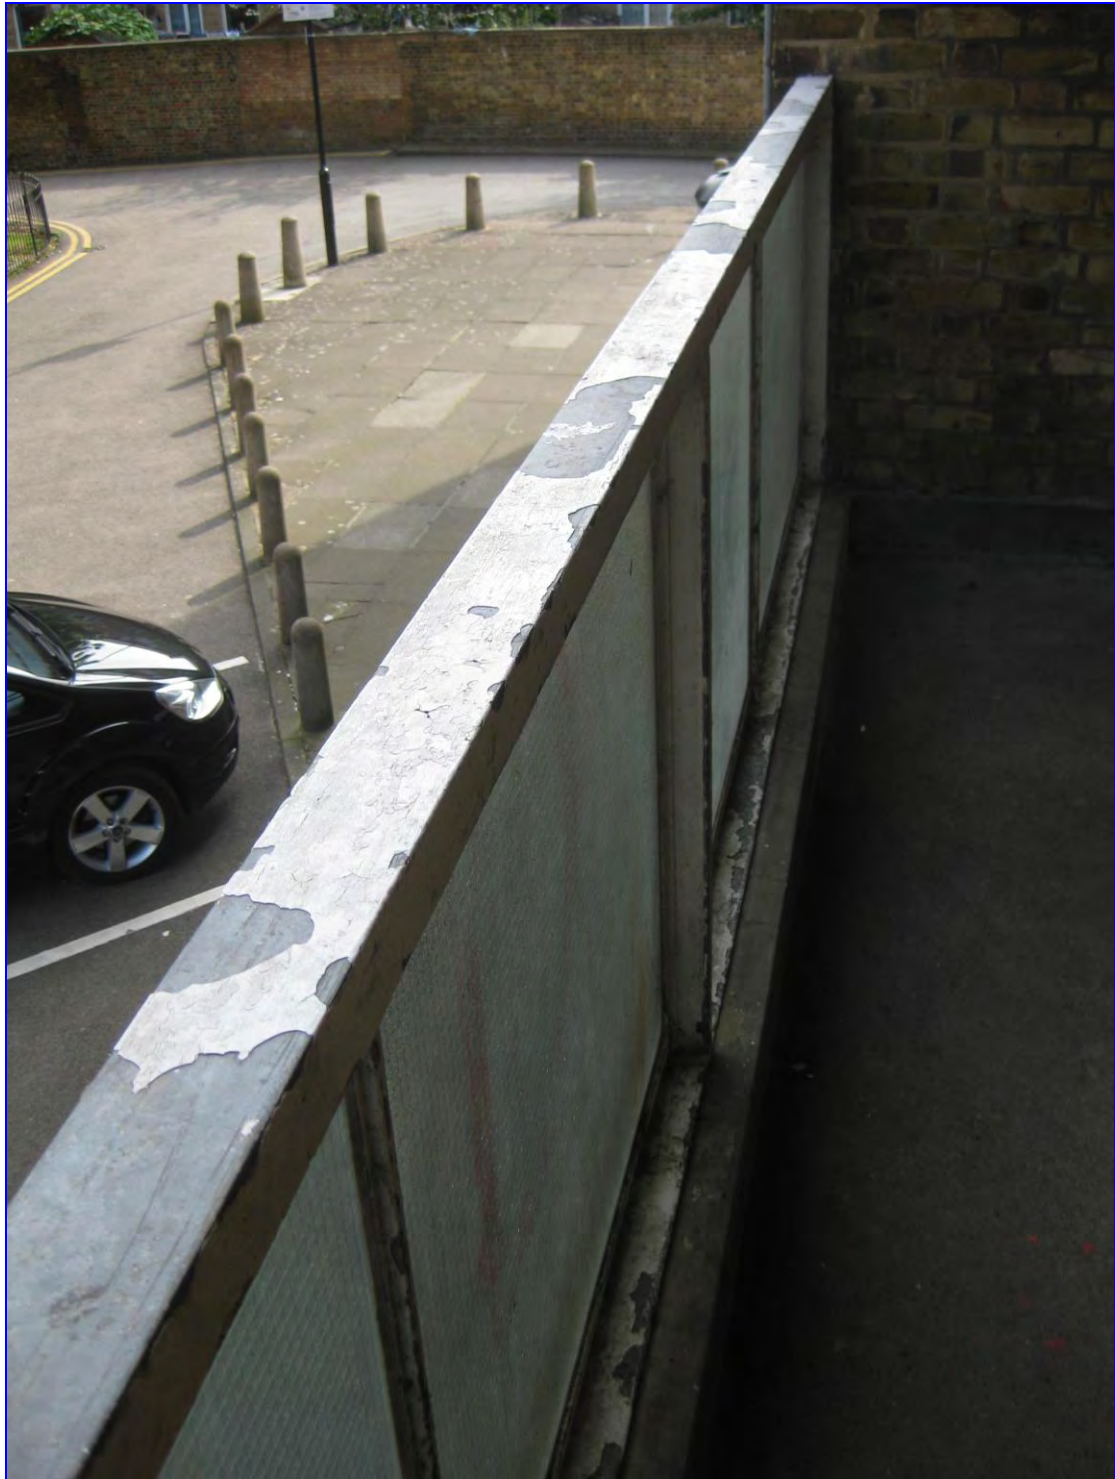
Photograph 18: Example of deteriorated paint coatings to handrail glazing system on walkway.

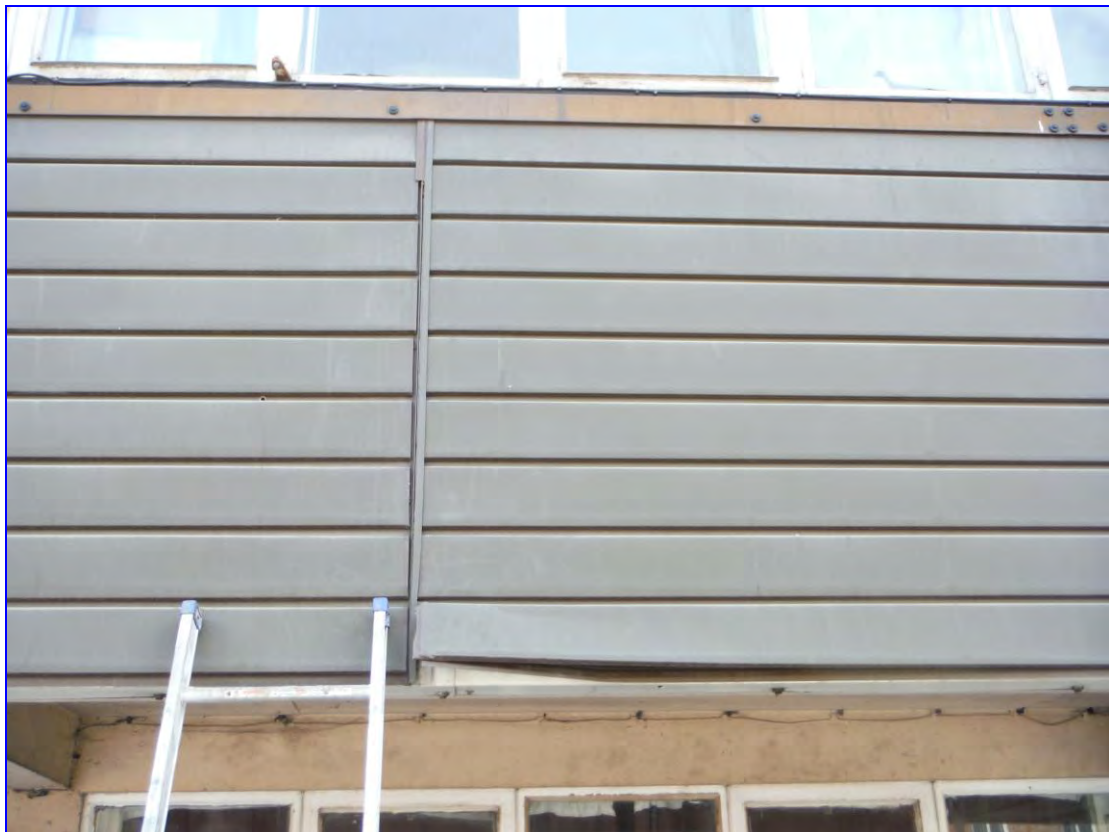
Photograph 19: General view showing typical metal cladding (on Lister House).

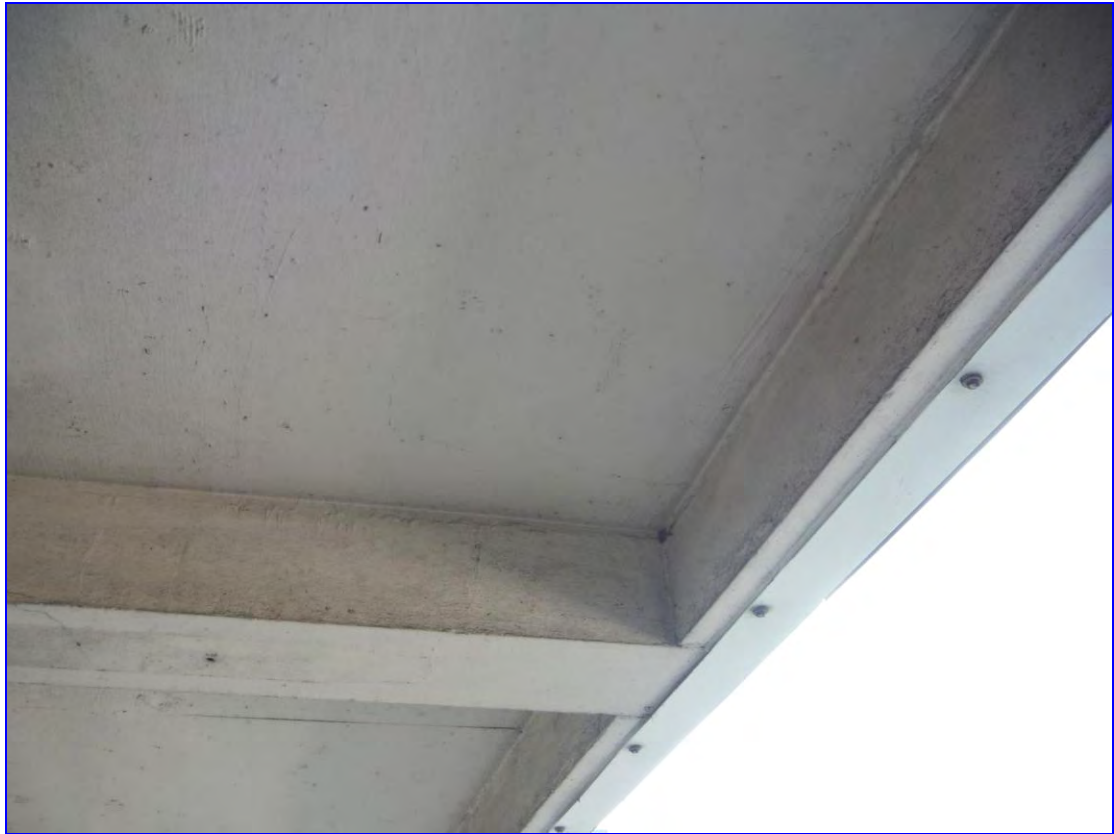
Photograph 20: View showing metal cladding secured along base of concrete slab edge. Note concrete exposed - first floor on Lister.

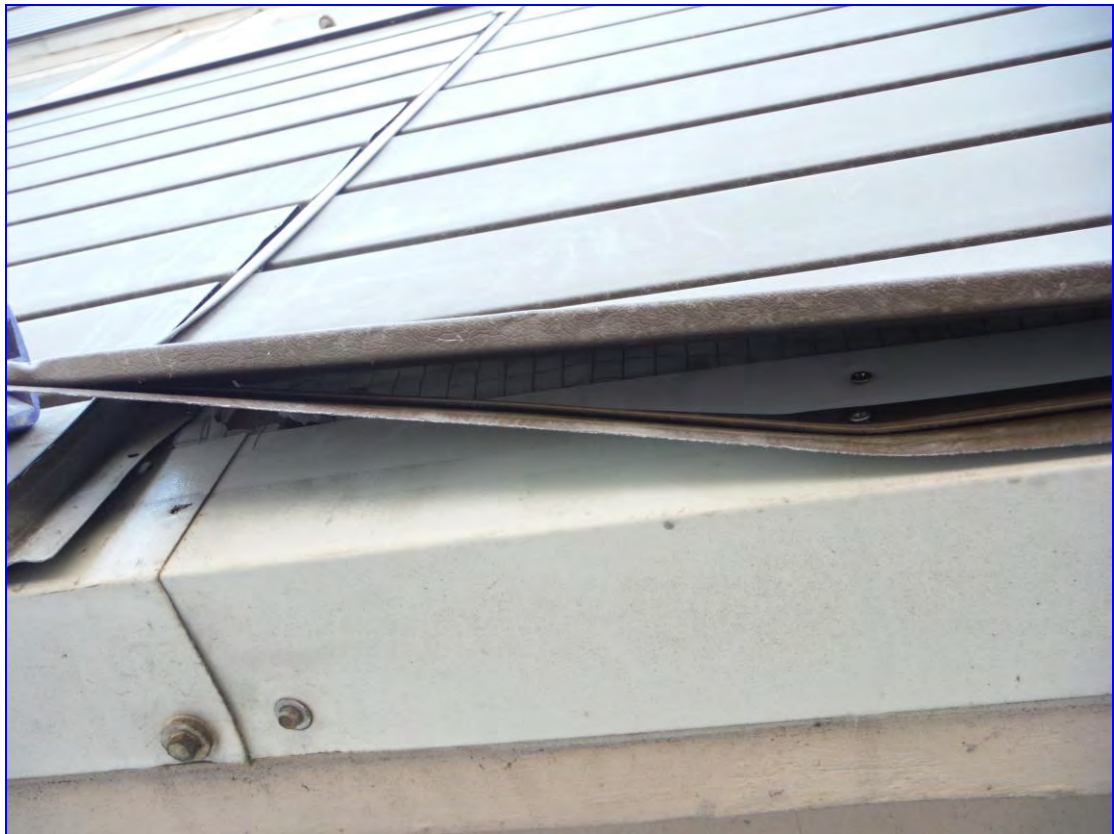
Photograph 21: As lower section of metal cladding lifted revealing edge strip over concrete.

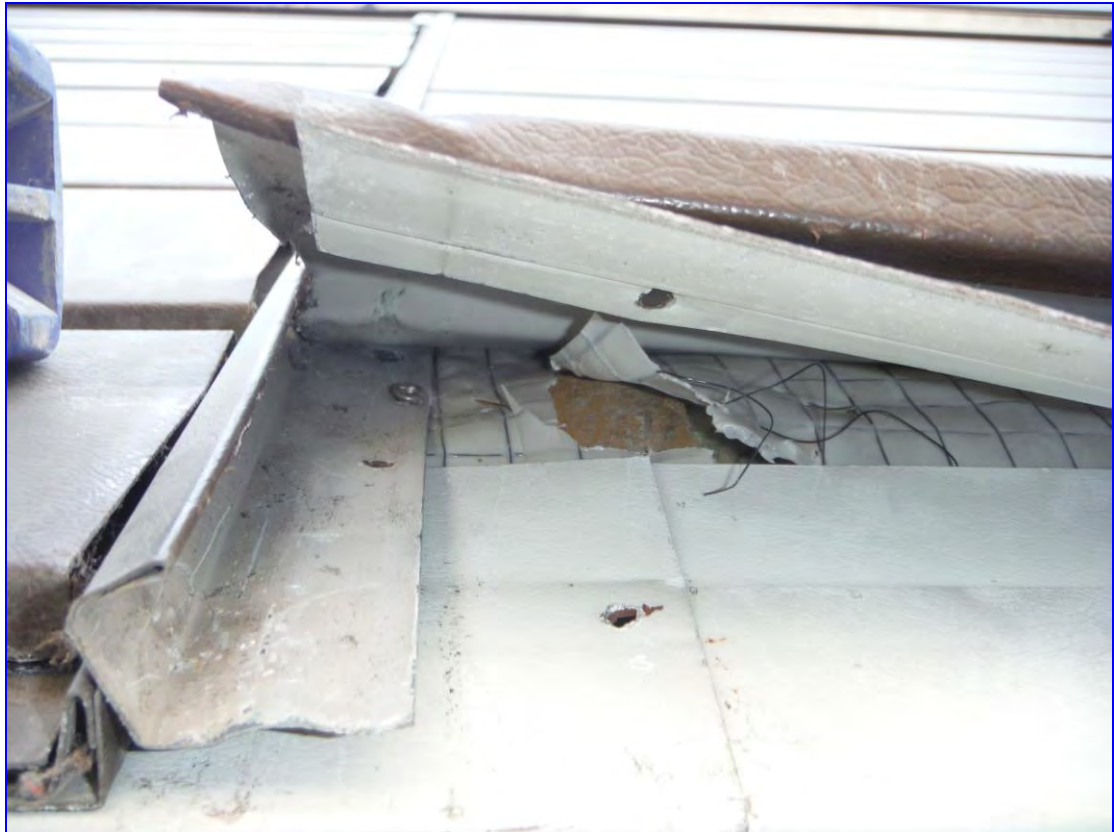
Photograph 22: View showing metal cladding with reinforced sheet behind, over wall insulation (broke through to expose it).

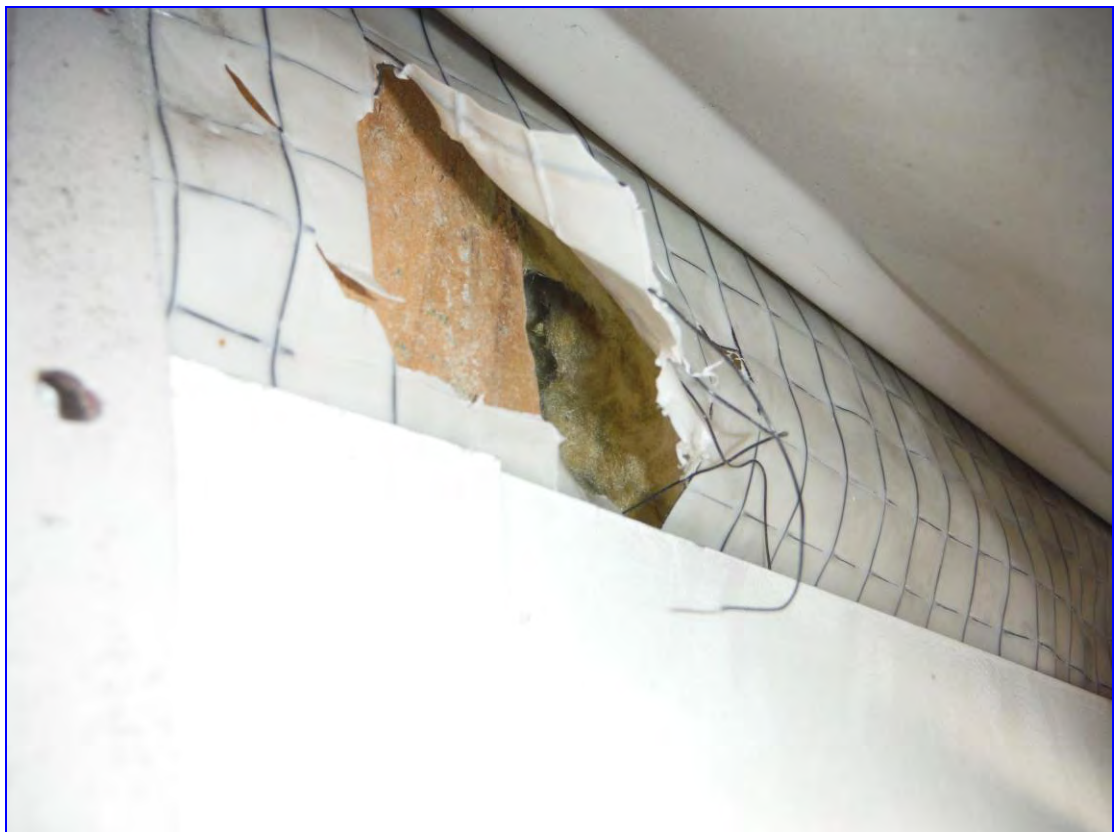
Photograph 23: A closer view, as previous photograph, showing insulation dug out to concrete behind.

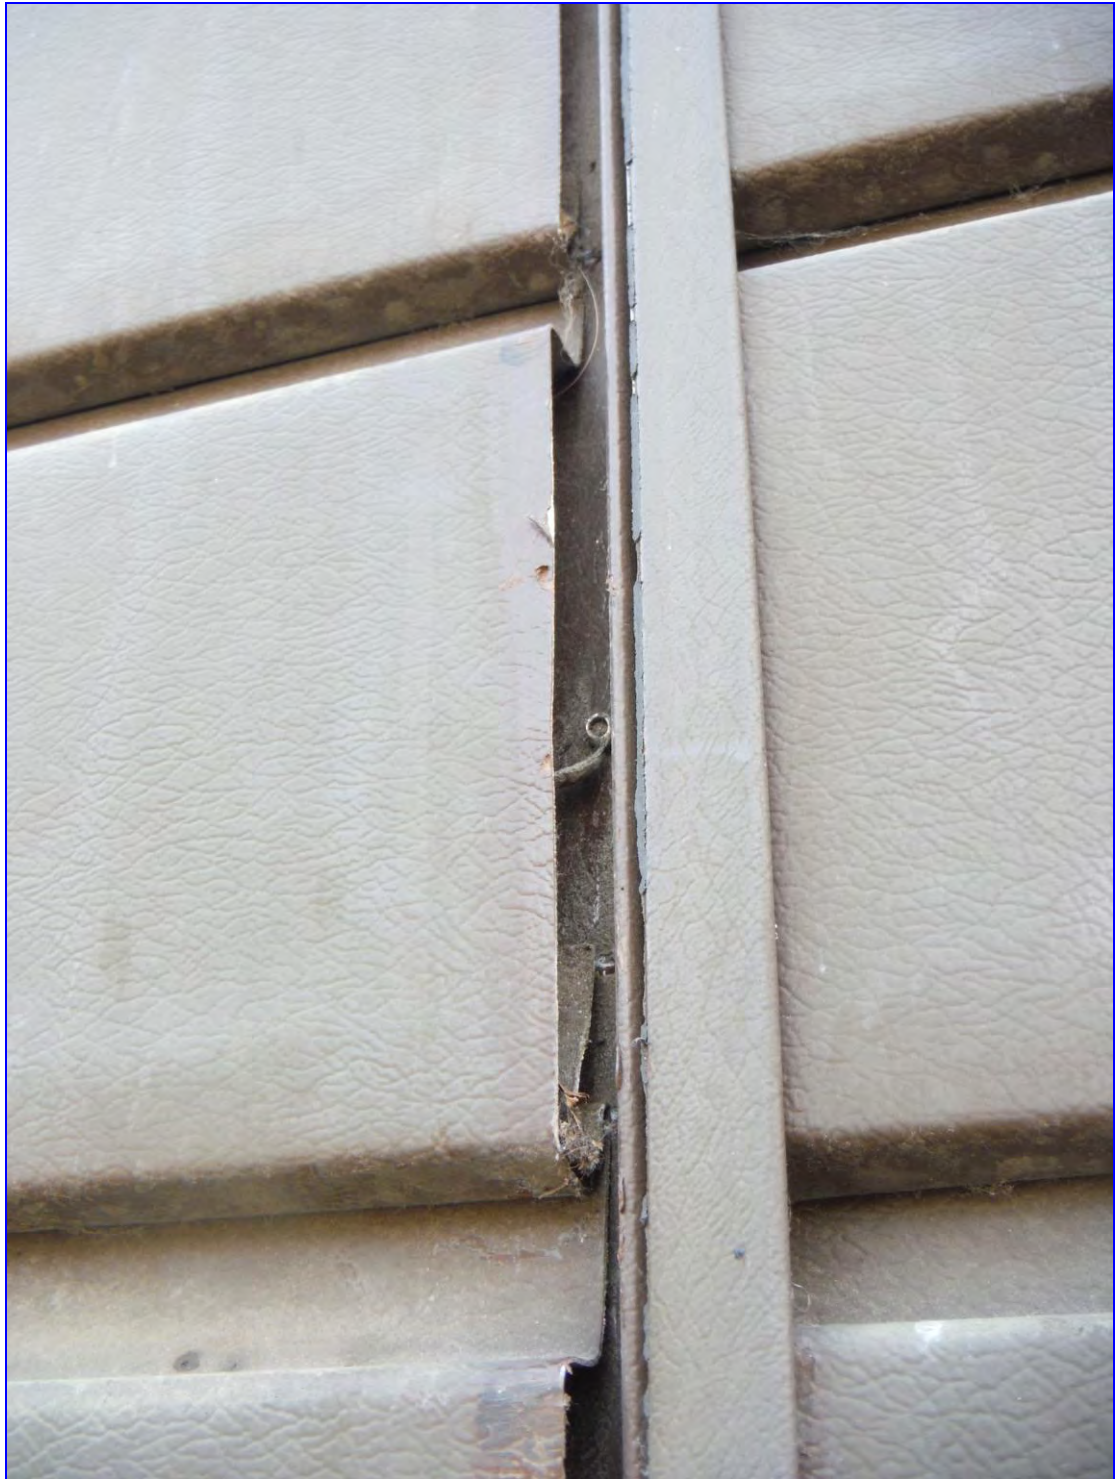
Photograph 24: View showing typical metal cladding profile externally.

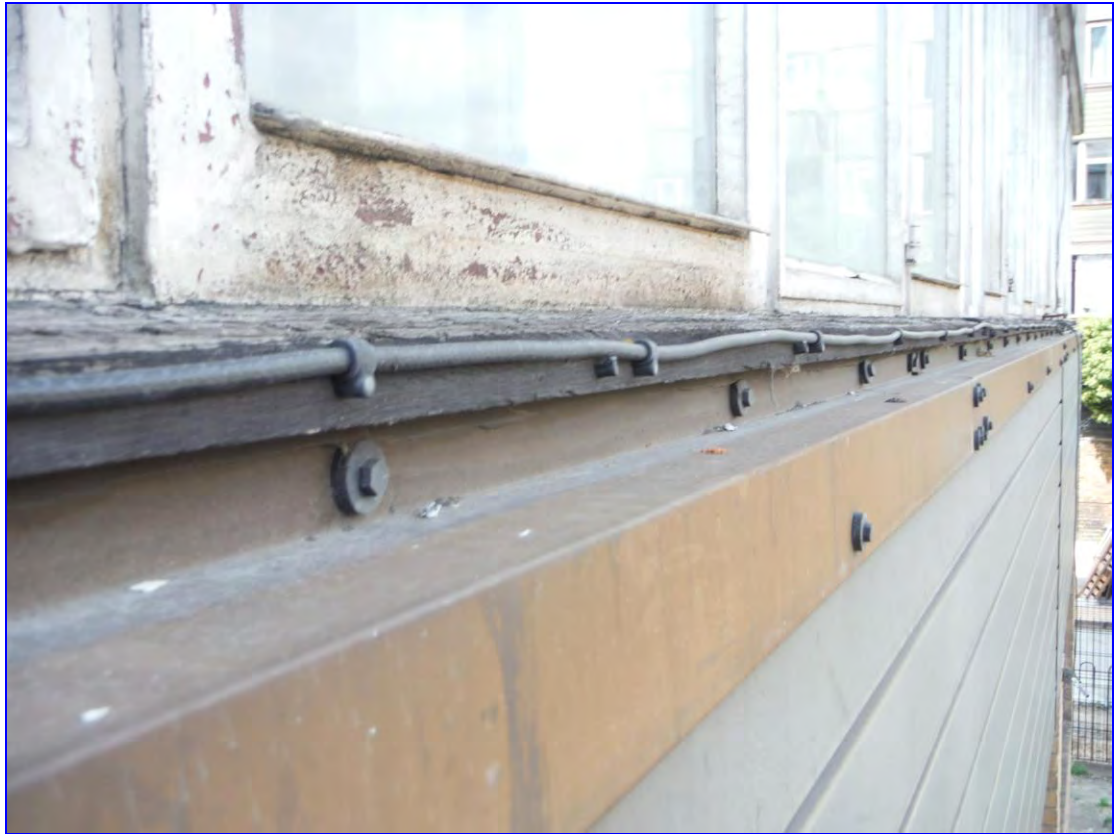
Photograph 25: General view showing typical fixing of cladding at timber work directly below window openings.

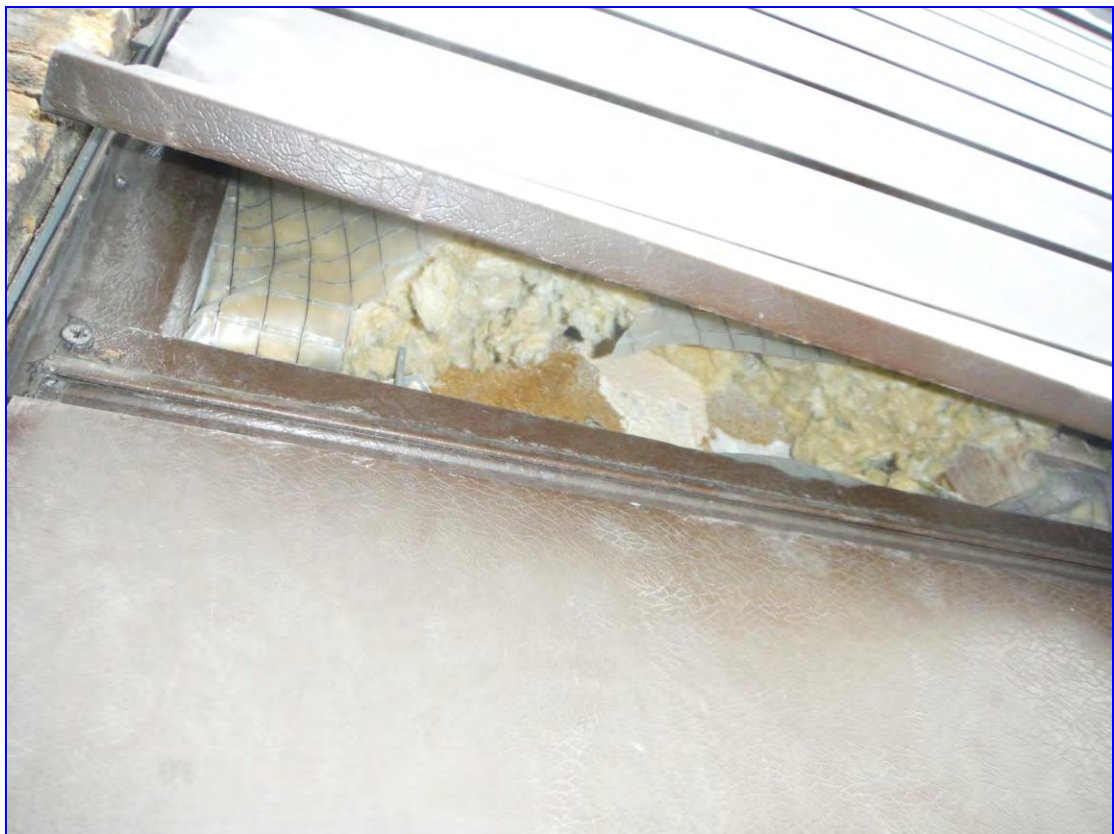
Photograph 26: Another opening up revealing insulation covered by reinforced sheet (on Treves House).

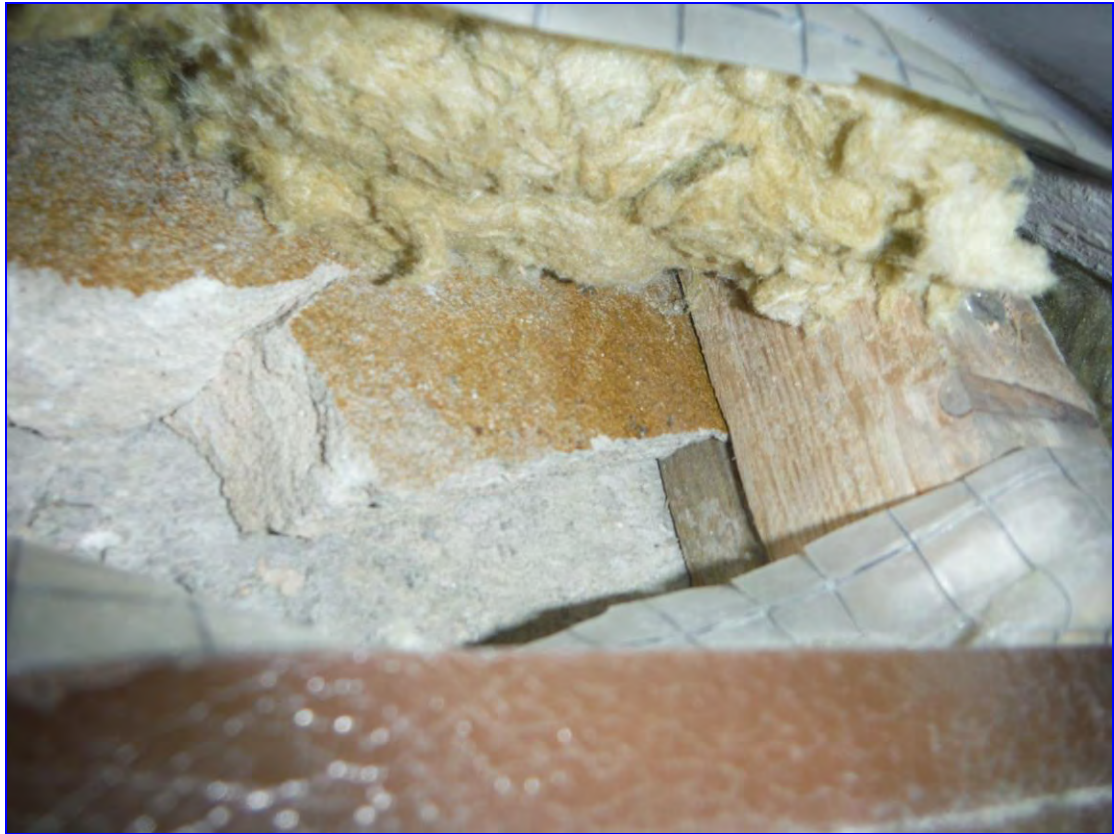
Photograph 27: As previous photograph but opened further revealing timber framework secured back to concrete. Here a render layer behind the insulation is also apparent.

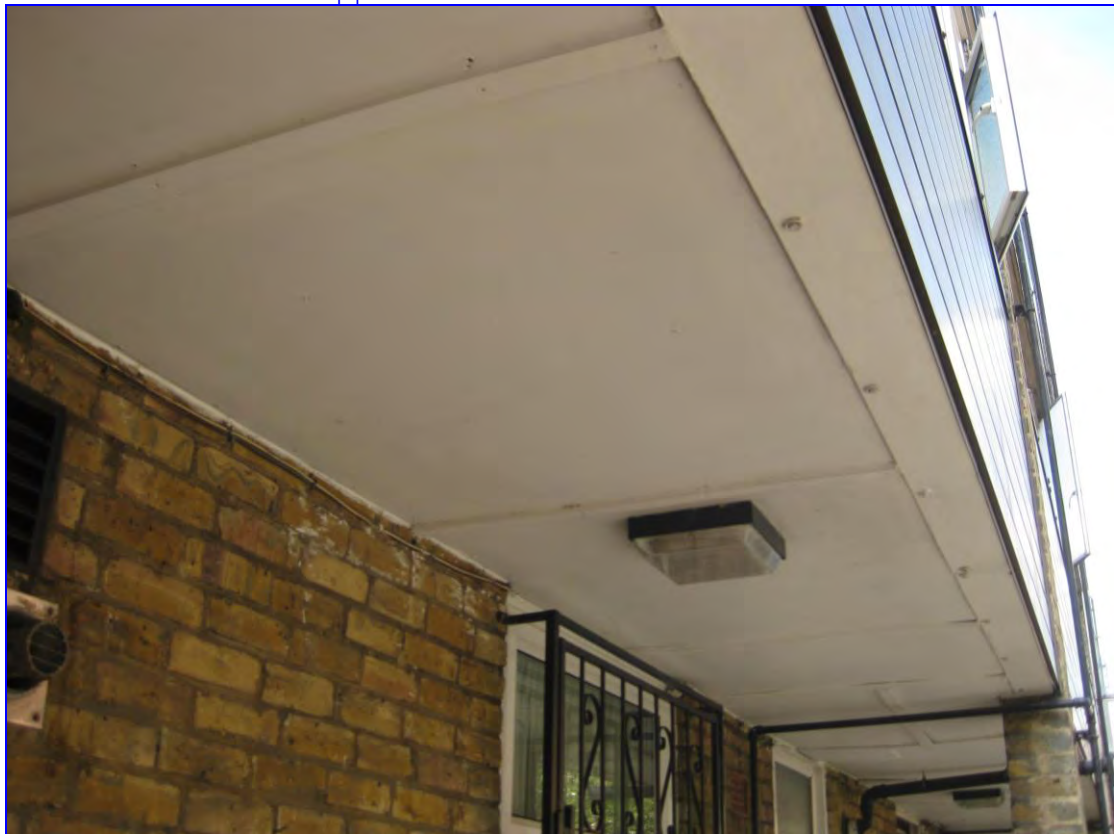
This was checked in a few locations and found to be repetitive to both Lister and Treves Houses. On Treves House there was old boarding to the floor soffit of unknown material.

Photograph 28: General view of underside at walkway to Treves, with boarding across the soffit.

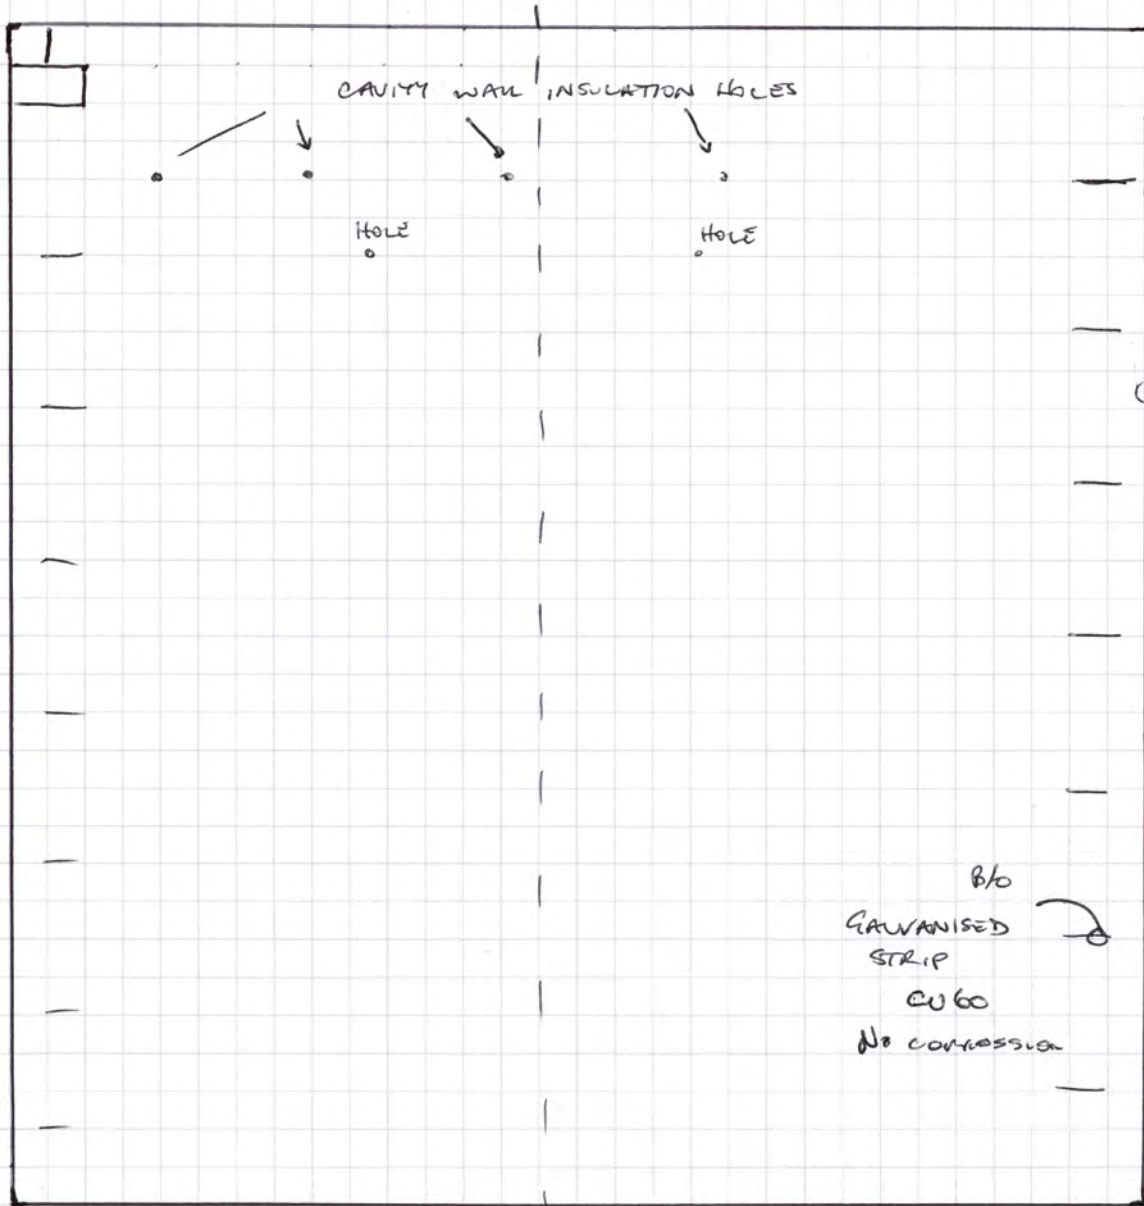
Location BWR 1.

Polystyrene ball insulation
80mm cavity

Stretcher bond brick outer
Mortar ok

No other ties detected

↑
300mm cavity
Service duct
pipe (gas water?)

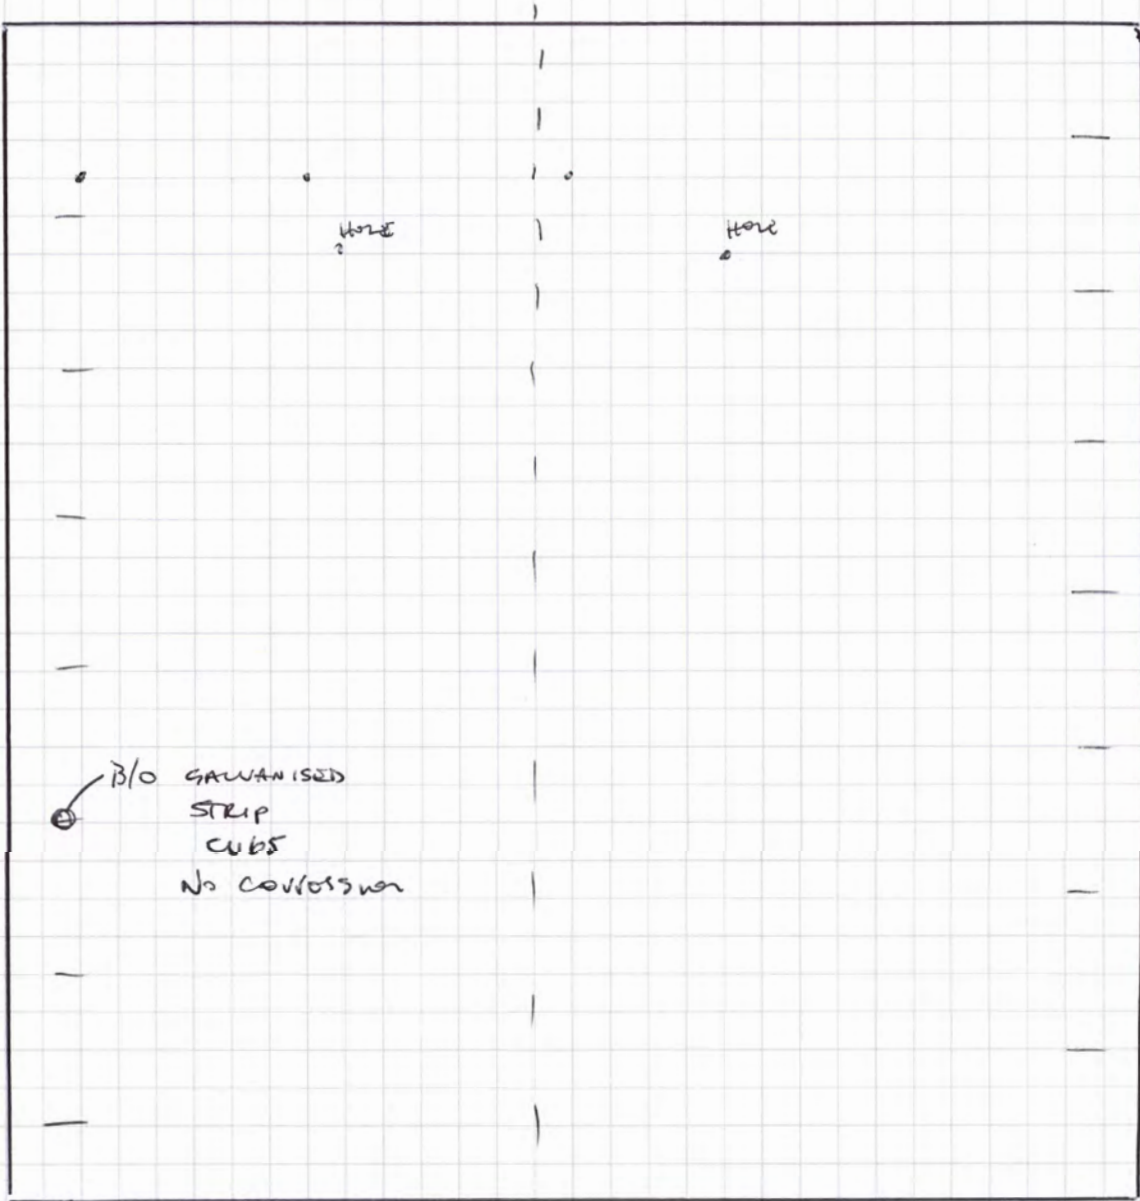
Location BWK 2

↑
 Polystyrene ball insulation
 30mm cavity
 Stretcher bond brick outer
 Mortar 22
 No other ties detected

↑
 300mm cavity
 Service duct.

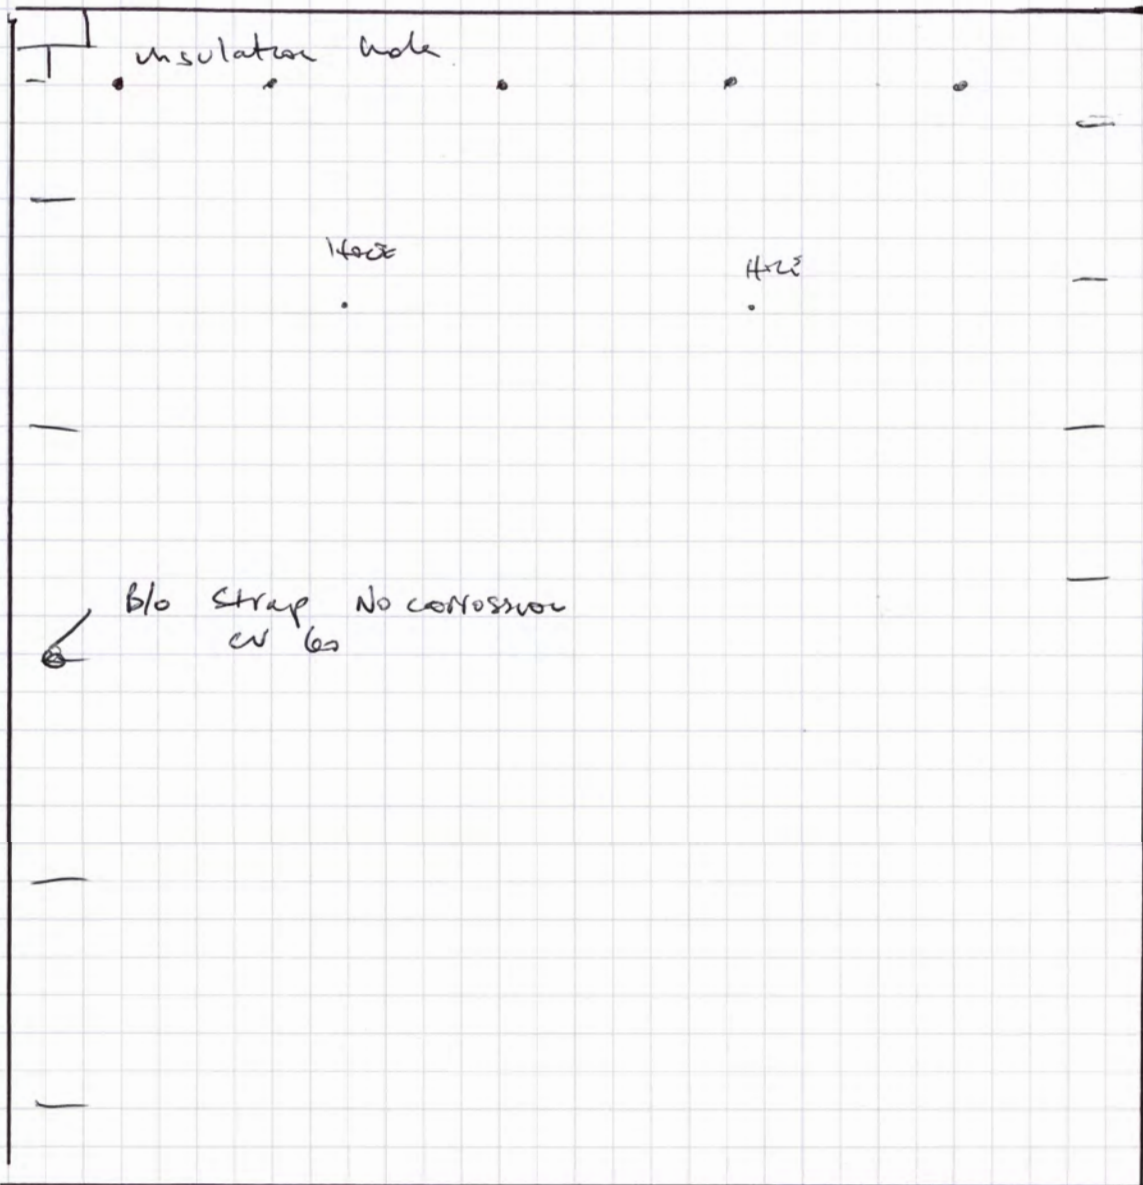
Location Buive 4

BRICKWORK OUTER STRUCTURE BOND
POLYSTYRENE BALL CAVITY INSULATION
MORTAR OR
80mm CAVITY.

No other ties detected

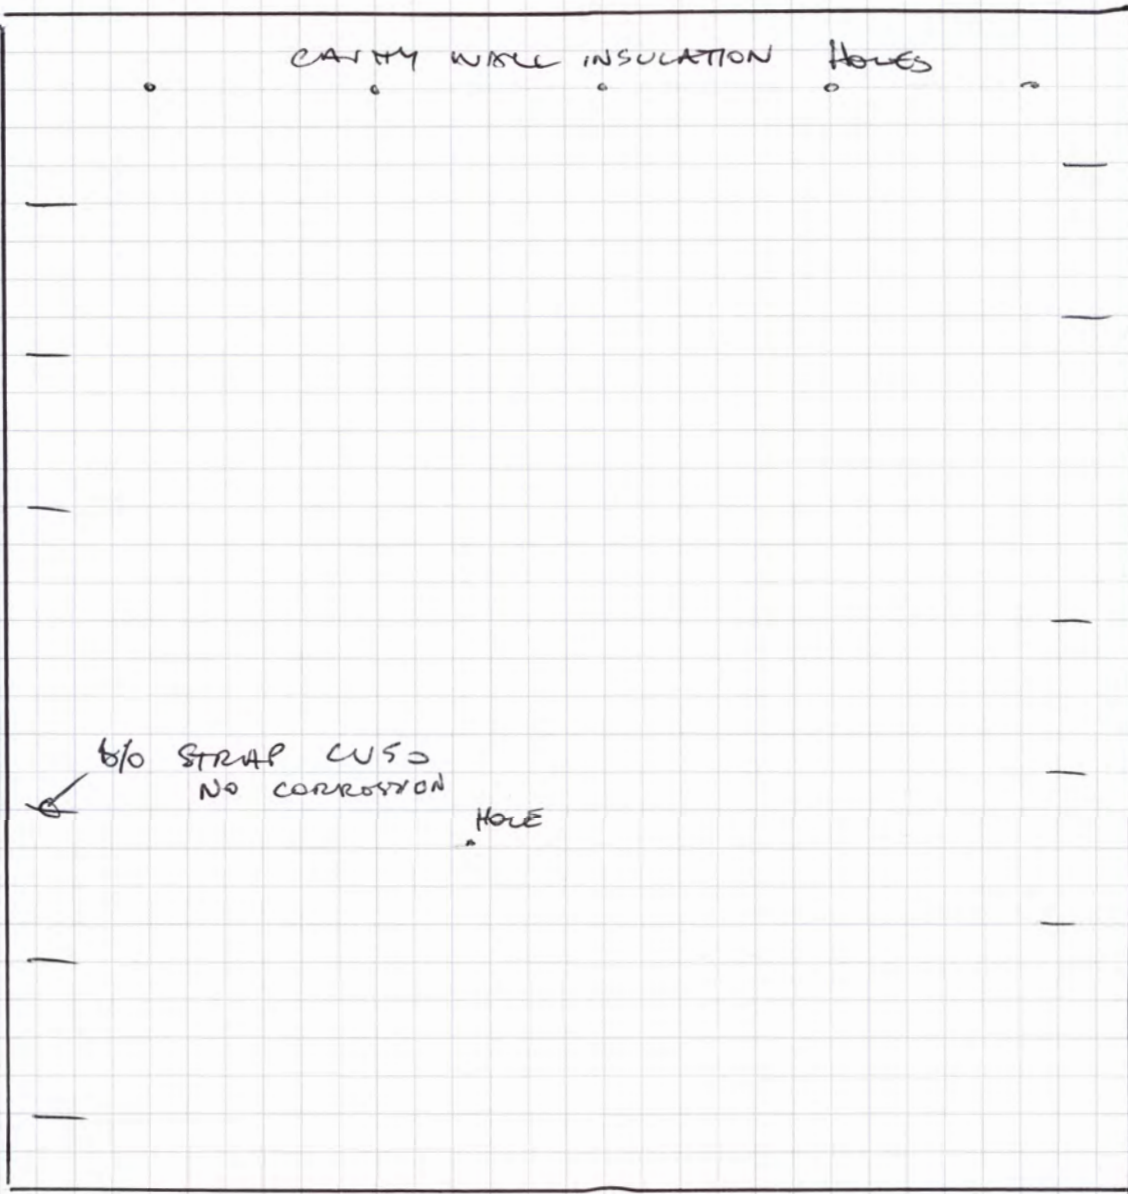
BNK 5 4th Floor

BRICKWORK OUTER STRUCTURE BAND
 MORTAR DR.
 CAVITY WALL INSULATION POLYSTYRENE BEADS
 CAVITY 40mm
 No other ties detected

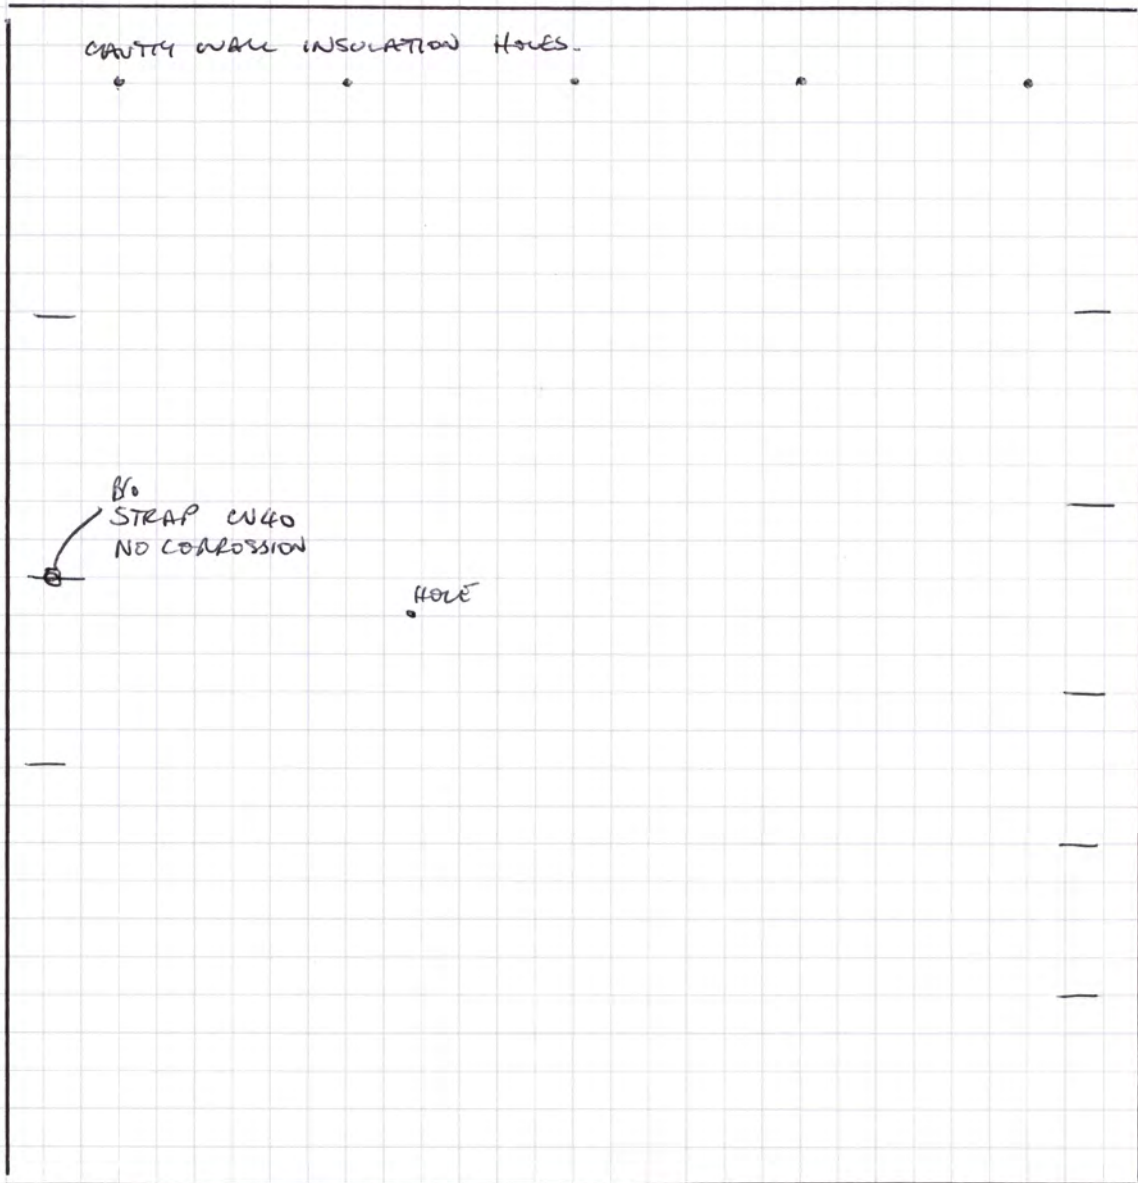
Location Bulk 6

BRICKWORK ON STEEL STRUTTING BOND
MORTAR OR
CAVITY WALL INSULATION POLYSTYRENE BEADS
CAVITY WIDTH 80mm

No other ties detected.

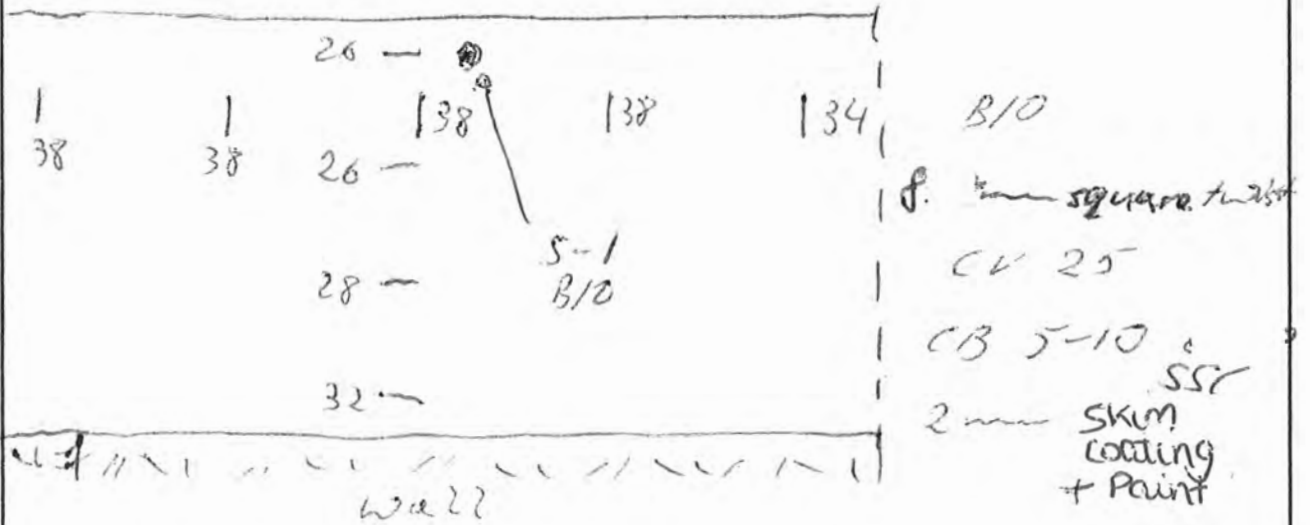
TA 1 Fire escape balcony slab 6th floor

A breakout at TA1, 6th floor fire escape balcony soffit, revealed an 8mm square twisted bar. The cover was 25mm and the carbonation was 5-10mm and the bar had slight surface corrosion. It should be noted that the chloride result for here was high risk at 0.97%. There was a 2mm skim and paint layer to the surface.

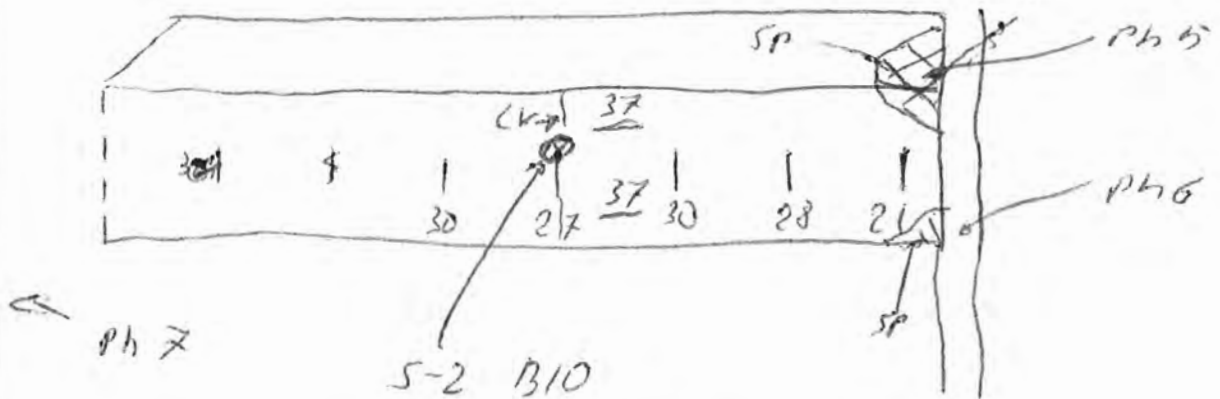
TA 2 3rd slab edge

A breakout at TA2, 3rd floor slab edge, revealed a pair of 6mm \emptyset plain bars which were clean and passive. The cover was 24mm and the carbonation was <5mm. There was a 4-5mm skim and paint layer to the surface.

4-5mm Skim + paint

B10 2x 6mm plain bar CV 24 CB C5

C+P

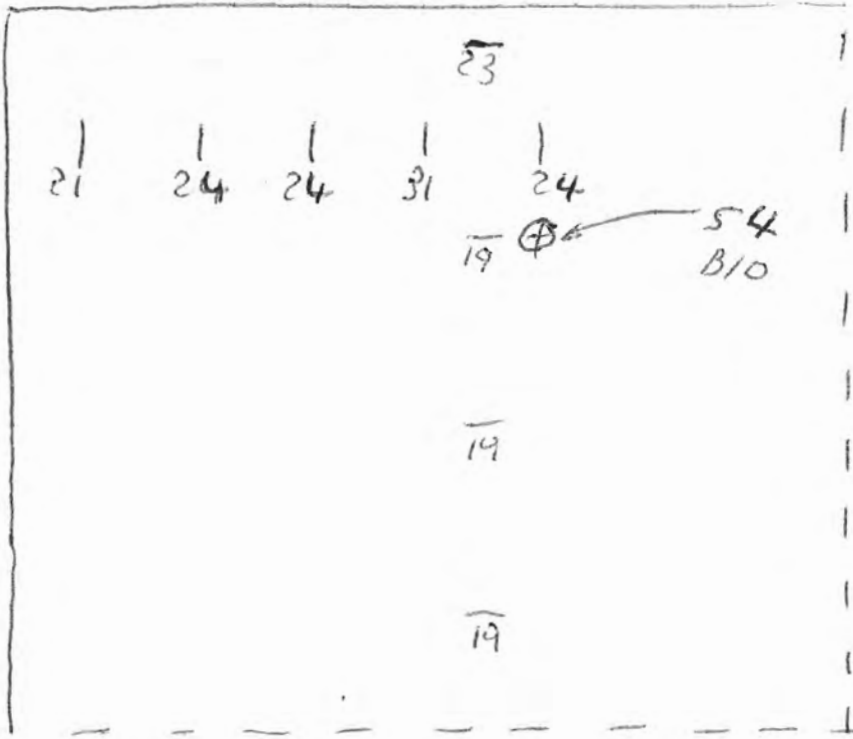
TA 4 7th Floor Stair Way Wall

A breakout at TA4, 3rd floor stairway wall, revealed a horizontal 6mm \emptyset plain bar and a vertical 10mm \emptyset plain bar at a minimum cover of 16mm. The carbonation was 5-10mm and the bars were clean and passive.

B/10 ← 6m plain bar CV 16
↓ 10m plain bar CV 21
CB 5-10 C + P

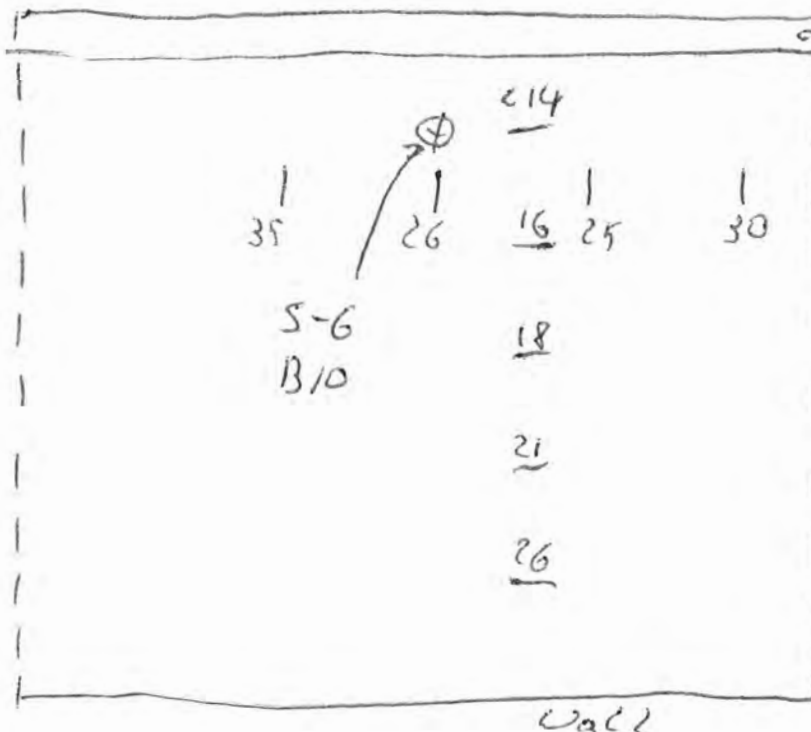
TA 6 First Floor Soffit

At TA6, 1st floor soffit, a breakout revealed an 8mm square twisted bar at a cover of 12mm with slight surface corrosion. It also revealed a perpendicular 6mm \emptyset plain bar at 21mm cover which was clean and passive. The carbonation was 5-10mm. The chloride test result for here was 1.12%.

8 in square twist
w/ 4
CV 12 SSC

1 in plain bar
C/P
CV 21

CB 5-10

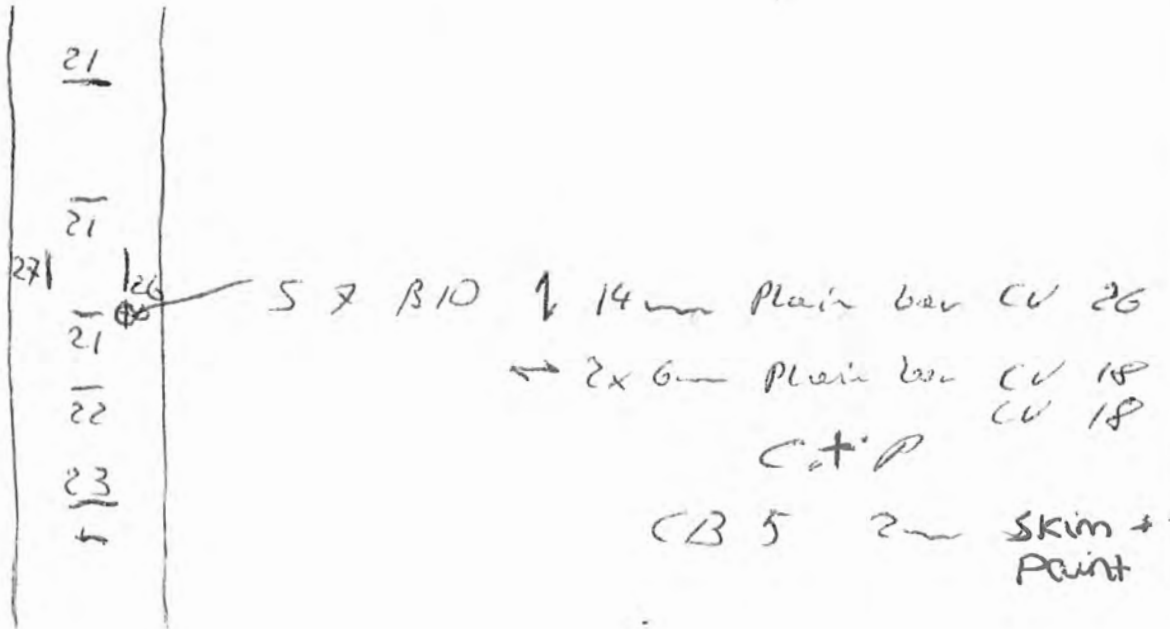
TA 7 8th Floor Column

A breakout at TA7, 8th floor column, revealed a 14mm \emptyset plain bar and two perpendicular 6mm \emptyset plain bars at a minimum cover of 18mm. The carbonation was 5mm and the bars were clean and passive. There was a 2mm skim and paint layer to the surface.

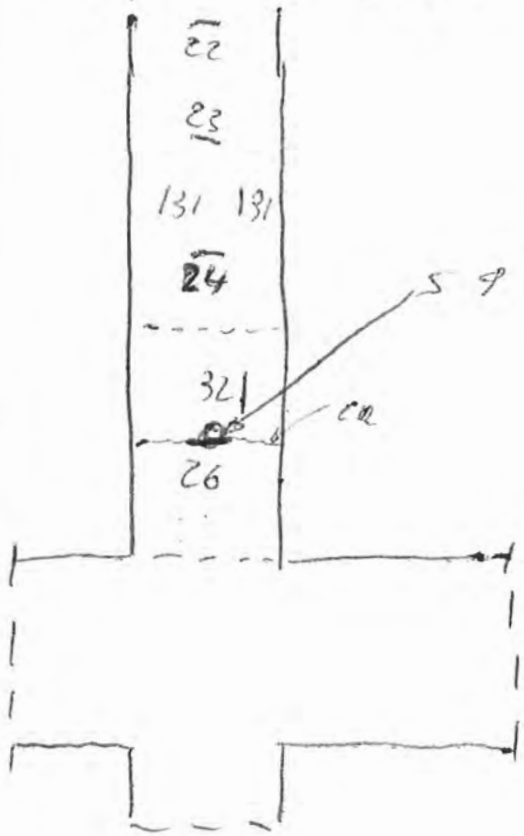
TA 9 8th Floor Column

At TA9, 6th floor column, a breakout over a crack revealed a 12mm \emptyset plain bar with surface corrosion. The cover was 28mm and the carbonation was >40mm.

5 9 B10 → 12mm Steel plank
 CV 28
 SC
 CB > 40
