The test results obtained at Lister and Treves Houses indicate that there is significant deterioration to the various elements.

Project LISTER & TREVES HSES.

Date _____
Report No 14093

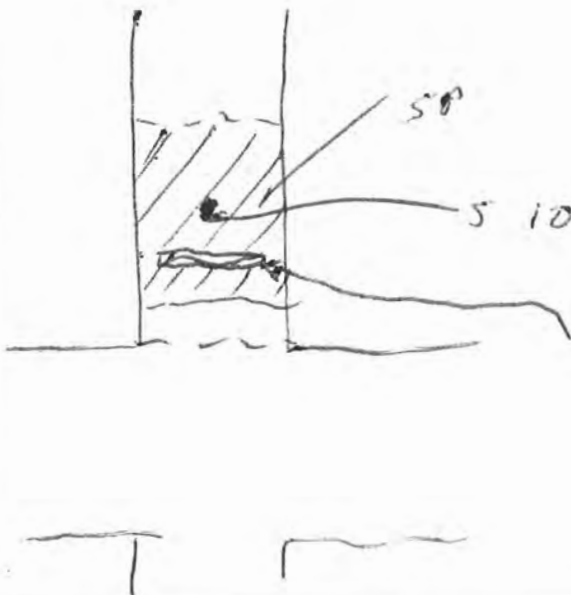
TA 10 3rd Floor Column

5 10 CB < 50 Patchy
 12mm 525
 Orig. CV 24mm

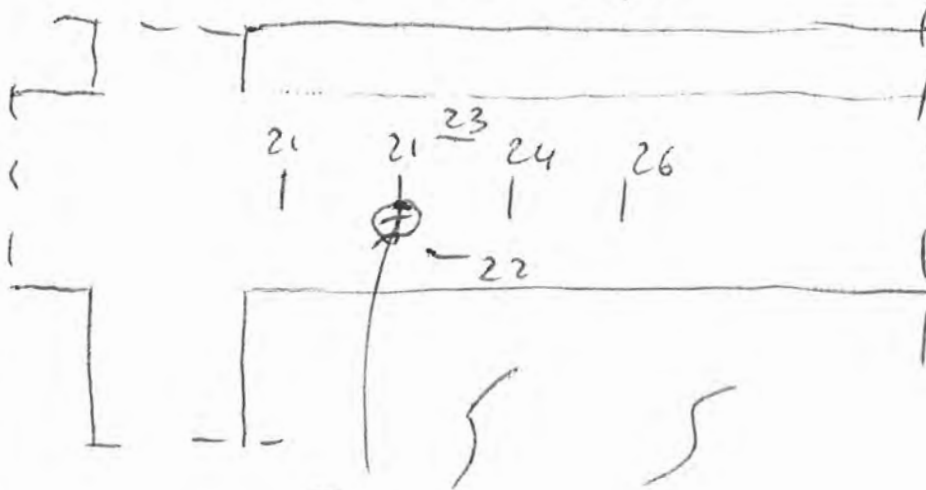
TA15 3rd Floor Slab Edge

A breakout at TA15, 3rd floor slab edge, revealed a 6mm \emptyset plain bar at 20mm cover. The carbonation was 5-10mm and the bar was clean and passive. There was a 2mm skim and paint layer.

16m plain bar @ 20 C+P

CB 5-10

2mm Skim + Paint

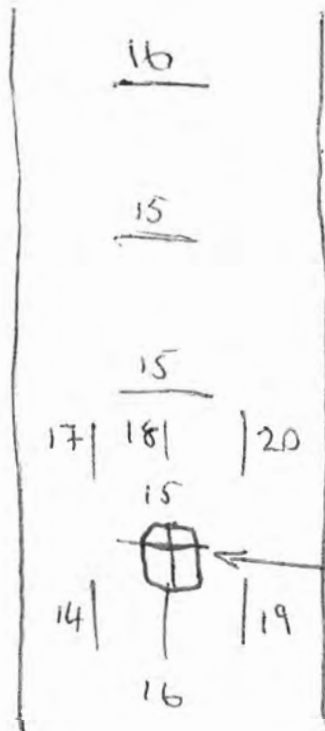
A18 Ground Floor Column

Finally a breakout at TA18, ground floor column, revealed a 12mm \emptyset plain bar at 20mm cover and a pair of 6mm \emptyset plain perpendicular bars at 14mm cover. The carbonation was <5mm and the bars were clean and passive.

S18/B.0
CB < 5

1x Main plain Bar 22 mm ϕ
 CV TO main 20 mm
 C+P
 2x 6mm ϕ Plain Links
 CV 14
 C+P
