Fish Island Section 19 Flood Investigation

08/08/2024

EXECUTIVE SUMMARY

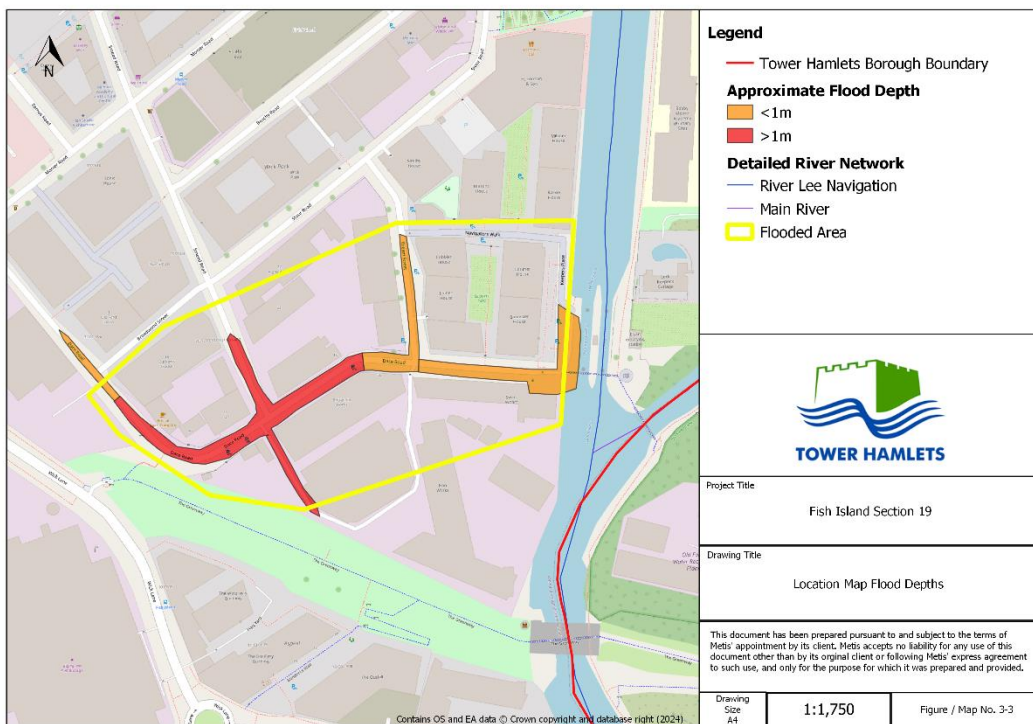
Local businesses and residents reported significant losses, for example, of equipment from camera studios, furniture, and stock, due to the 4th January flooding incident. As Hackney Wick is a designated Creative Enterprise Zone, with multiple affordable warehouses and live-work spaces for artists, many residents store equipment in the studios so the loss of this equipment and days of work resulted in a significant financial burden. Dampness and mould have been reported since the incident, which has caused a potential health hazard to impacted residents and business owners. Most internal flooding reports were received from the Peanut Factory, a live-work unit located on Dace Road. The flood waters reached a level of approximately 1 m in this area and is shown within the red area of *Figure 3-3*.

Figure 3-3 Locations of flooding with approximated depths

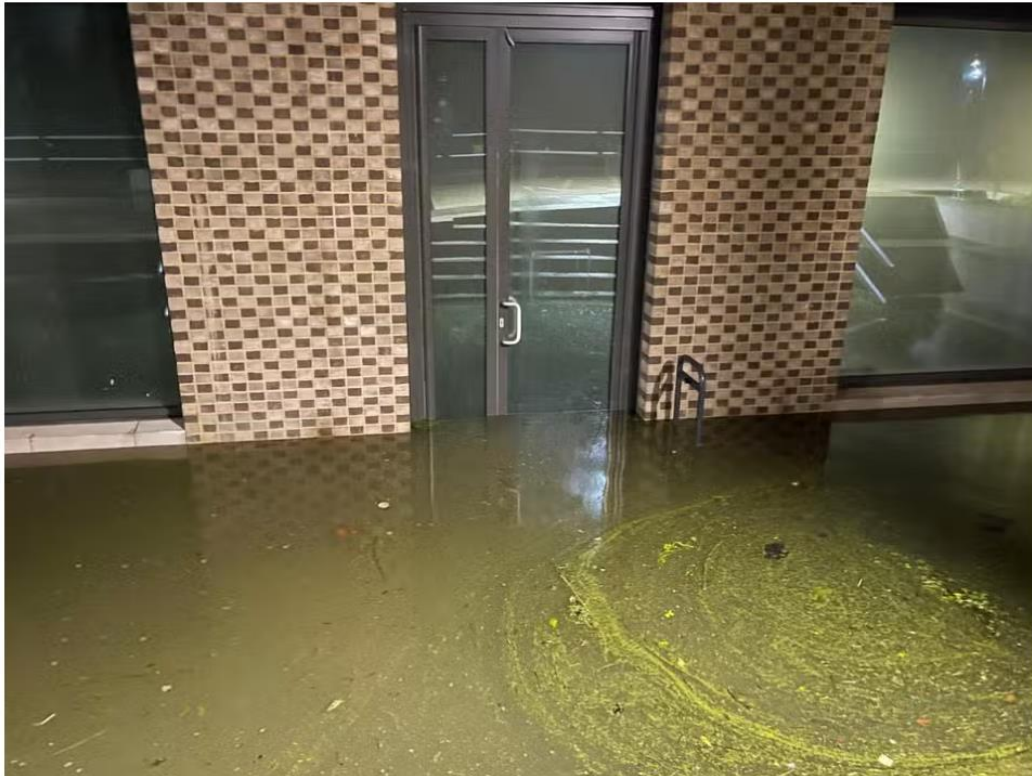
However, the distance of these rain gauges from the site does introduce some uncertainty. *Figure 3-6* and *Figure 3-7* evidence the canal overtopping and height of flooding respectively.

*Figure 3-6 Water level on Dace Road 4th January 2024
(Source: [The Evening Standard](#))*

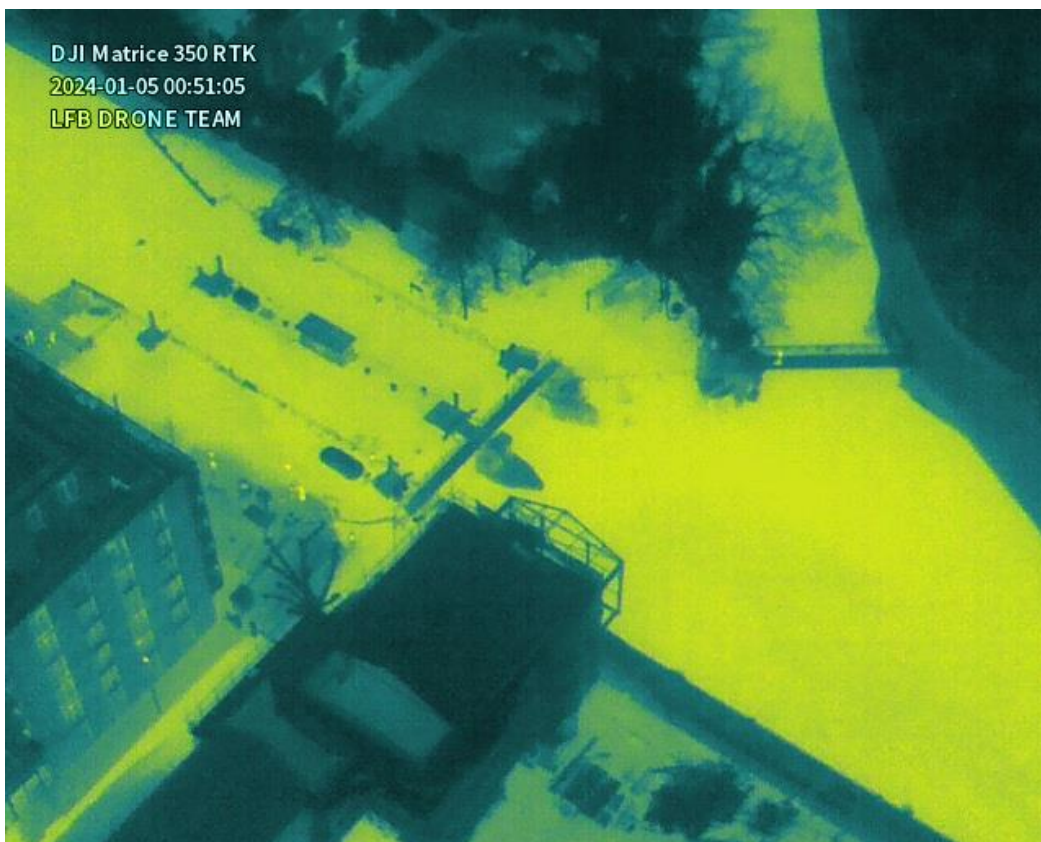
*Figure 3-7 Drone imaging of flooding on the 5th January 2024 00:51
(Source: London Fire Brigade)*

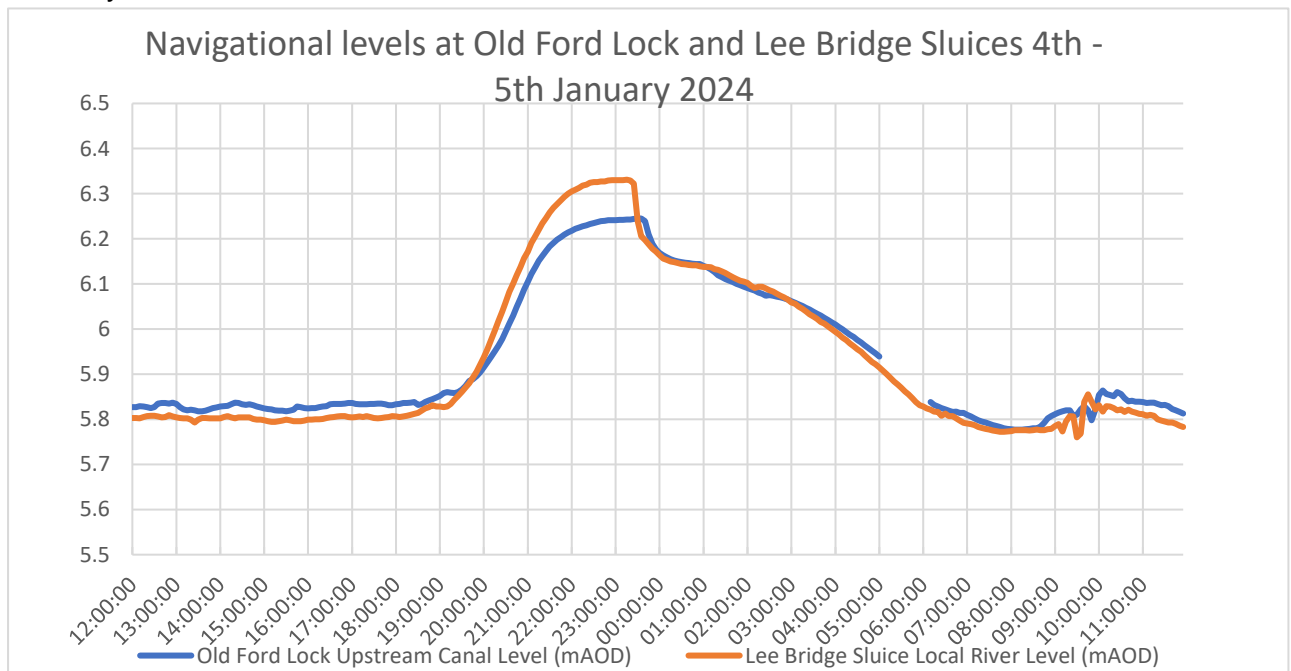
The usual range of the River Lea at Lea Bridge is between 5.78mAOD and 6.10mAOD. It has been between these levels for 90% of the time since monitoring began, according to information available at the time of writing. *Figure 3-8* illustrates the 4th January flooding event caused levels far higher than this (~6.33m) and also demonstrates that the water level rising occurred far earlier than the lock gate was opened (01:00). Significantly, The Trust assets in this area have been in below optimum condition since 2021 when sluice D was rendered inoperable due to a twisted frame and then in late 2021, sluice C started to demonstrate the same failures and was locked off but could still be used in manual mode if necessary. According to EA data, with all Lea Bridge Sluice gates operational, they were designed to convey 70 m³/s. EA telemetry data from Lea Bridge Road gauging station (TQ3517787240, approx. 800m upstream) shows that flows did not exceed 50 m³/s on 4th /5th January 2024.

It should also be noted that in the morning of 4th January “Sluice B” failed and had to be opened manually, it was subsequently opened 5%, then by the early evening (19:43) the “High High” alarm (second of a two tier warning system of canal water level) sounded from both sluices. This should result in water controllers attending the automatic sluices, however, no action occurred on site until 23.00. The Water Control Manual (London Waterways East) states that specifically for “Old Ford Lock” or “Lea Bridge Sluices” SCADA sites any water level alarm must always be followed up by the water control staff as both sites monitor levels in the same pound and abnormal water levels are likely to be caused by a failure of the automatic sluice. An empty pound will cause many boats to be grounded and a high pound could potentially overtop, threatening adjacent properties. It is therefore clear that ongoing technical issues with the sluices at Lea Bridge are causing an increased risk of canal flooding to the area, which would have contributed to the flooding experienced on 4th January 2024.

Figure 3-8 Canal levels data before, during, and after the 4th January 2024 flooding event (Source: Canals and Rivers Trust)

- The Trust to continue with project to refurbish the sluice system at Lea bridge and bring all 4 sluices back into automated mode. At present, the on-going issues with sluice malfunctions are causing a higher risk of flooding in the area; this should be addressed as a priority as repair / maintenance of these sluices is crucial to bring back the full capacity of the canal.

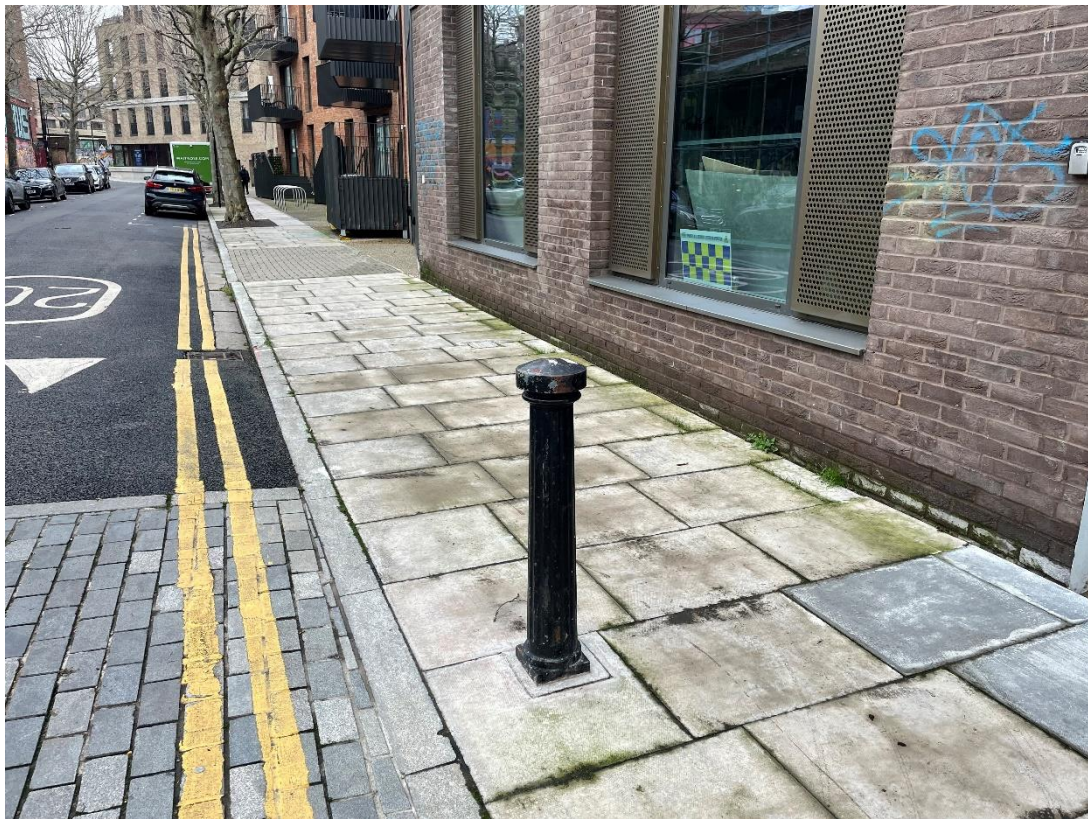
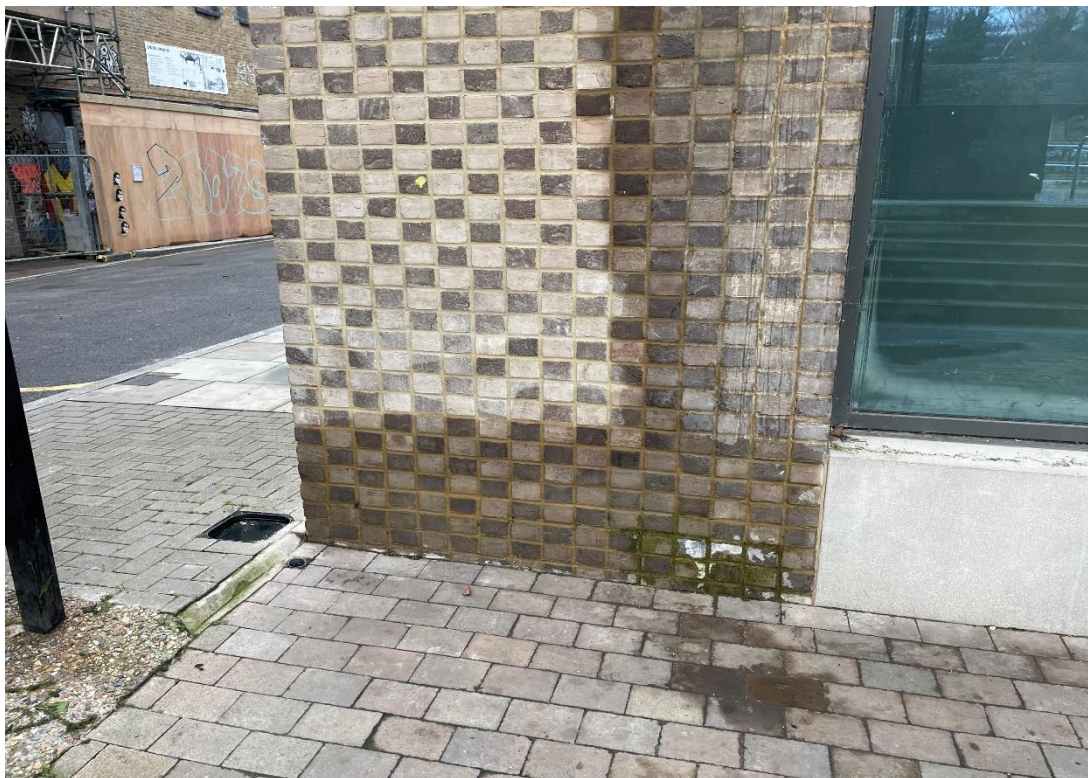
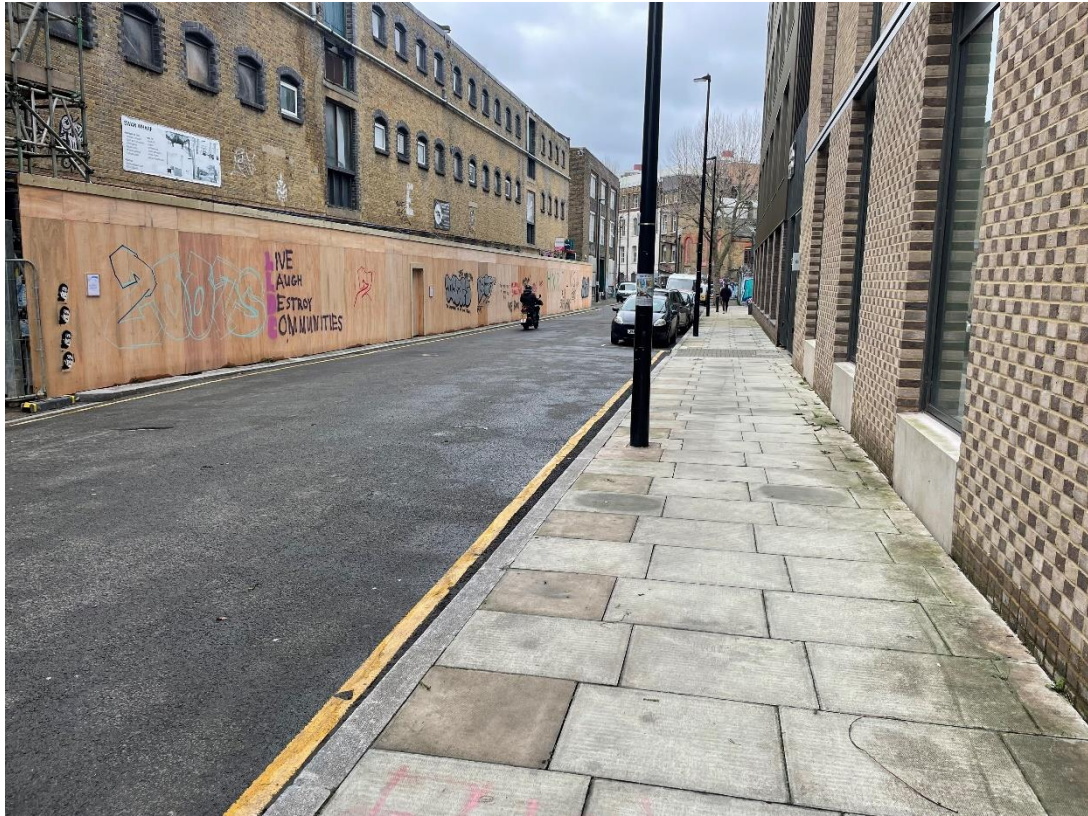
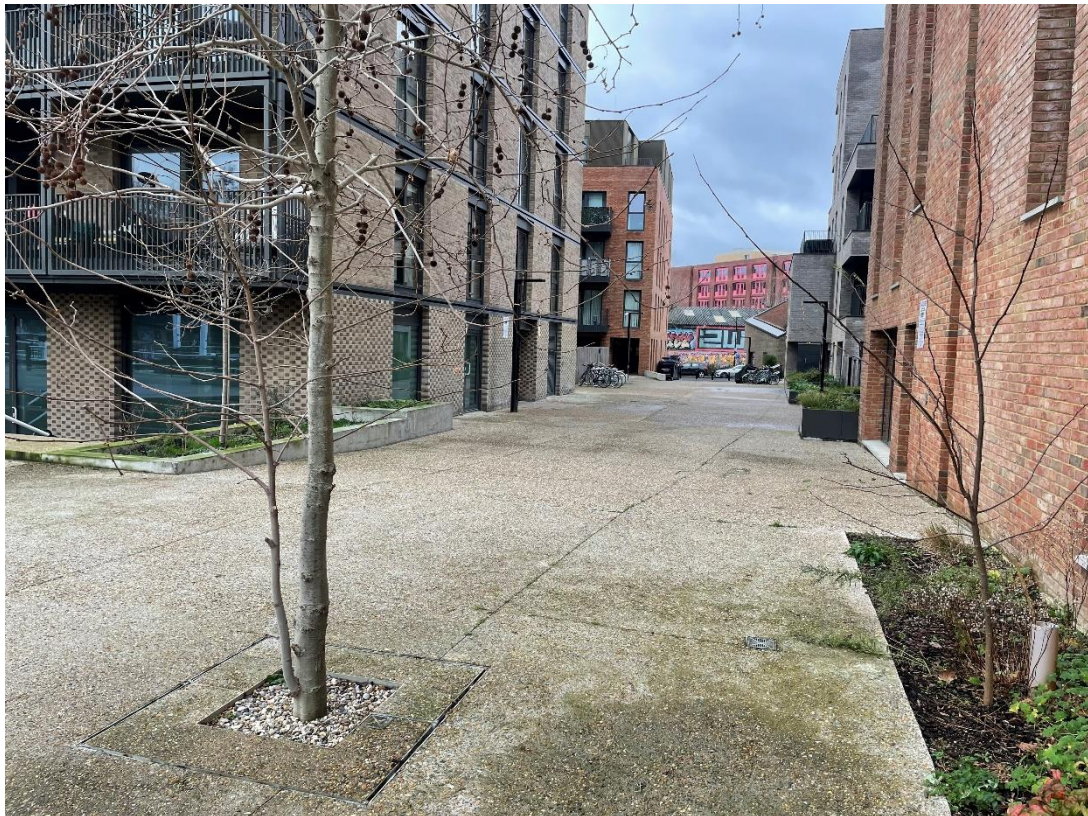
Appendix A – Photos received from Tower Hamlets following site visit

<p>at this time the water had receded. (Please see Appendix A for site photos). No gully drainage issues were noted during this site investigation.</p> <p><u>After:</u> Immediately following the flooding Tower Hamlets commissioned this Section 19 report to investigate the cause of the flooding and provide future recommendations to address flood risk in the area.</p> <p>Multiple businesses were affected by the flooding and Tower Hamlets have been in correspondence to aid residents and businesses with the process of applying for funding. (such as the Government payments for communities affected by flooding fund)</p> <p>Tower Hamlets have also provided £67,000 in both community and business recovery grants combined and a total of £5,744 of council tax discounts have been awarded.</p>
EA	<p><u>Before:</u> 02/01/2024 16:08 – In response to forecast rain and impacts from Storm Henk, a Flood Alert was issued for several areas including Lower River Lea from Hoddesdon to Canning Town (62WAF53LowerLee).</p> <p>05/01/2024 03:00 – Flood Alert Removed</p> <p>The debris screen camera network was actively monitored throughout the week and field operatives attended to clear the screens and any potential blockages throughout this period.</p> <p><u>During:</u> 04/01/2024 21:09 – A call was received from a member of the public regarding high river levels north of Hackney Wick and reports of debris on a weir. The Flood Incident Duty Officer passed this information to the customer and Operations Manager at the Canal and Rivers Trust.</p> <p>04/01/2024 21:36 – The EA received the first reports of flooding to property in the Hackney Wick area.</p> <p>04/01/2024 22:09 – The Flood Incident Duty Officer (FIDO) contacted the emergency contact at The Trust. FIDO checked if The Trust were aware of this situation and asked what was being done at Lea Bridge Sluices to maximise flow. The call handler confirmed The Trust were aware of the situation, that people were attending the site, and that it was the sheer volume of water that was causing the problems. The handler said that when there is such a large volume of water and rainfall, there is nothing else that can be done.</p>
