**EXAMINATION OF LBTH LOCAL PLAN
HEARING STATEMENT TOM RIDGE (EEWG)
MATTER 10: SITE ALLOCATIONS
ISSUE 10: QUESTION 10.3**

Appendix A

Appendix B

Appendix C

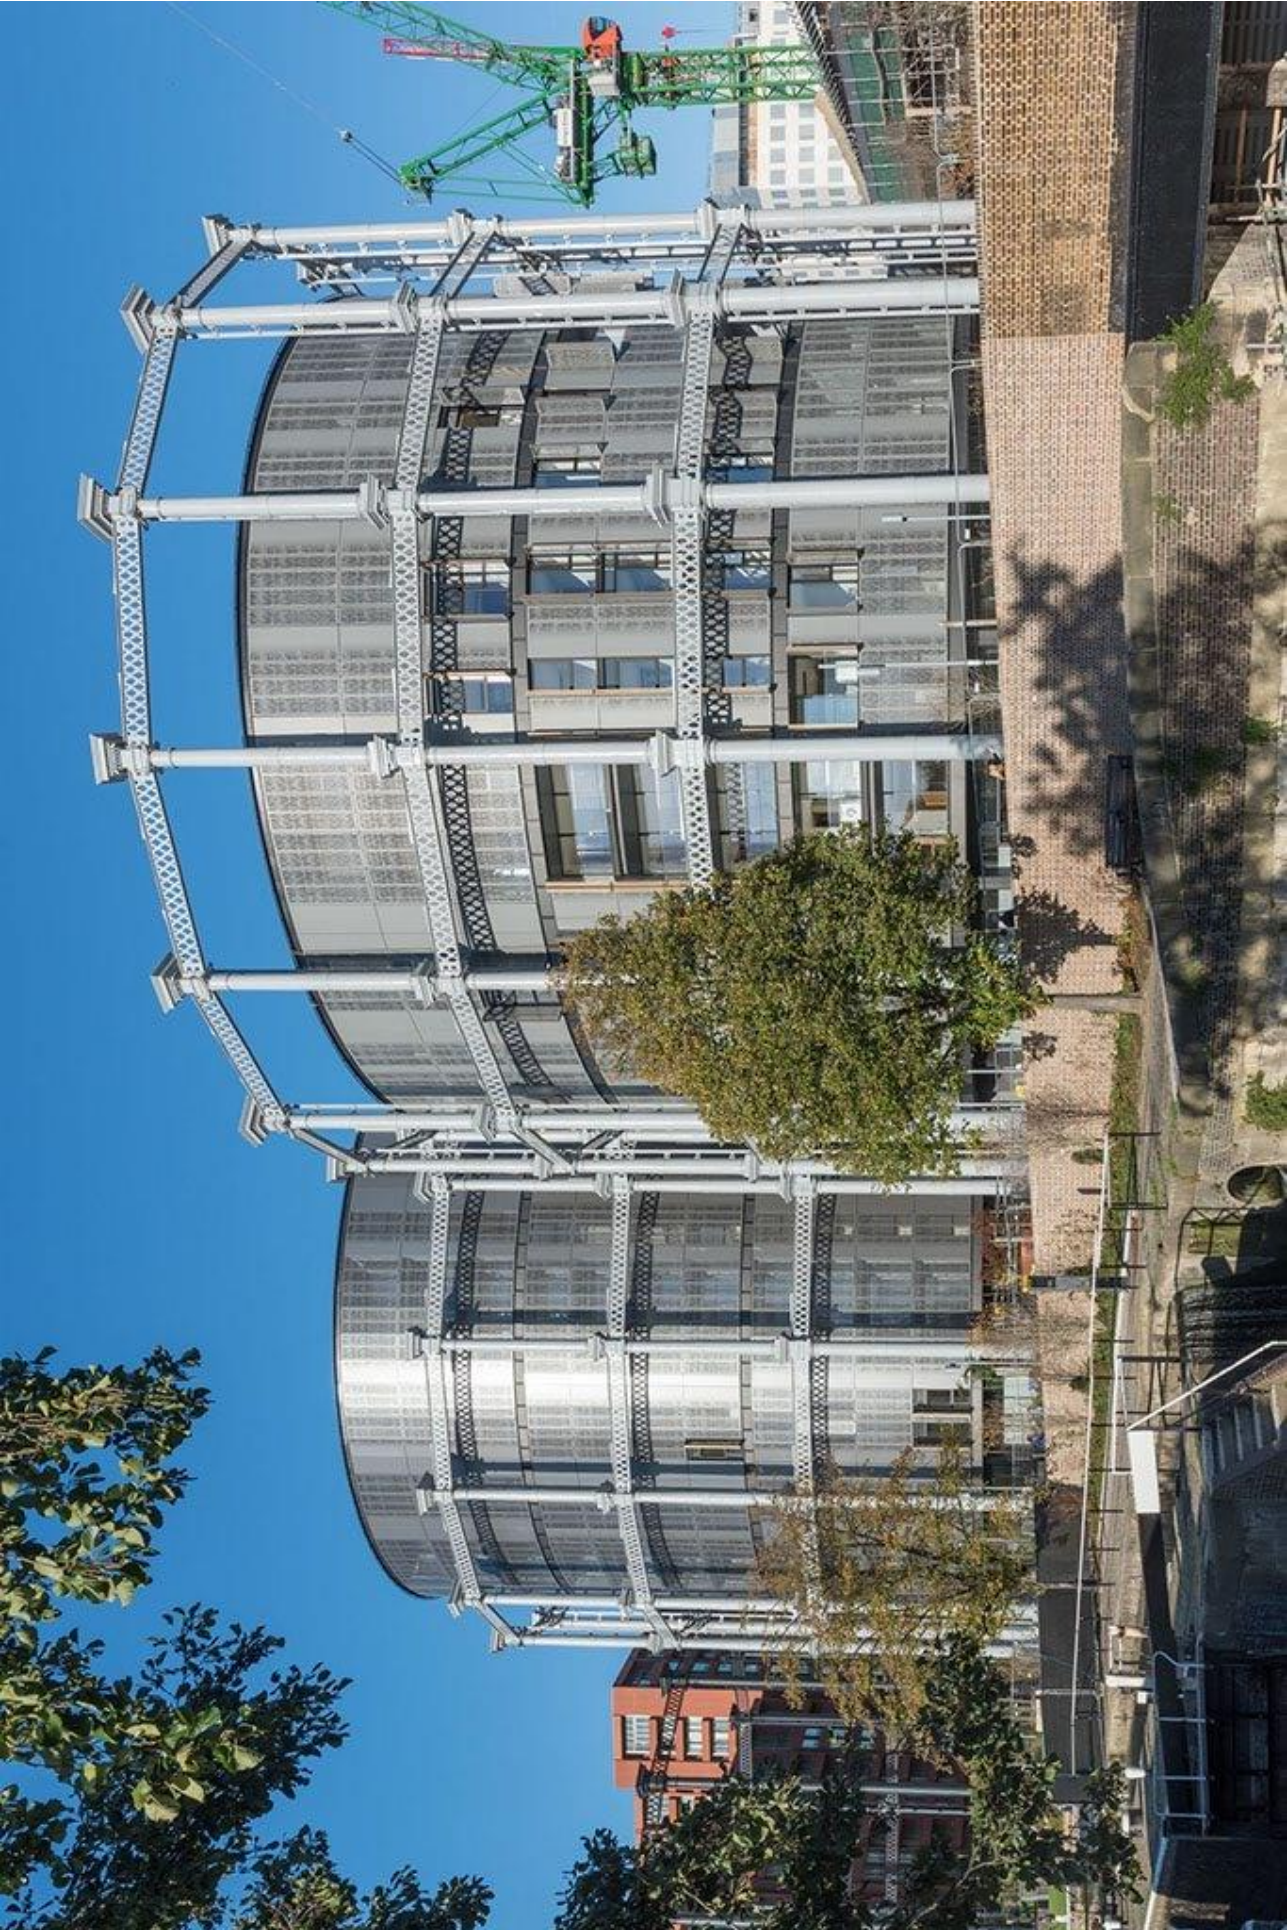
Appendix A
Photograph 1

- two of the three-tier guide frames (1880) reassembled on new foundations around well-designed circular blocks of flats

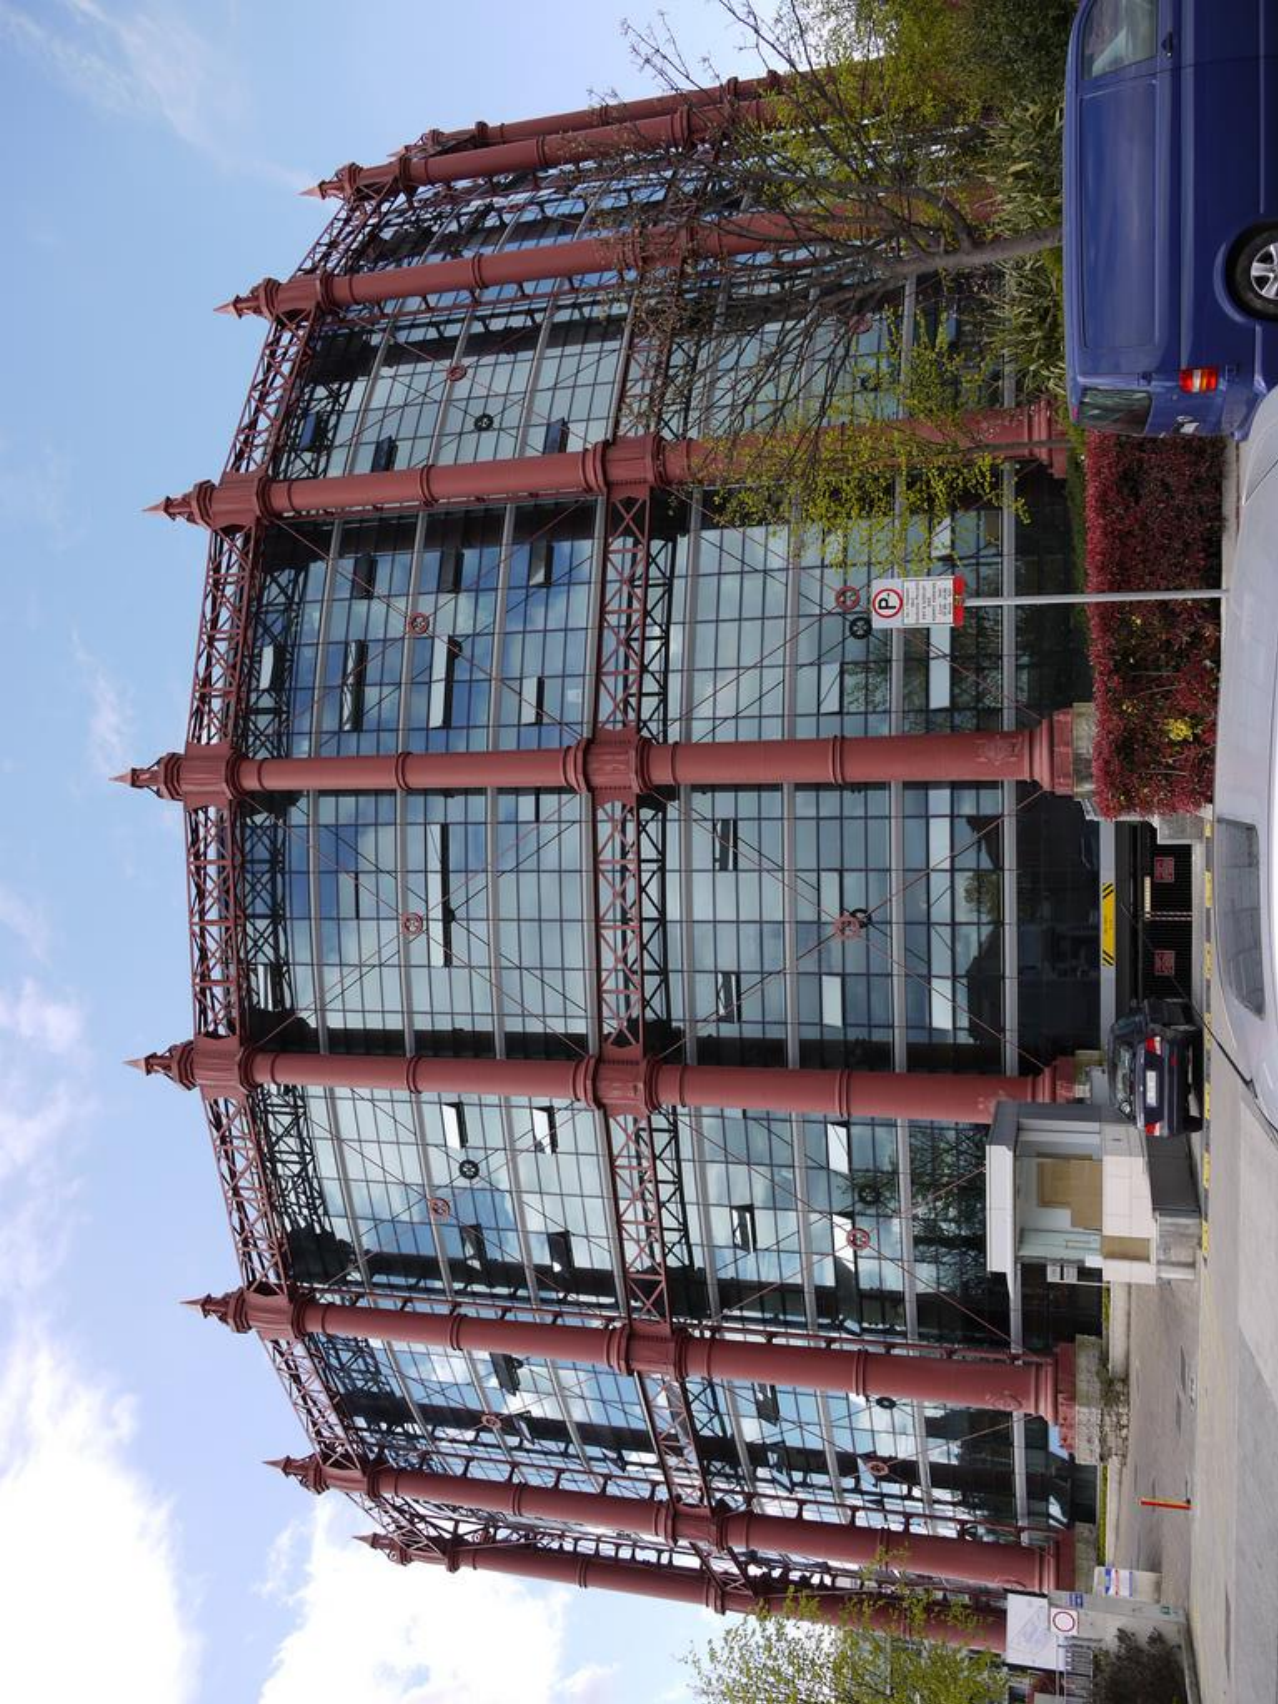
Appendix B
Photograph 1

The columnar guide frame (erected 1885 by Samuel Cutler & Sons of Millwall) was retained on its in-ground tank and a nine-storey circular block of flats was built 2006 inside the *in situ* columnar guide frame (photographs 2, 3, 4, 5 Malcolm Tucker 2016).

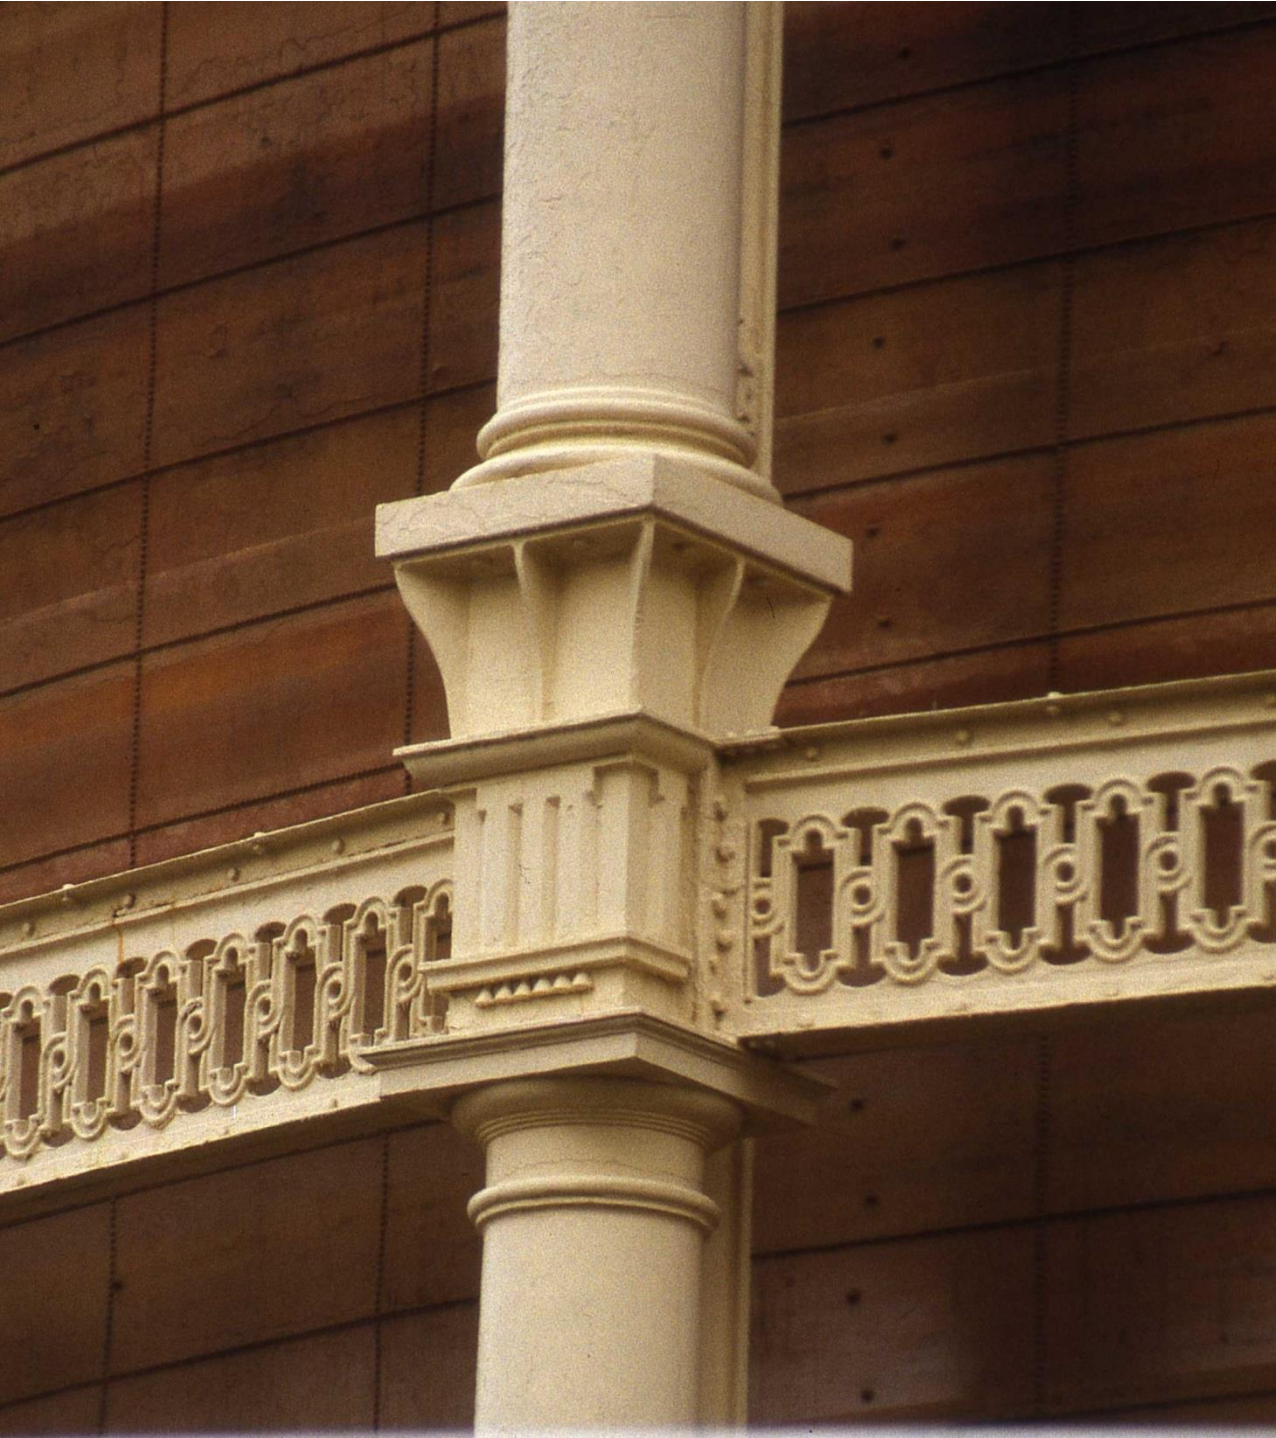
Appendix C
Photograph 11

- photograph 12 looking into Gasholder Park at King's Cross with the reassembled 1883 two-tier columnar guide frame; note particularly the utilitarian lattice girders (joining the junction boxes between the superimposed columns and above the upper columns) and compare and contrast with photograph 11 showing one of the junction boxes (between the superimposed columns in the No. 2 guide frame at Bethnal Green) and the ends of its classically-inspired decorated girders; note also that the attenuated upper and lower columns are much longer than the utilitarian girders, and compare and contrast with photograph 5 which shows that the upper and lower columns are only slightly longer than the decorated girders in the more 'classical' and better-proportioned 1866 columnar guide frame at Bethnal Green.

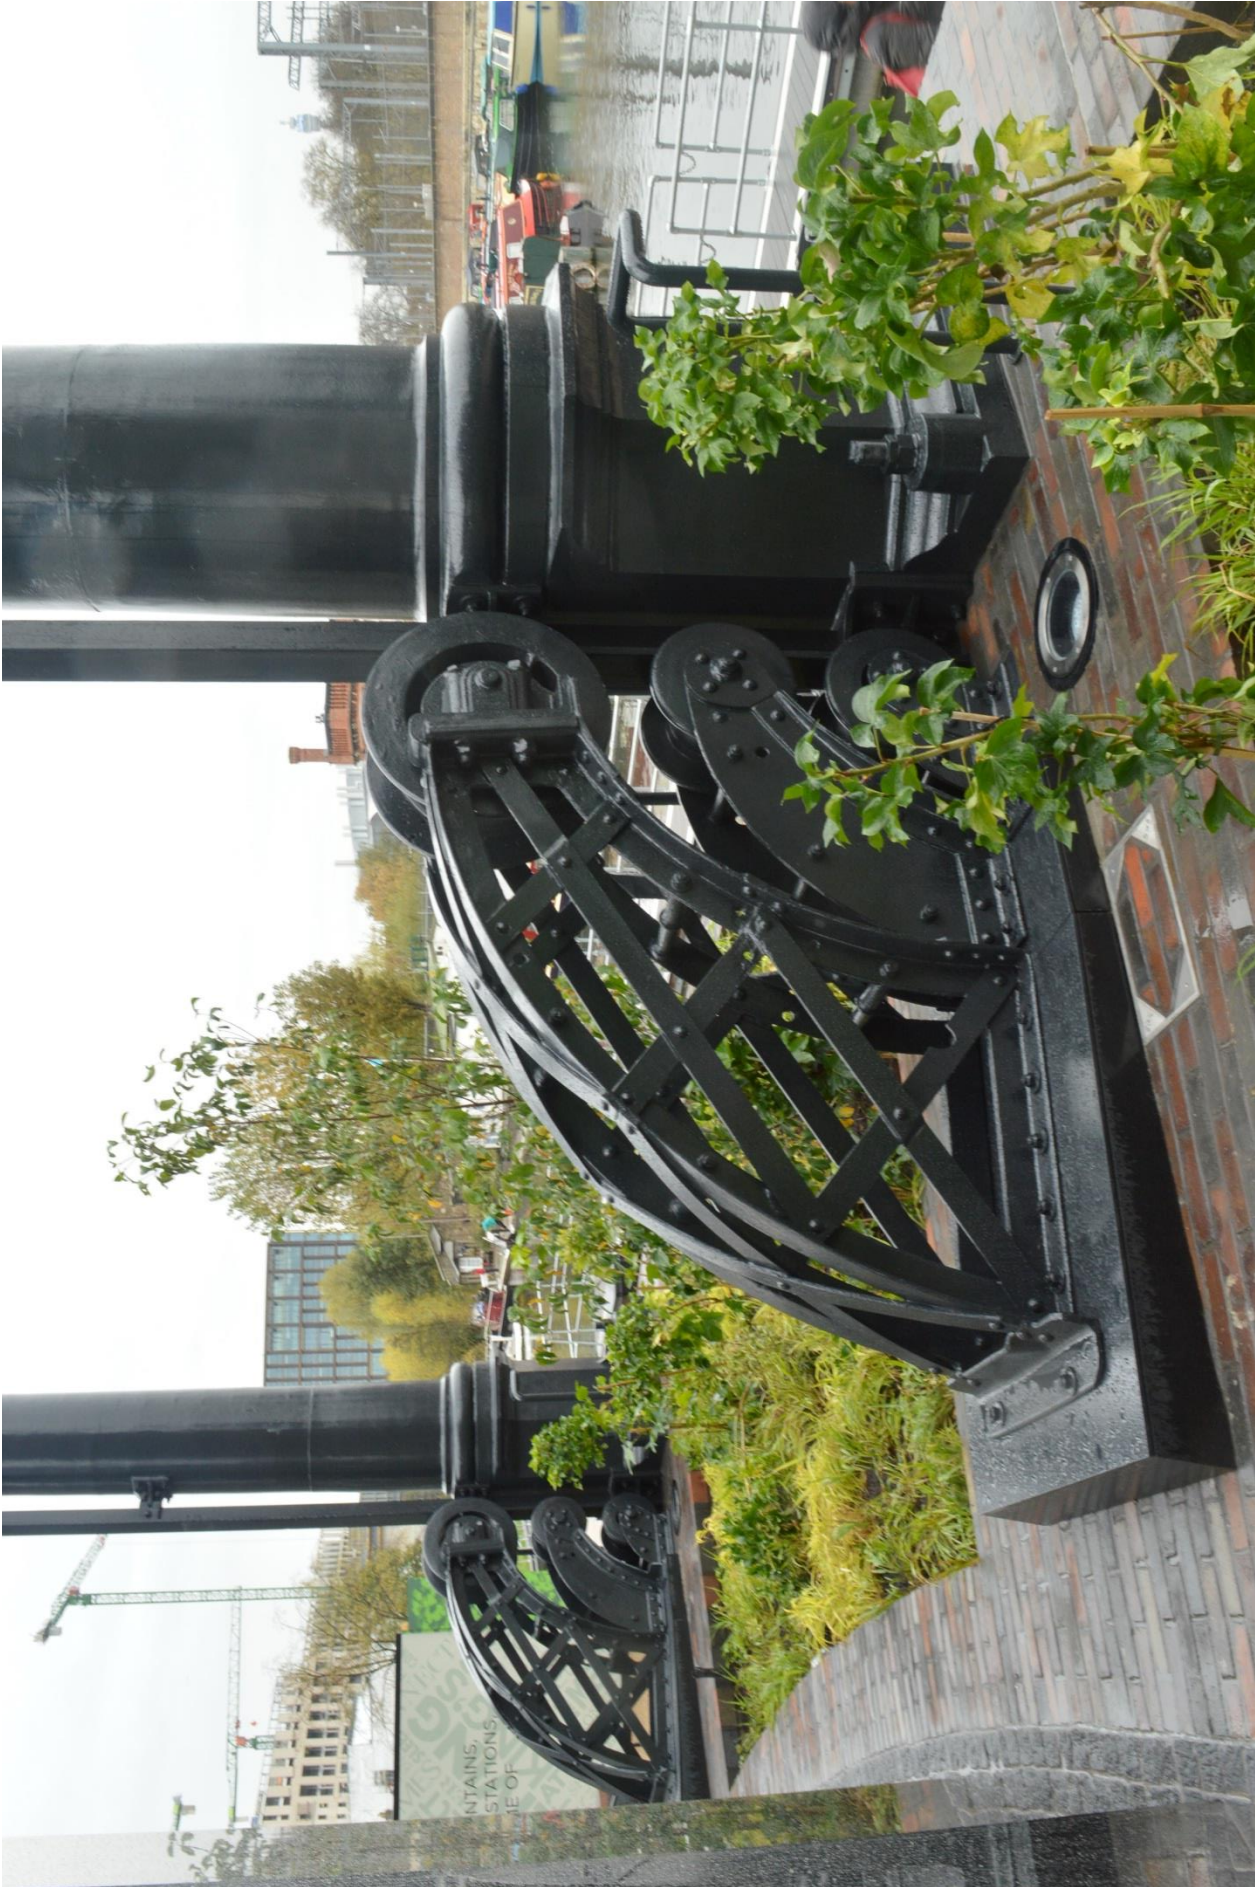
Appendix C
Photograph 14

- photograph 14 showing the basal parts of two superimposed columns at Gasholder Park with the lower ends of the guide rails (on the backs or inner sides of the pedestals and lower columns) each with two lattice-girder carriage rollers, which were originally fixed to the rims of the two telescopic lifts to guide the rise and fall of the lifts (Malcolm Tucker 2016); compare and contrast with photograph 13 showing a junction box (above the upper column in one of the superimposed columns in the No. 2 guide frame at Bethnal Green) with the ends of decorated girders and the guide rail part of the unusual and very distinctive carriage roller on the rim of the upper telescopic lift with its plate girder sides connected by rods and closed flat bars.

Clearly, the carriage rollers from the rims of the two telescopic lifts in the No. 2 gasholder at Bethnal Green should be salvaged for placement at the bottom of each of the guide rails on the backs or inner sides of the sixteen superimposed columns, which is the position they would have occupied when the telescopic lifts were down and fully accommodated within the circular sides of the in-ground brick tank. Photograph 5 shows the No. 2 gasholder at Bethnal Green with the upper telescopic lift almost fully accommodated in the circular in-ground brick tank, and four of its carriage rollers are seen behind the upper parts of square-section pedestals.
