Fish Island Section 19 Flood Investigation

08/08/2024

EXECUTIVE SUMMARY

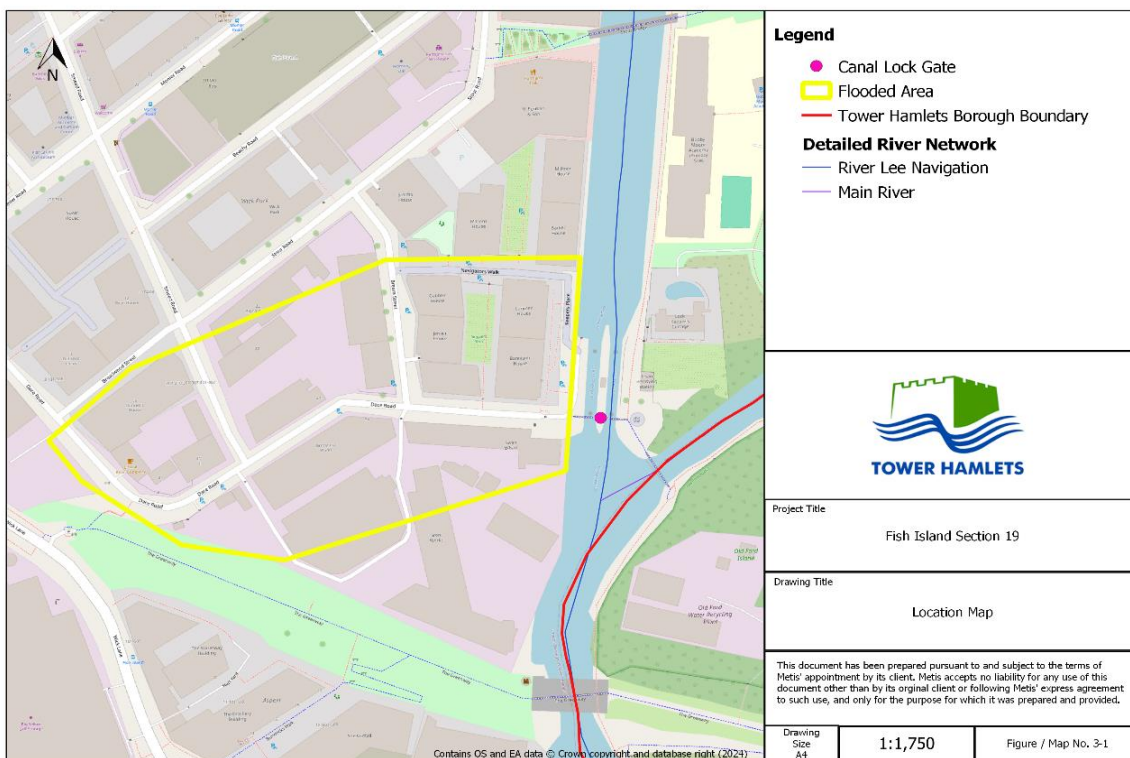
Figure 3-1 Locations of reported flooding at Fish Island on 4th January 2024

Fish Island is located in the northeast of Tower Hamlets. The areas that flooded on 4th January 2024 are all located west of the River Lee Navigation and are topographically lower than the canal. The layout of the roads and the location of the canal are shown in *Figure 3-1*. The affected areas are located within a Creative Enterprise Zone. This is an initiative funded by the Mayor of London to designate areas where artists and creative businesses can find permanent affordable space to work and grow their businesses. The area is made up of multiple newly built apartment blocks and work-live studios.

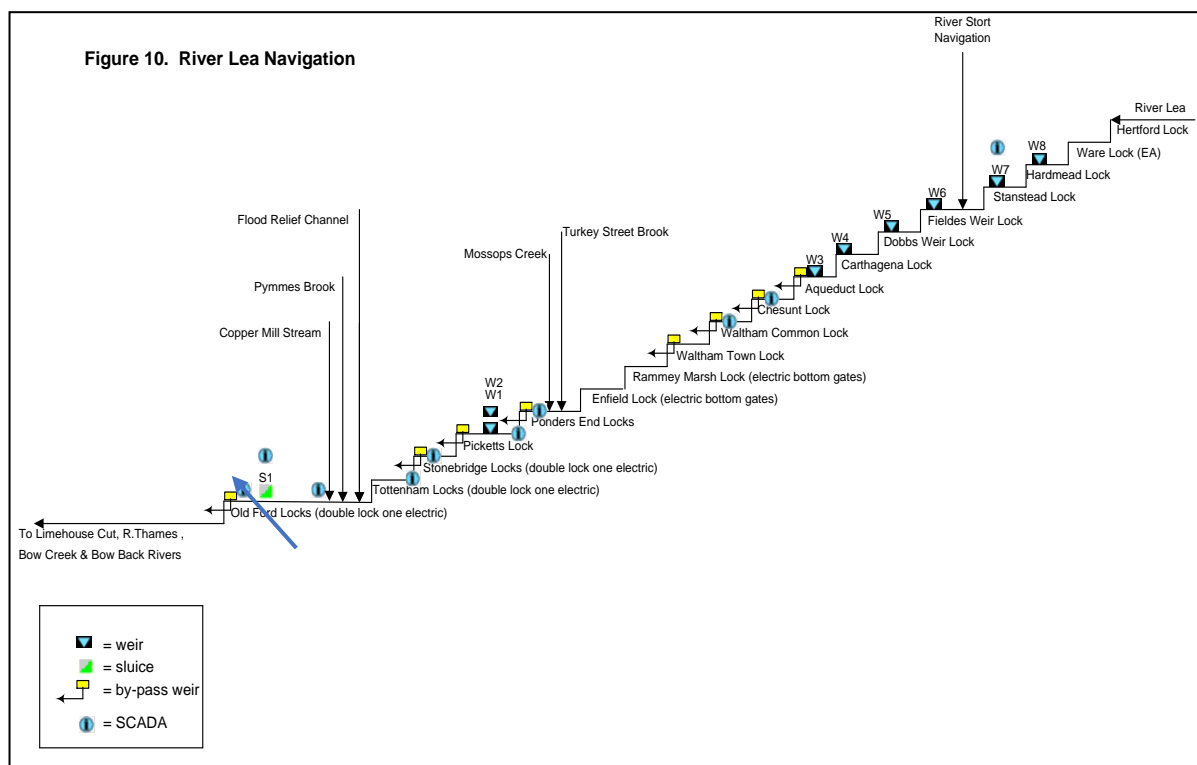
Figure 3-2 Location of Old Ford Lock within the River Lee Navigation
(Source: Canals and Rivers Trust)

Although there is a by-pass weir at the lock 5.686m AOD), it is not the control structure; the Lea Bridge automatic sluices are set to maintain the level in the canal (5.800m AOD).

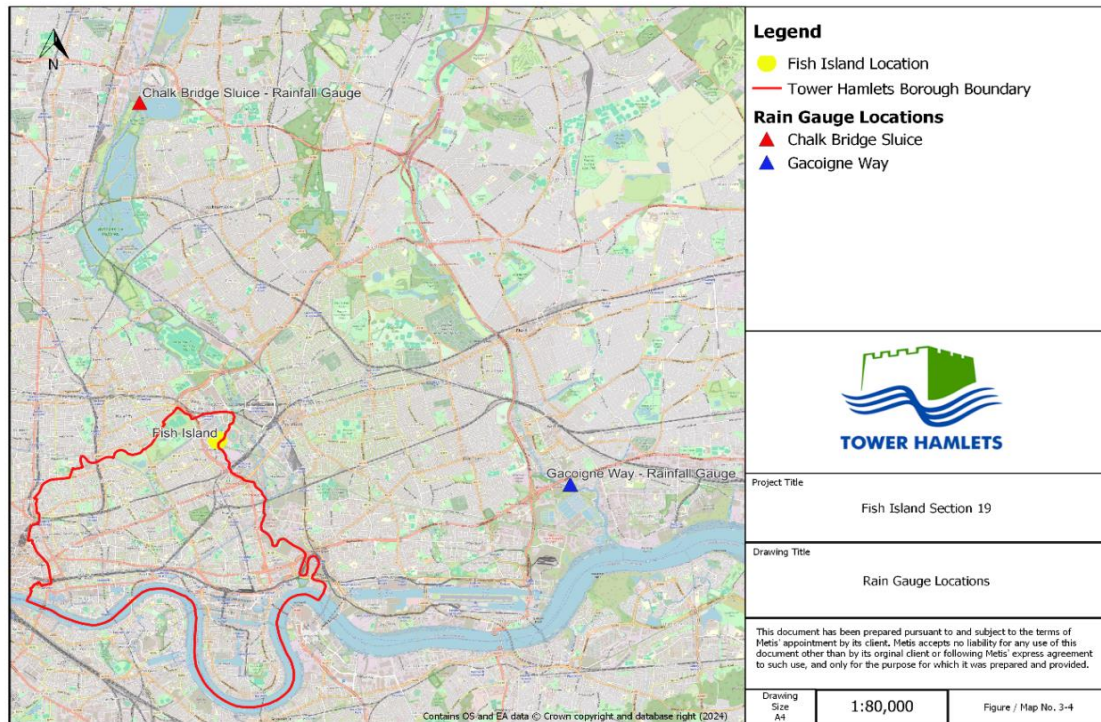
Figure 3-4 Locations of EA Rain Gauges

As is evident from *Figure 3-4*, there are no rain gauges in close proximity to Fish Island. *Table 3-1* summarises the peak rainfall period during this storm event, and *Figure 3-5* shows the rain gauge data provided, indicating a similar scale of event.

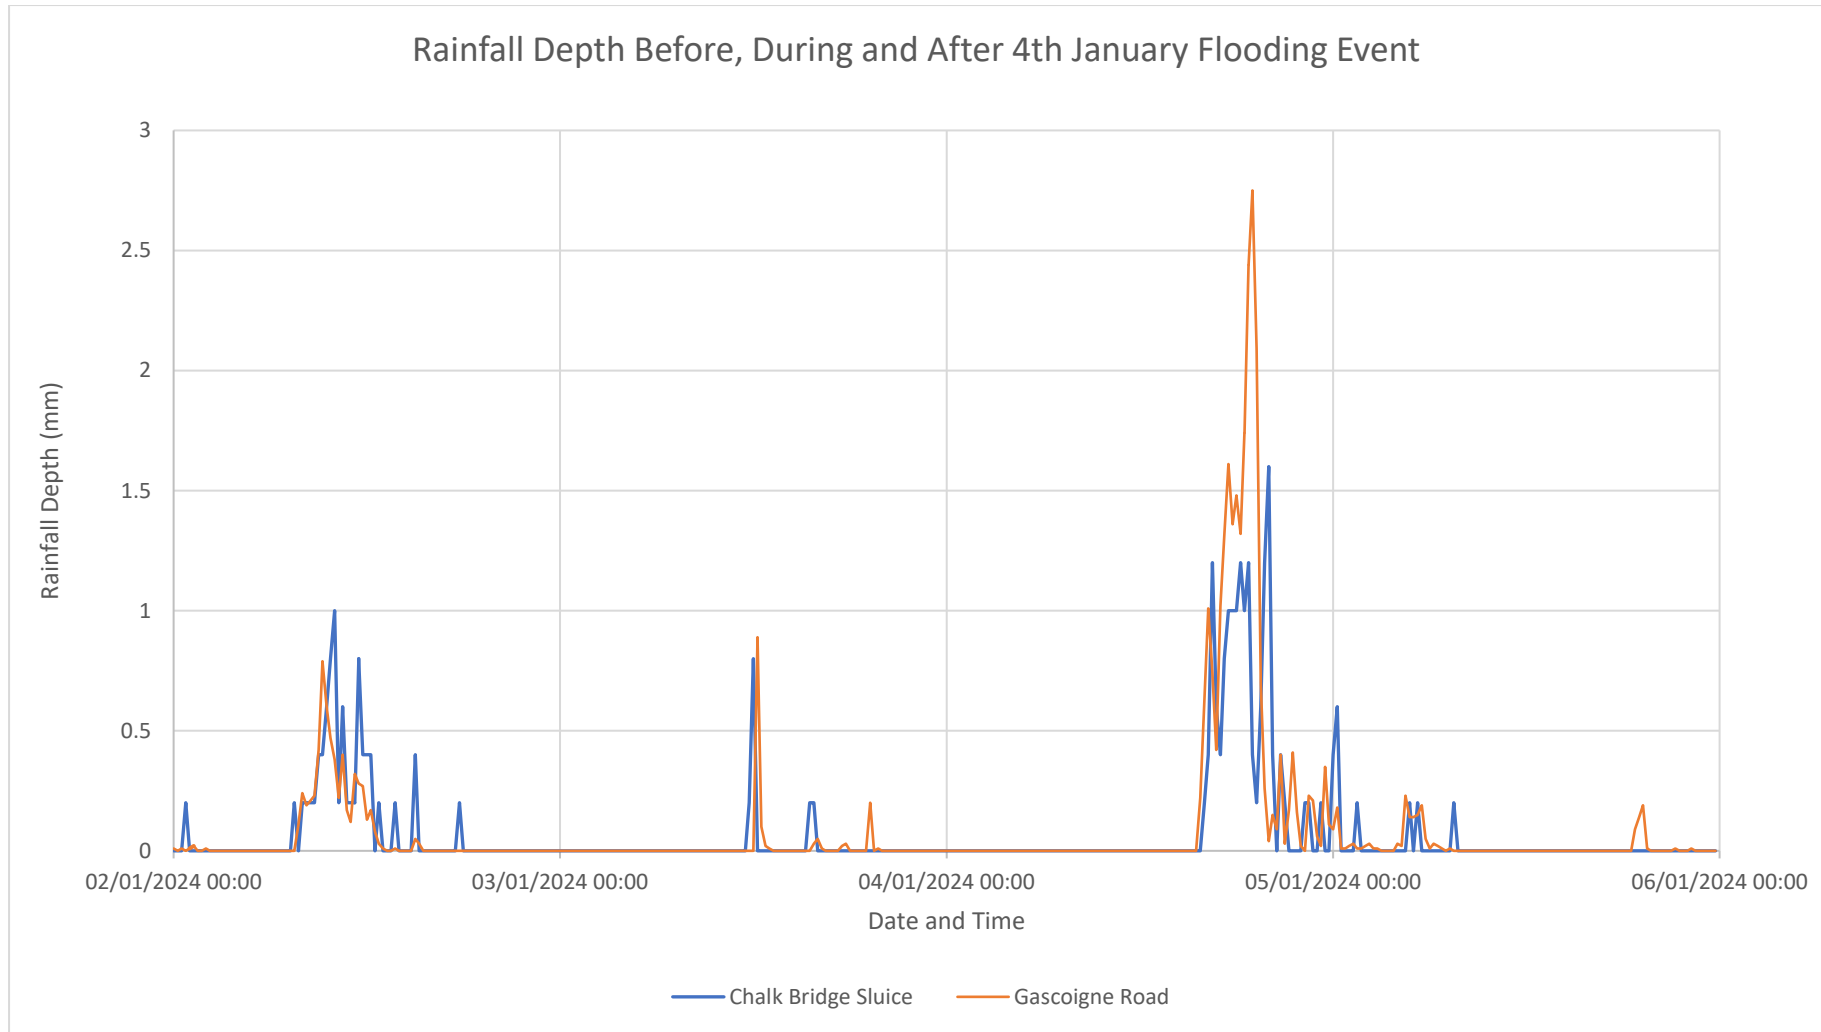
Figure 3-5 Rainfall depth before, during, and after the 4th of January 2024 flooding event (Source: EA)

Rainfall Period	Peak Time	Rainfall Peak (mm/15 min)	Cumulative Rainfall Over Rainfall Period (mm)
04/01/2024 15:45:00 - 05/01/2024 02:45:00	04/01/2024 18:45	2.175	20.39

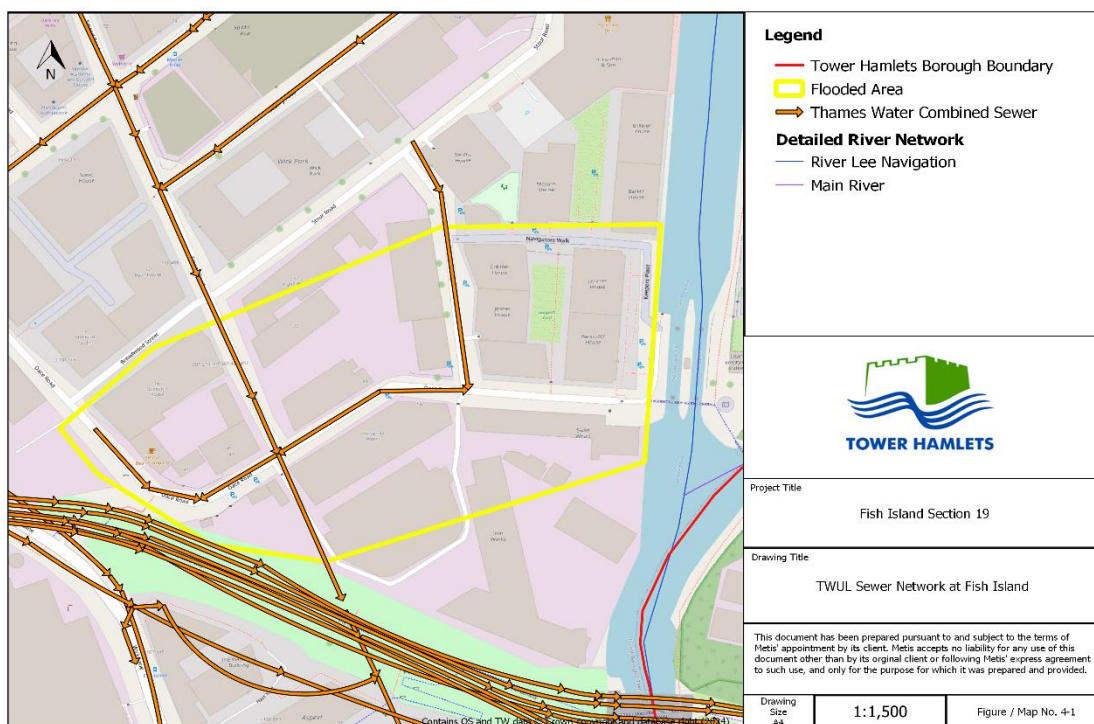
Figure 4-1 Thames Water sewer network

Figure 4-1 shows the TWUL sewer network within the local area. All the sewers within the vicinity of the flooded area are classed as combined.

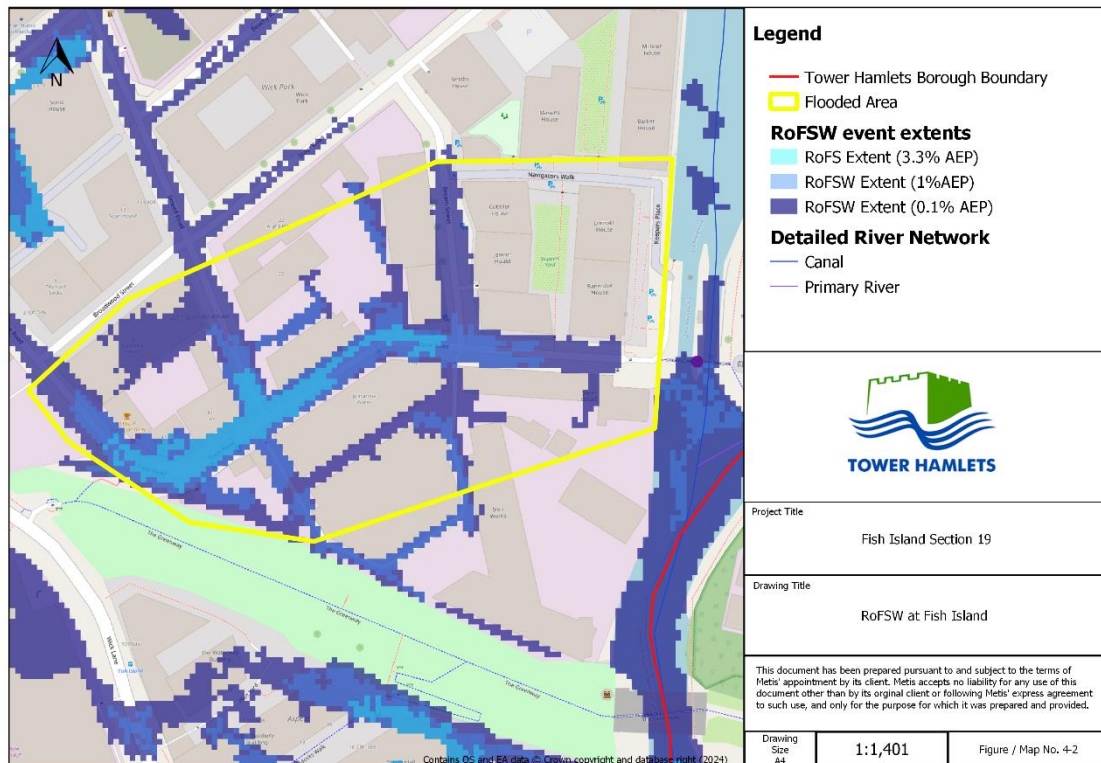
Figure 4-2 RoFSW within Fish Island

A review of the EAs Risk of Flooding from Surface Water (RoFSW) data shows that there is risk from a 3.3% AEP event within Dace Road and the surrounding properties. The internal flood reports were also mainly located within the 3.3% AEP, or 1% AEP extent as shown in Figure 4-2. It should be noted that Fish Island is not located within a Critical Drainage Area (CDA) and has a relatively low surface water flooding risk in relation to the rest of the borough.

Surface water flooding can be eliminated as the cause of this flooding event, as it was noted that following the opening of the sluice gates, flood waters receded rapidly, indicating sufficient performance of the local drainage network. This is also supported by accounts that water flowed down Dace Road from the canal, rather than surcharging from blocked gullies. Gullies in the area are cleaned regularly, with gullies on Dace Road (23 no.) being cleaned twice a year and Bream Road (6 no.), Smeed Road (8 no.), Beachy Road (10 no.) and Stour Road (8 no.) all cleaned annually, normally in autumn after leaf fall. As the gullies were cleaned recently, water drained away quickly clearly indicating that the drainage network, and therefore surface water flooding, was not the cause of the flooding on 4th January.

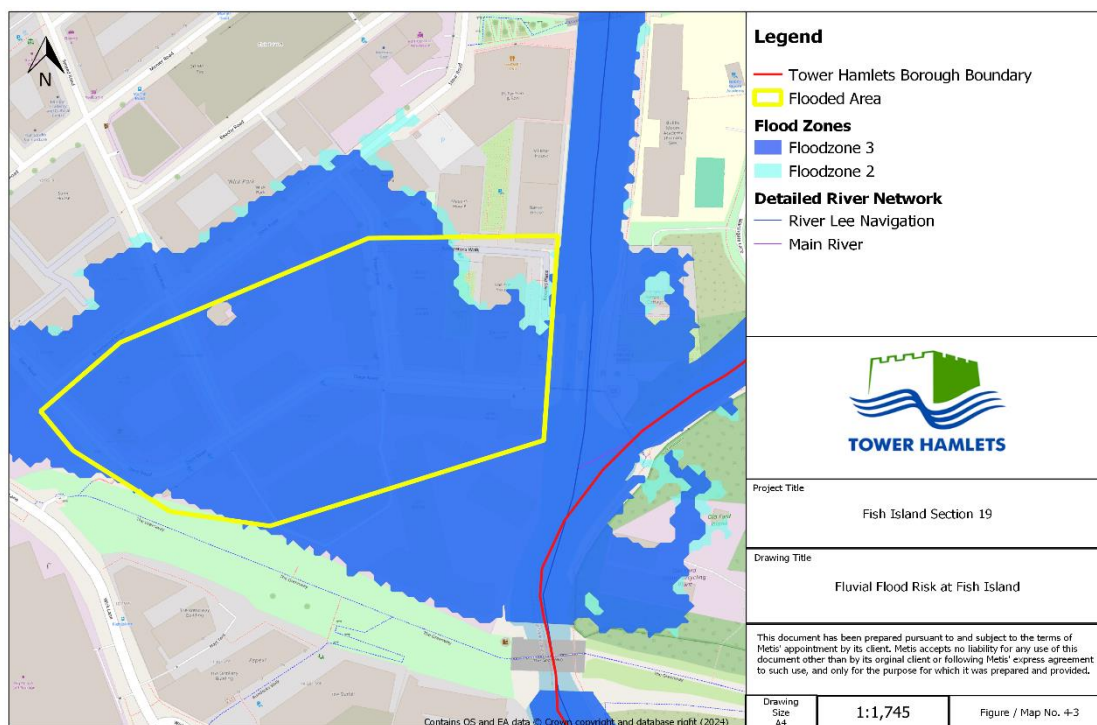
Figure 4-3 Fluvial flood risk zones of the Fish Island area

The EA's fluvial flood zone mapping shows that the majority of Fish Island is located within Flood Zone 3, including the properties that reported flooding in 4th January event, as shown in *Figure 4-3*. Considering the evidence provided of the high likelihood of the canal overtopping, the area of Fish Island being within Flood Zone 3, the severity of the rainfall event, eyewitness accounts and photographs from the night it is evident that fluvial flooding was the cause of the flooding incident.

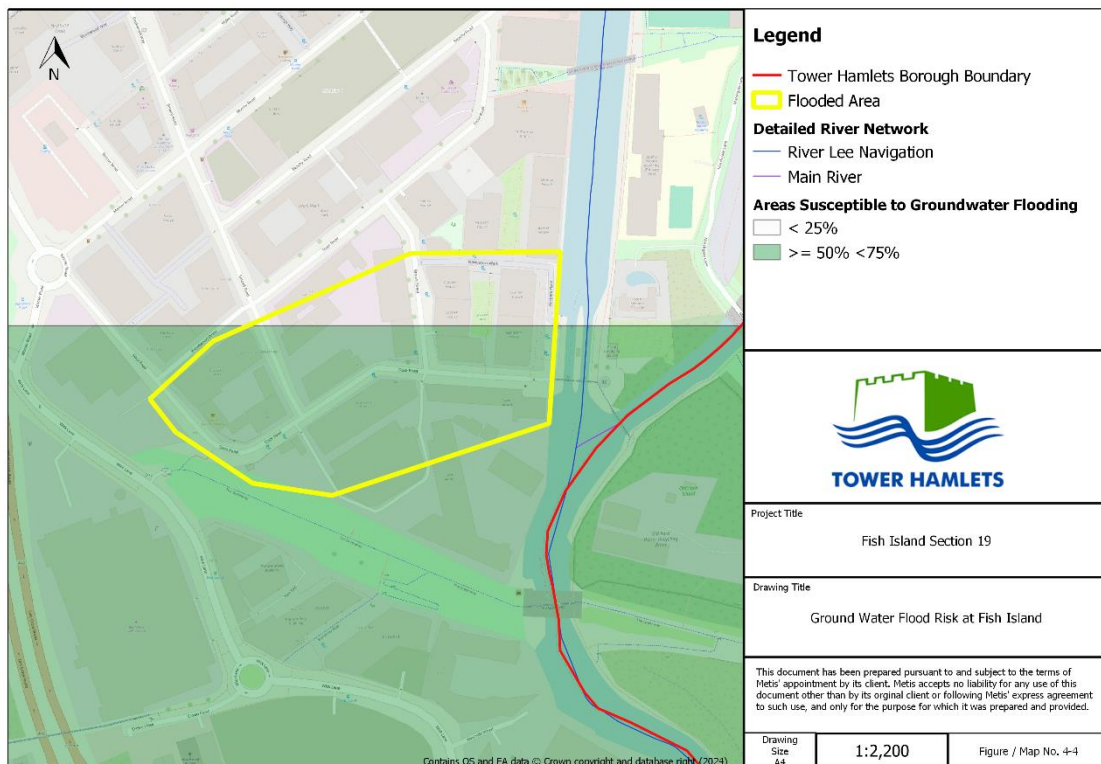
Figure 4-4 Groundwater flood risk zones at Fish Island

Groundwater flooding occurs when prolonged rainfall causes the water table to rise. If the water table is too high, surface water is no longer able to infiltrate into the ground, causing flooding. In extreme circumstances, flooding can be caused by groundwater emerging directly from the ground. An area’s risk of groundwater flooding is closely tied to the ground composition and presence of aquifers. Based on the EA’s Areas Susceptible to Groundwater Flooding data, Fish Island lies within the ‘greater than or equal to 50% and less than 75%’ and the “less than 25%” risk classifications as seen in *Figure 4-4*. This classification is comparatively low within the borough. With no reports of groundwater flooding and the risk being low, groundwater flooding can be ruled out as a cause of this flooding event.
