London Borough of Tower Hamlets

# Driffield Road Conservation Area Detailed design guidance for façade enhancements

Consultation Draft April 2017

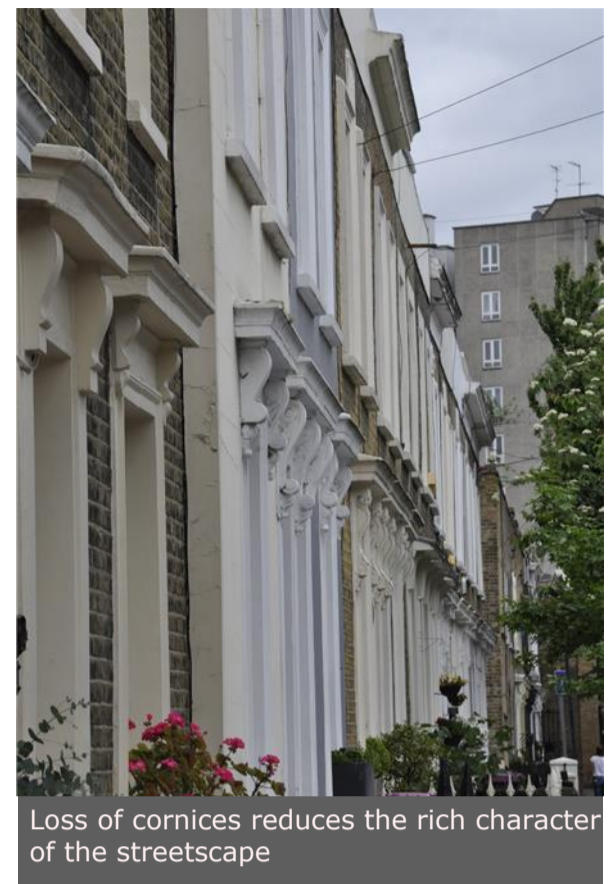
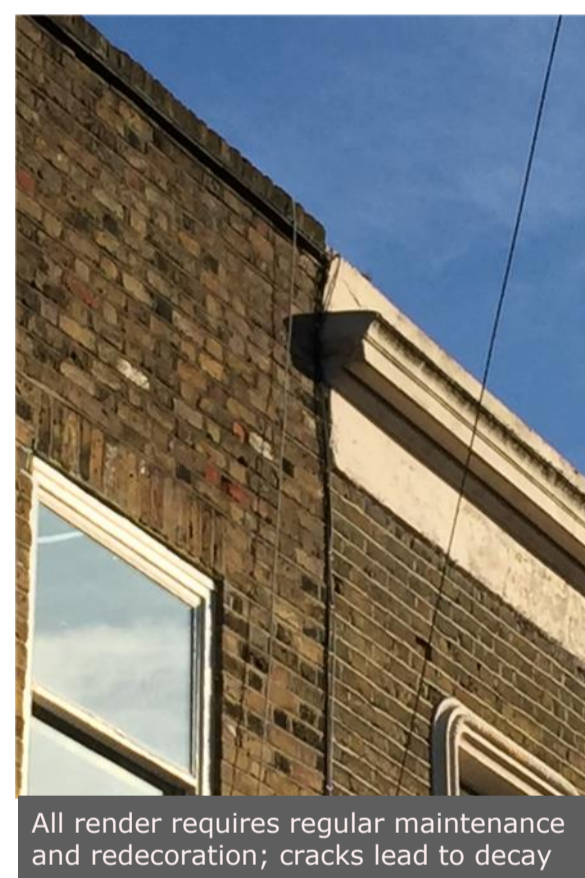
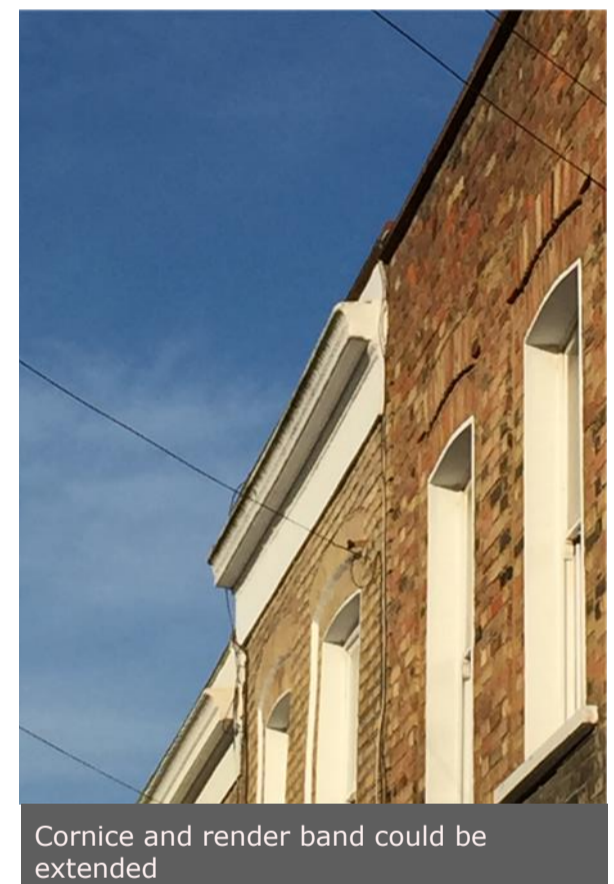
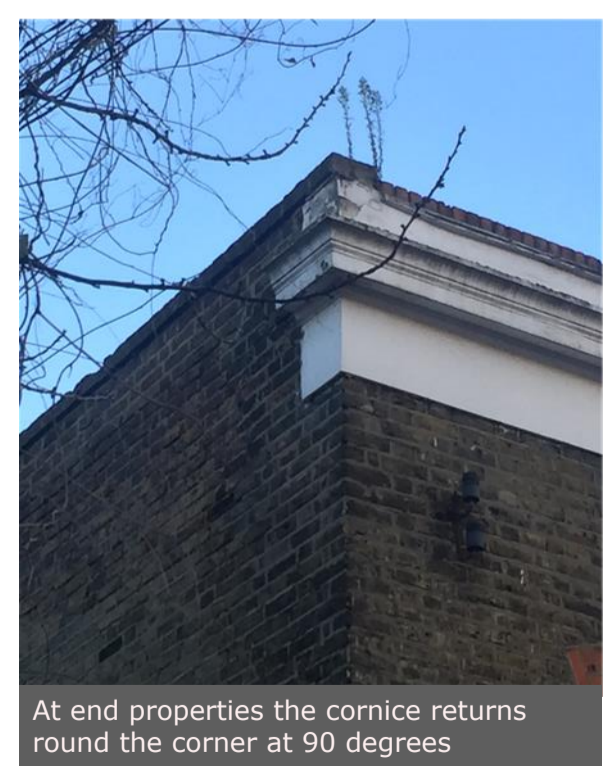
## Sheet 2

### Enhancement of cornices and parapets in Driffield Road Conservation area

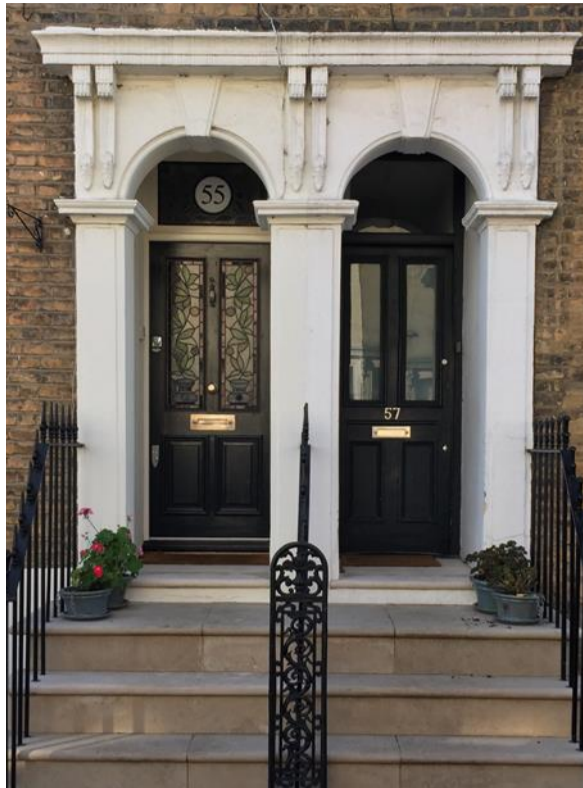
The paired doorways with painted stucco surrounds are characteristic of the area

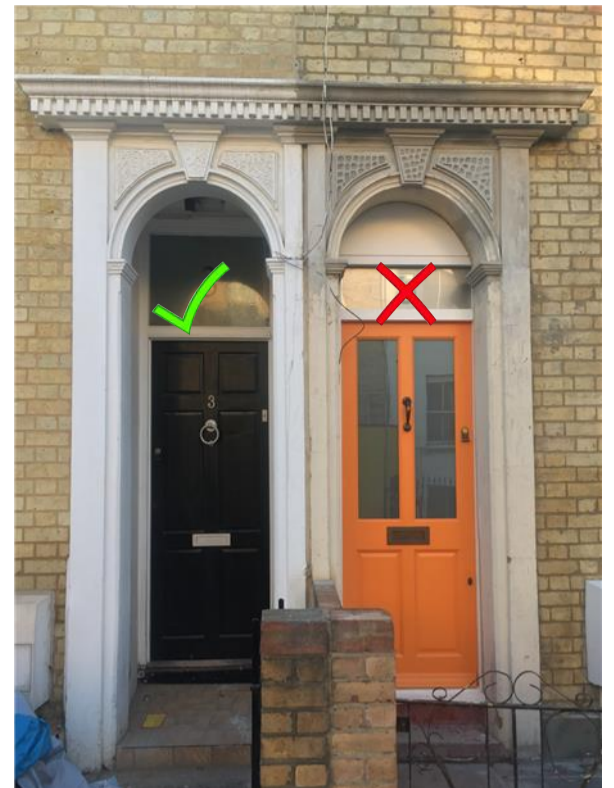
Bringing the door forwards in the opening reduces the modulation on the street

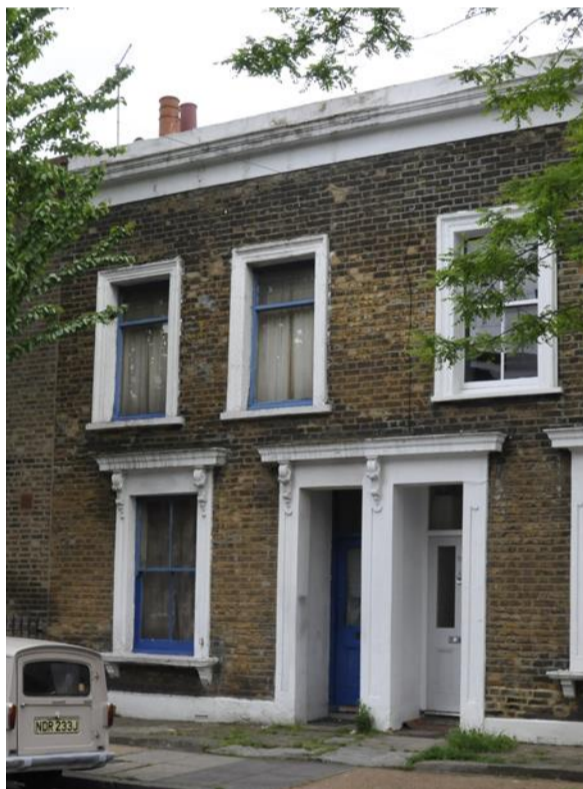
Zealand Road loss of sash windows and stucco console brackets

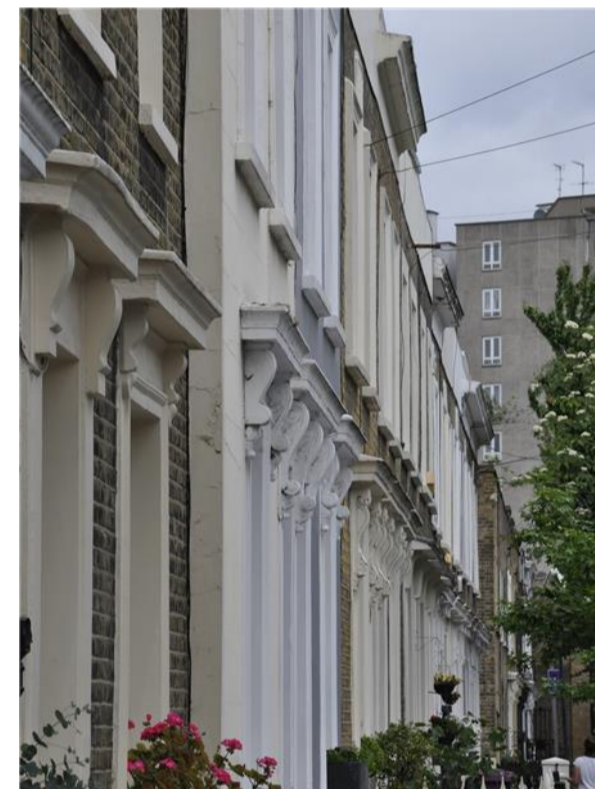
Kenilworth road The replaced consoles in the house to the left have lost the character of the original ornate consoles

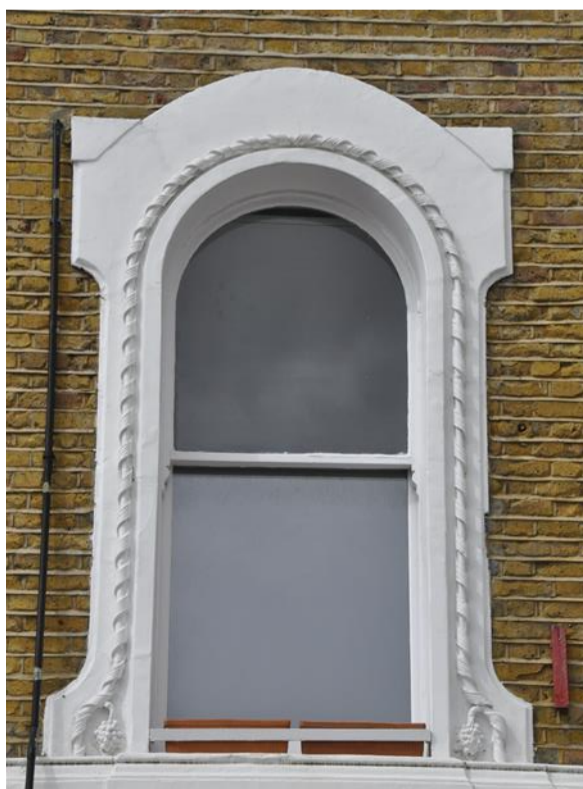
Hewlett Road first floor window with characterful rope moulding with grapes

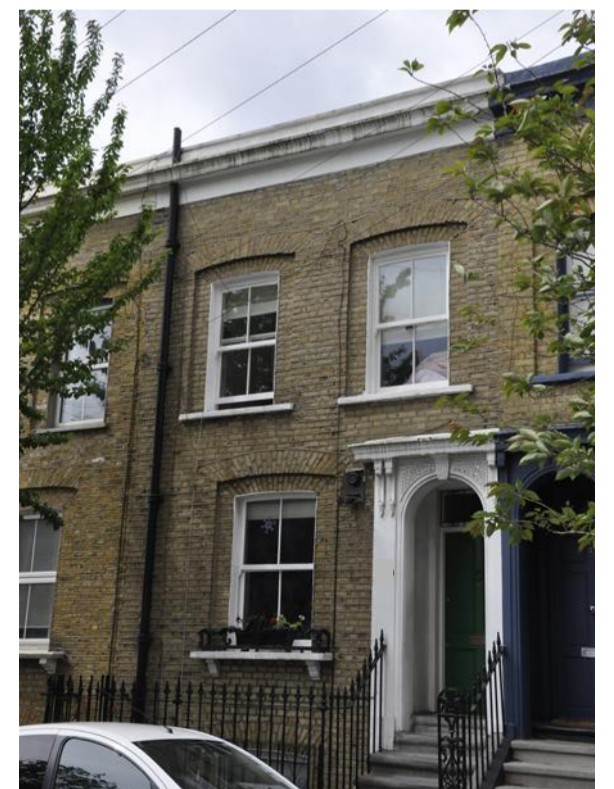
Driffield Road cornice penetrated by pipework

Services should not be run on the front facade and care should be taken to avoid penetrating through original features

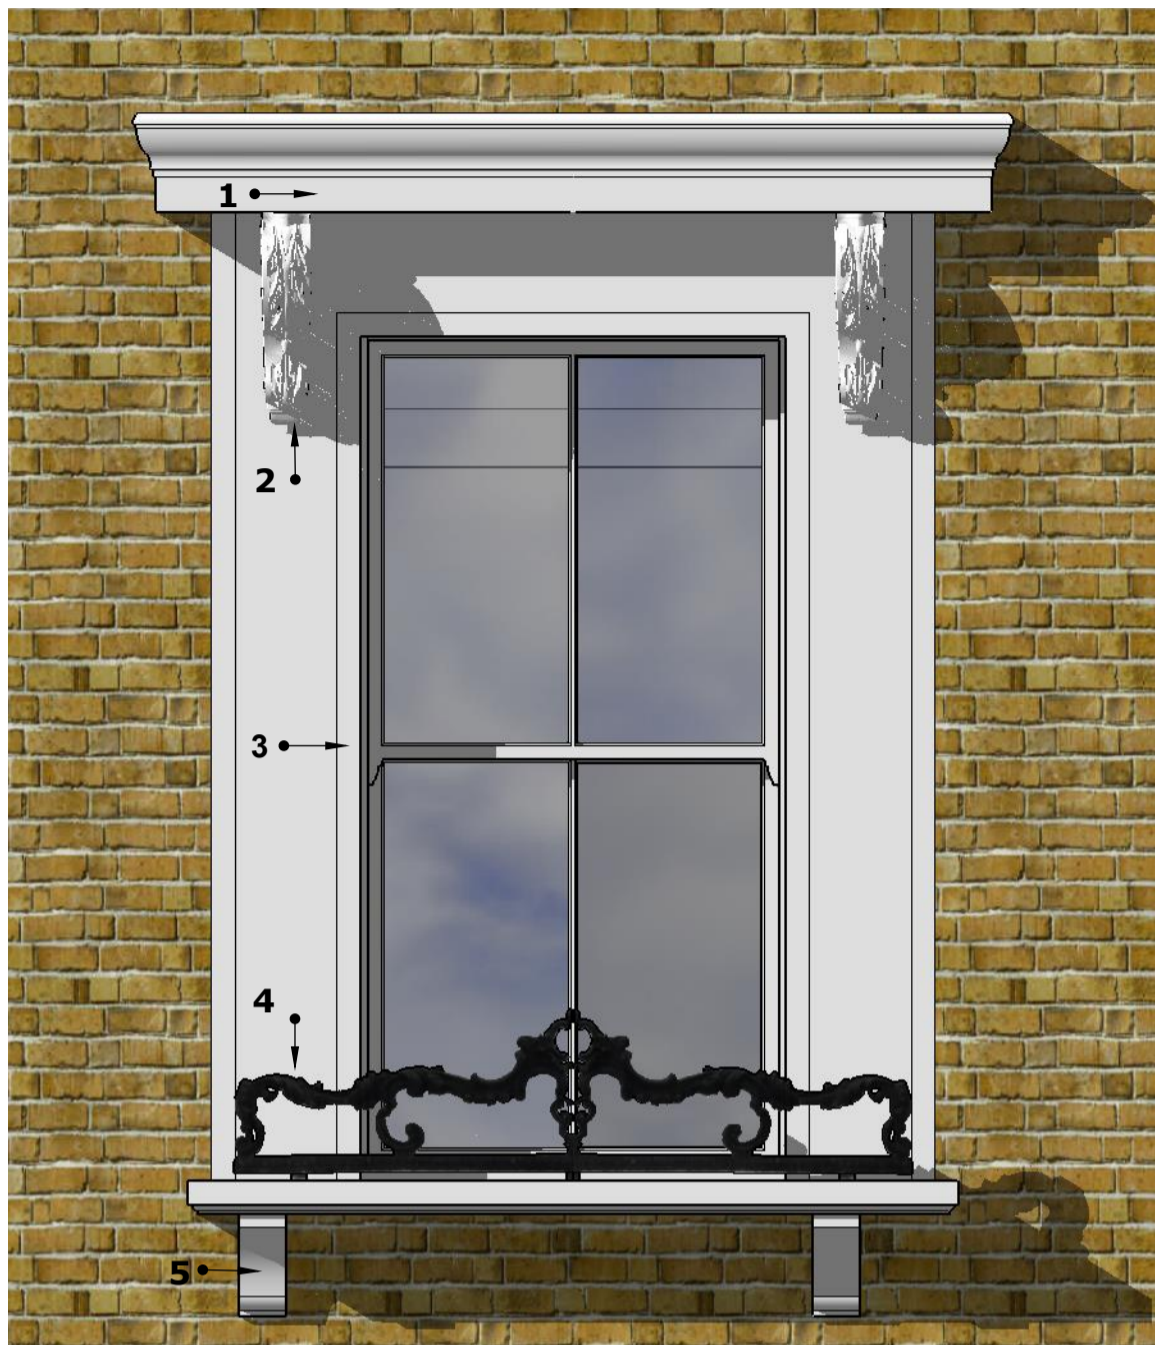
Typical timber sash window in Driffield Road Conservation Area

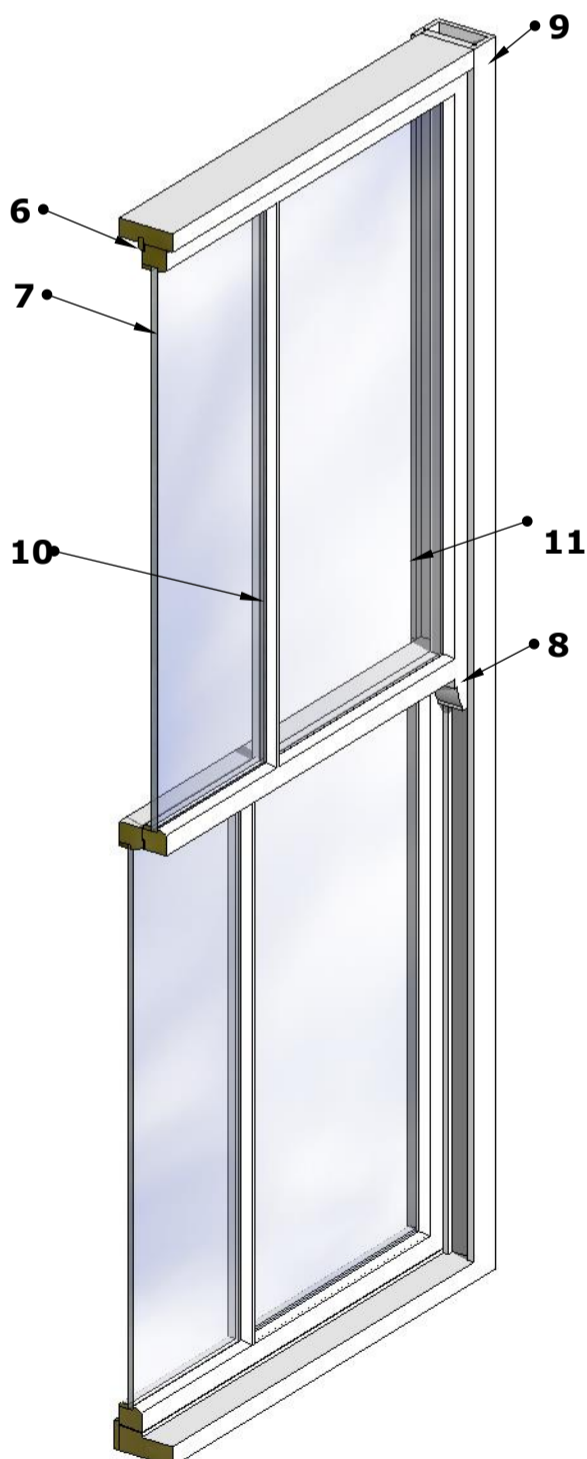
6. Staff bead & parting bead may be replaced with timber bead incorporating a concealed draught excluder brush or rubber strip
  7. Original glass looks uneven and should be retained
  8. Horns provide strength; these are characteristic of late C19th windows and were often curved
  9. Box sash timber frame with lead weights the weights may need adjusting to suit the weight of glass.
  10. Victorian style glazing bead with linseed oil putty externally
  11. Concealed sash locks can be fitted to the internal frame
- (not illustrated) Internal shutters and heavy curtains provide good thermal and acoustic performance

Typical timber sash window components

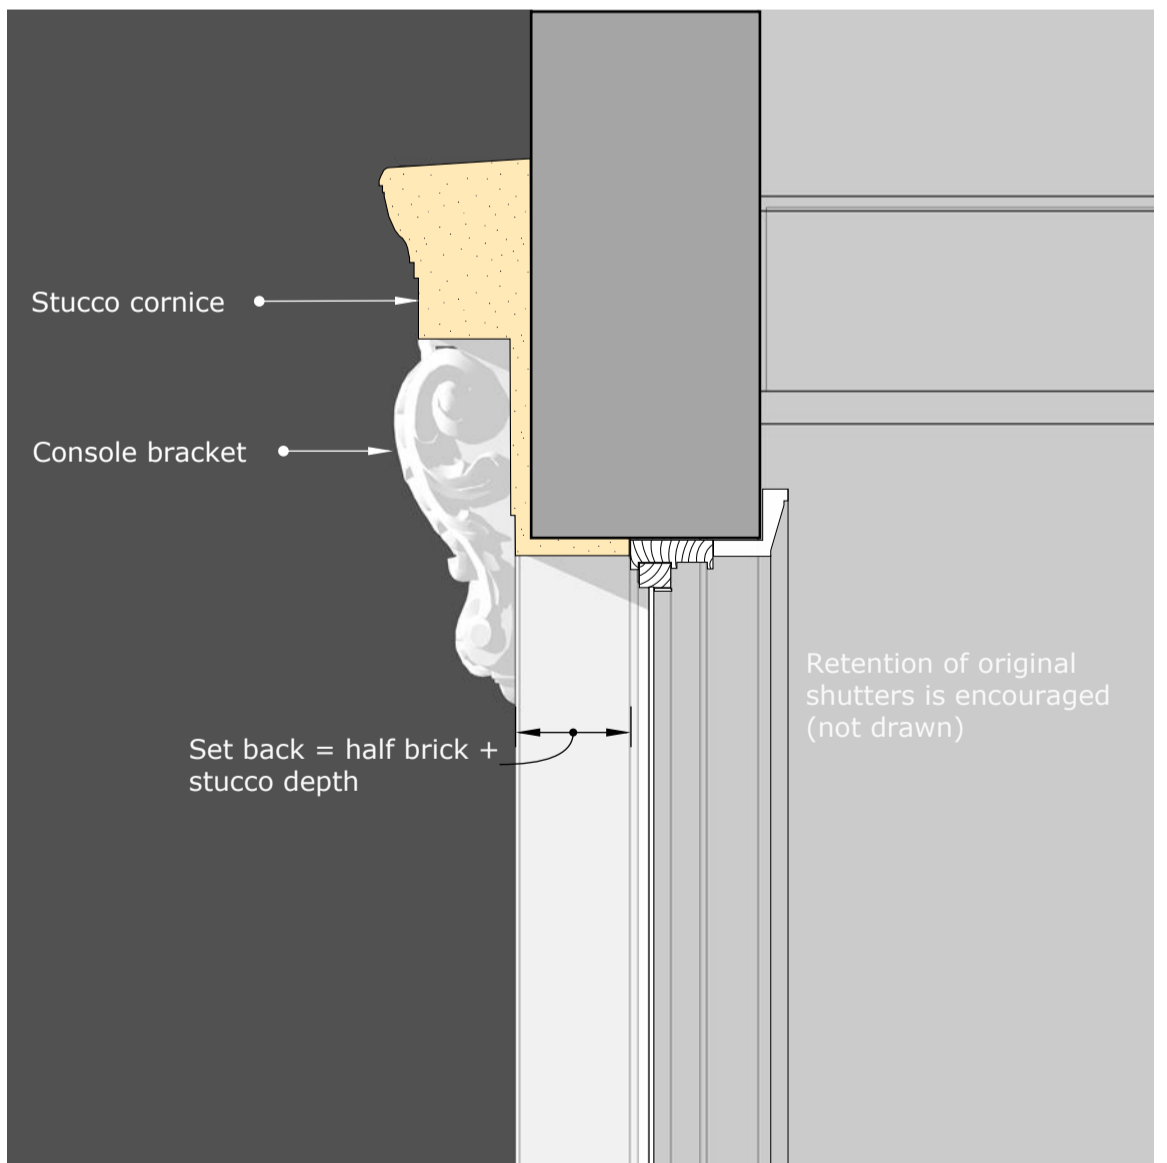
Section through window showing position of window in reveal

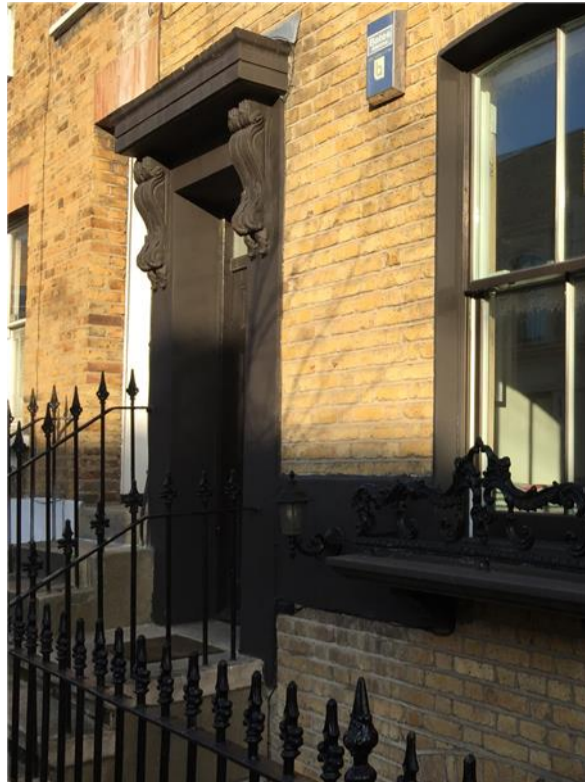
The dark colour is not characteristic of the area

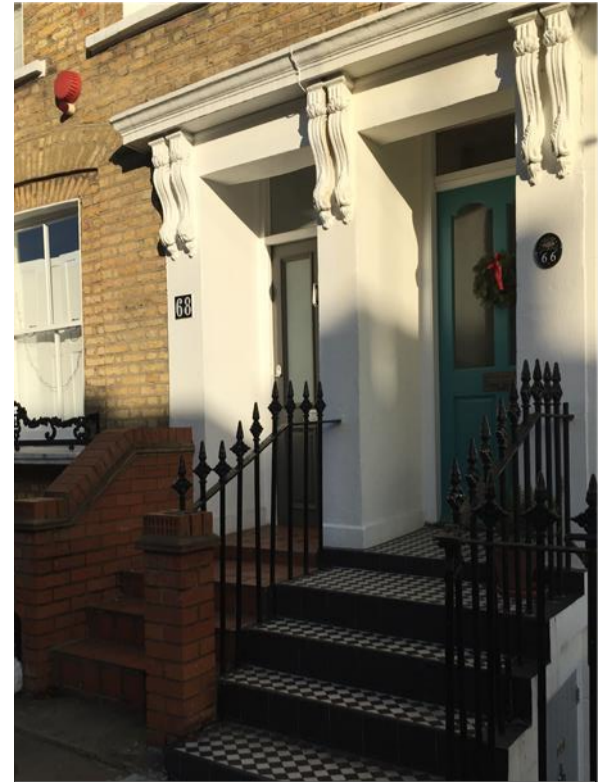
The deep door recess enhances the character of the streetscape

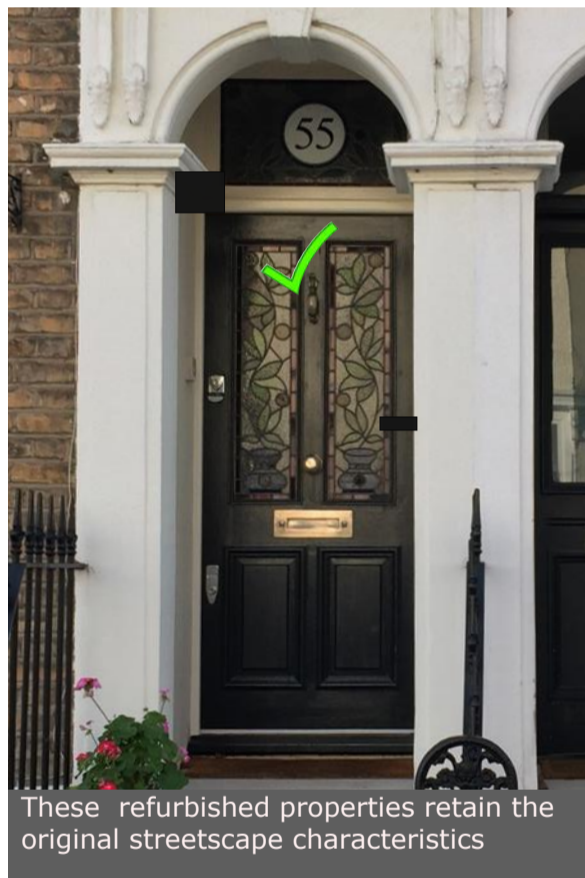
These refurbished properties retain the original streetscape characteristics

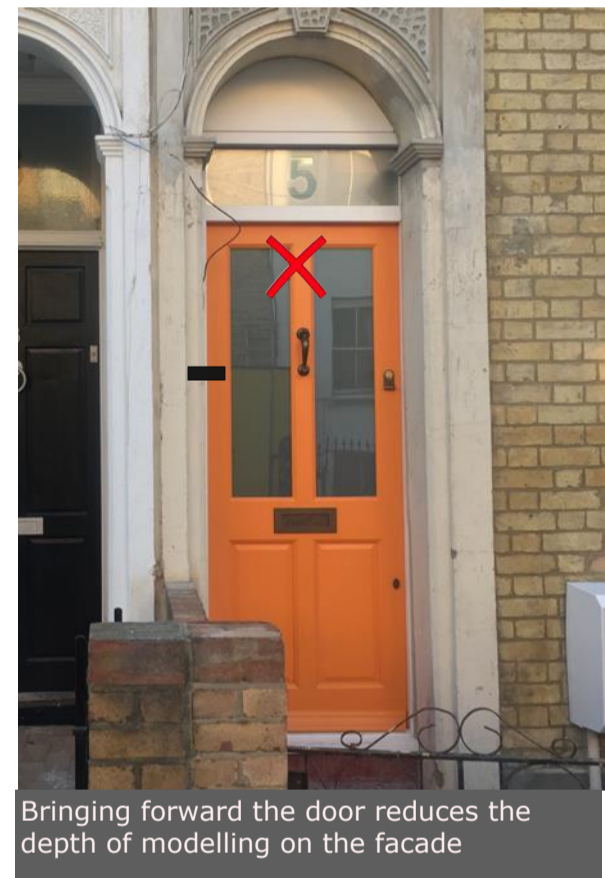
Bringing forward the door reduces the depth of modelling on the facade

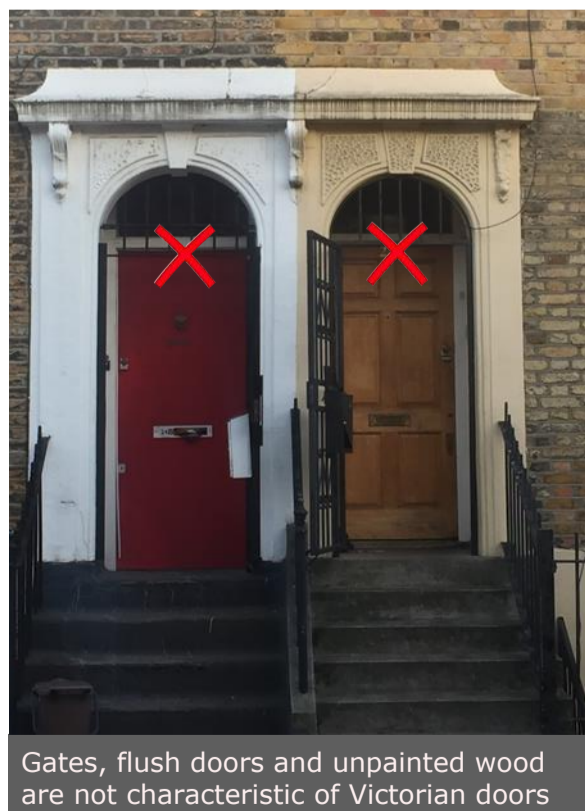
Gates, flush doors and unpainted wood are not characteristic of Victorian doors

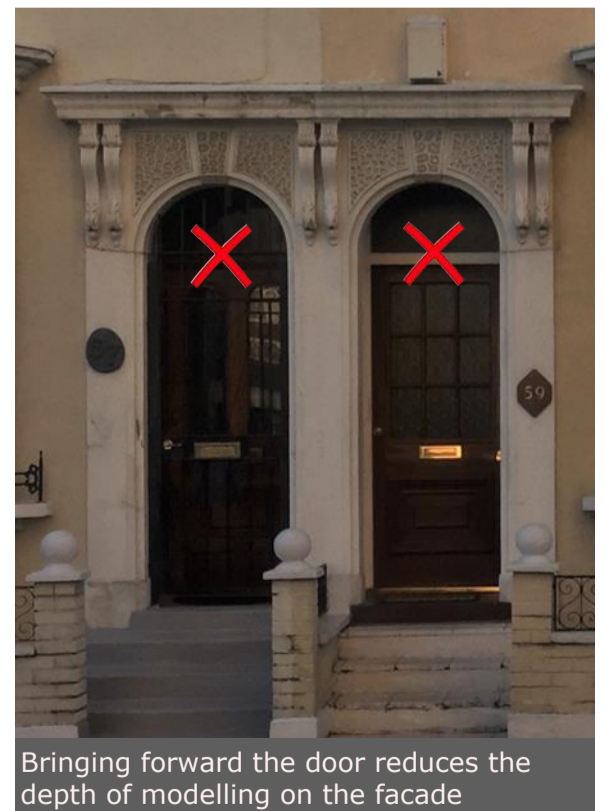
Bringing forward the door reduces the depth of modelling on the facade

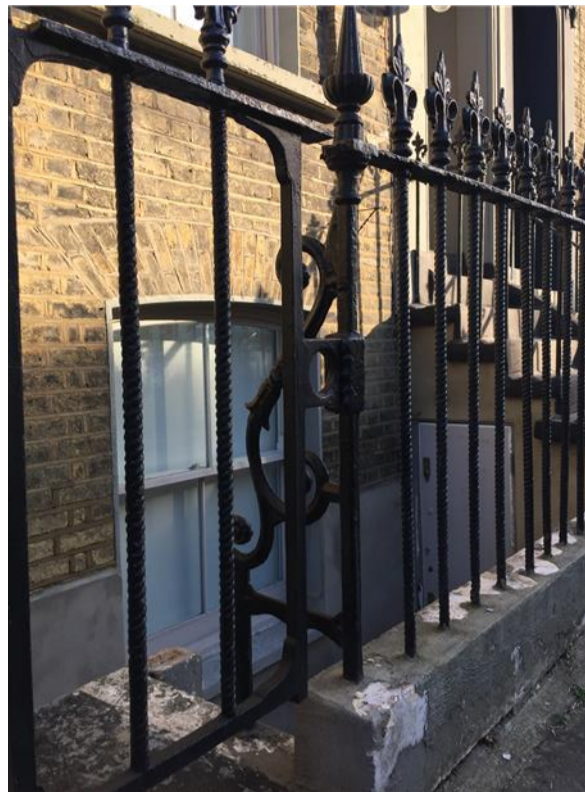
The gate post often had an ornate cast iron finial and decorative support brackets.

Gate posts often had more ornate finials

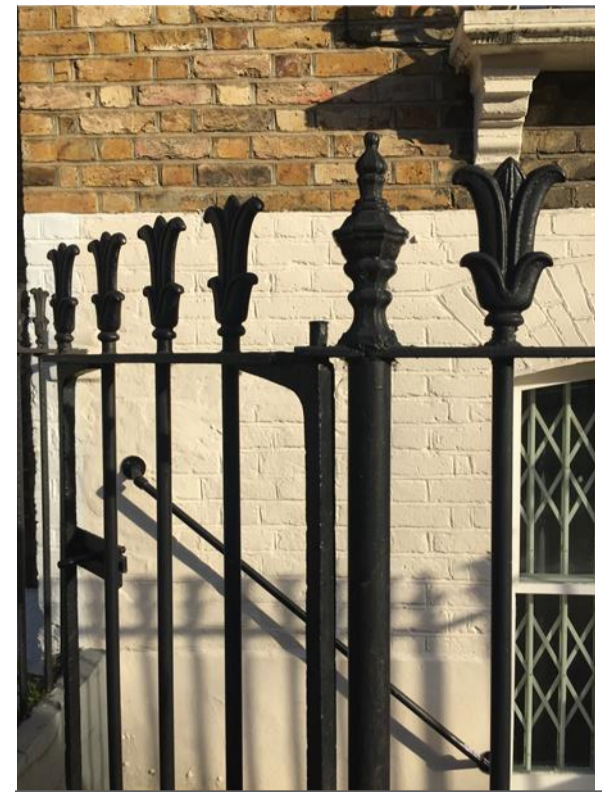
Gate posts often had different finials

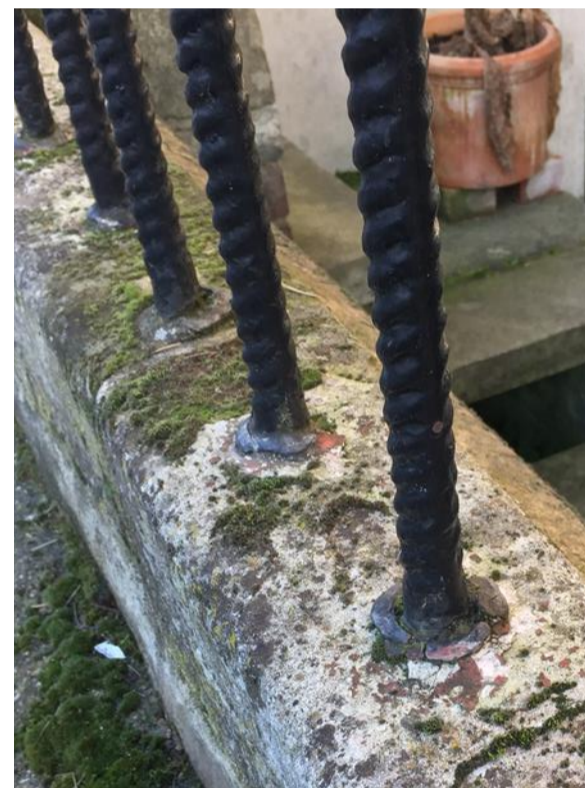
Bars were caulked into the stone plinth / base. Pockets were cut into the stone to form a circular recess. This is still the preferred method of installation and whilst today many of the bases are formed in concrete as a substitute for stone, this method can still be used. Once each bar (or paling) is in place, molten lead (or caulking) is poured in carefully, and is left 3mm proud of the base to ensure moisture run off. In properties with the curved metal capping, the railings would have been caulked in the same way and the lead would be installed flush with the capping or filled with a stone dust mix to allow moisture run-off.

Bars lead caulked into stone base

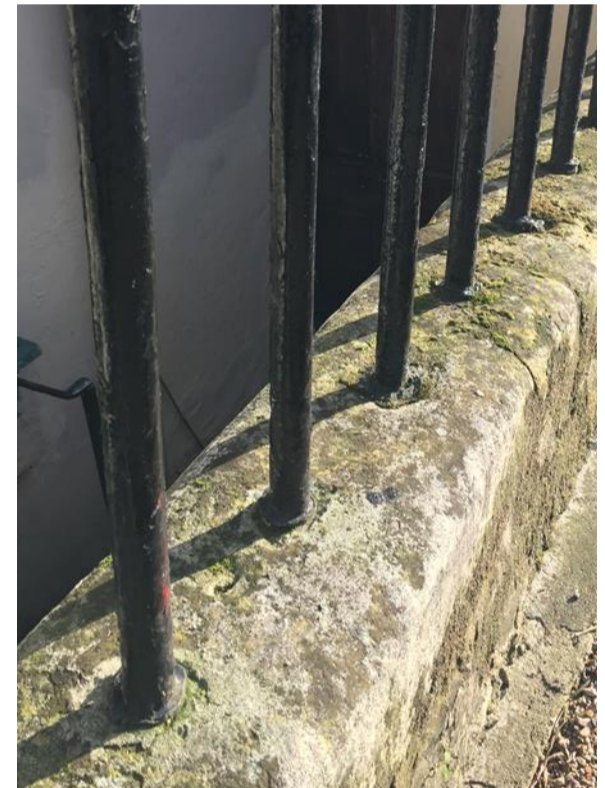
Bars lead caulked into stone base

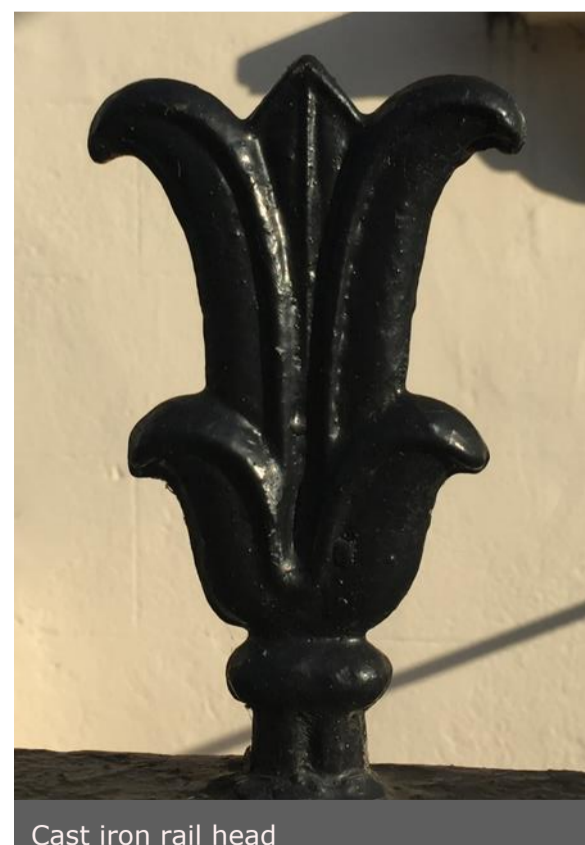
Cast iron rail head

7/6/205  
H240+43  
W92  
B23DIA  
1.15KG

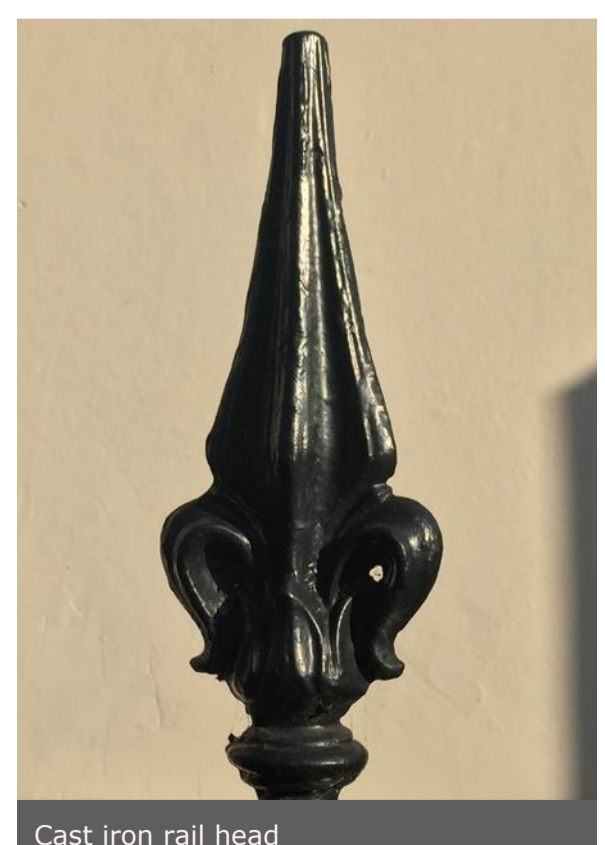
Cast iron rail head

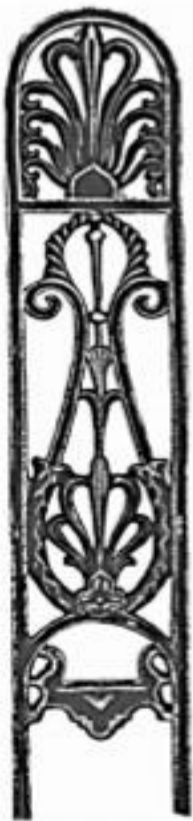
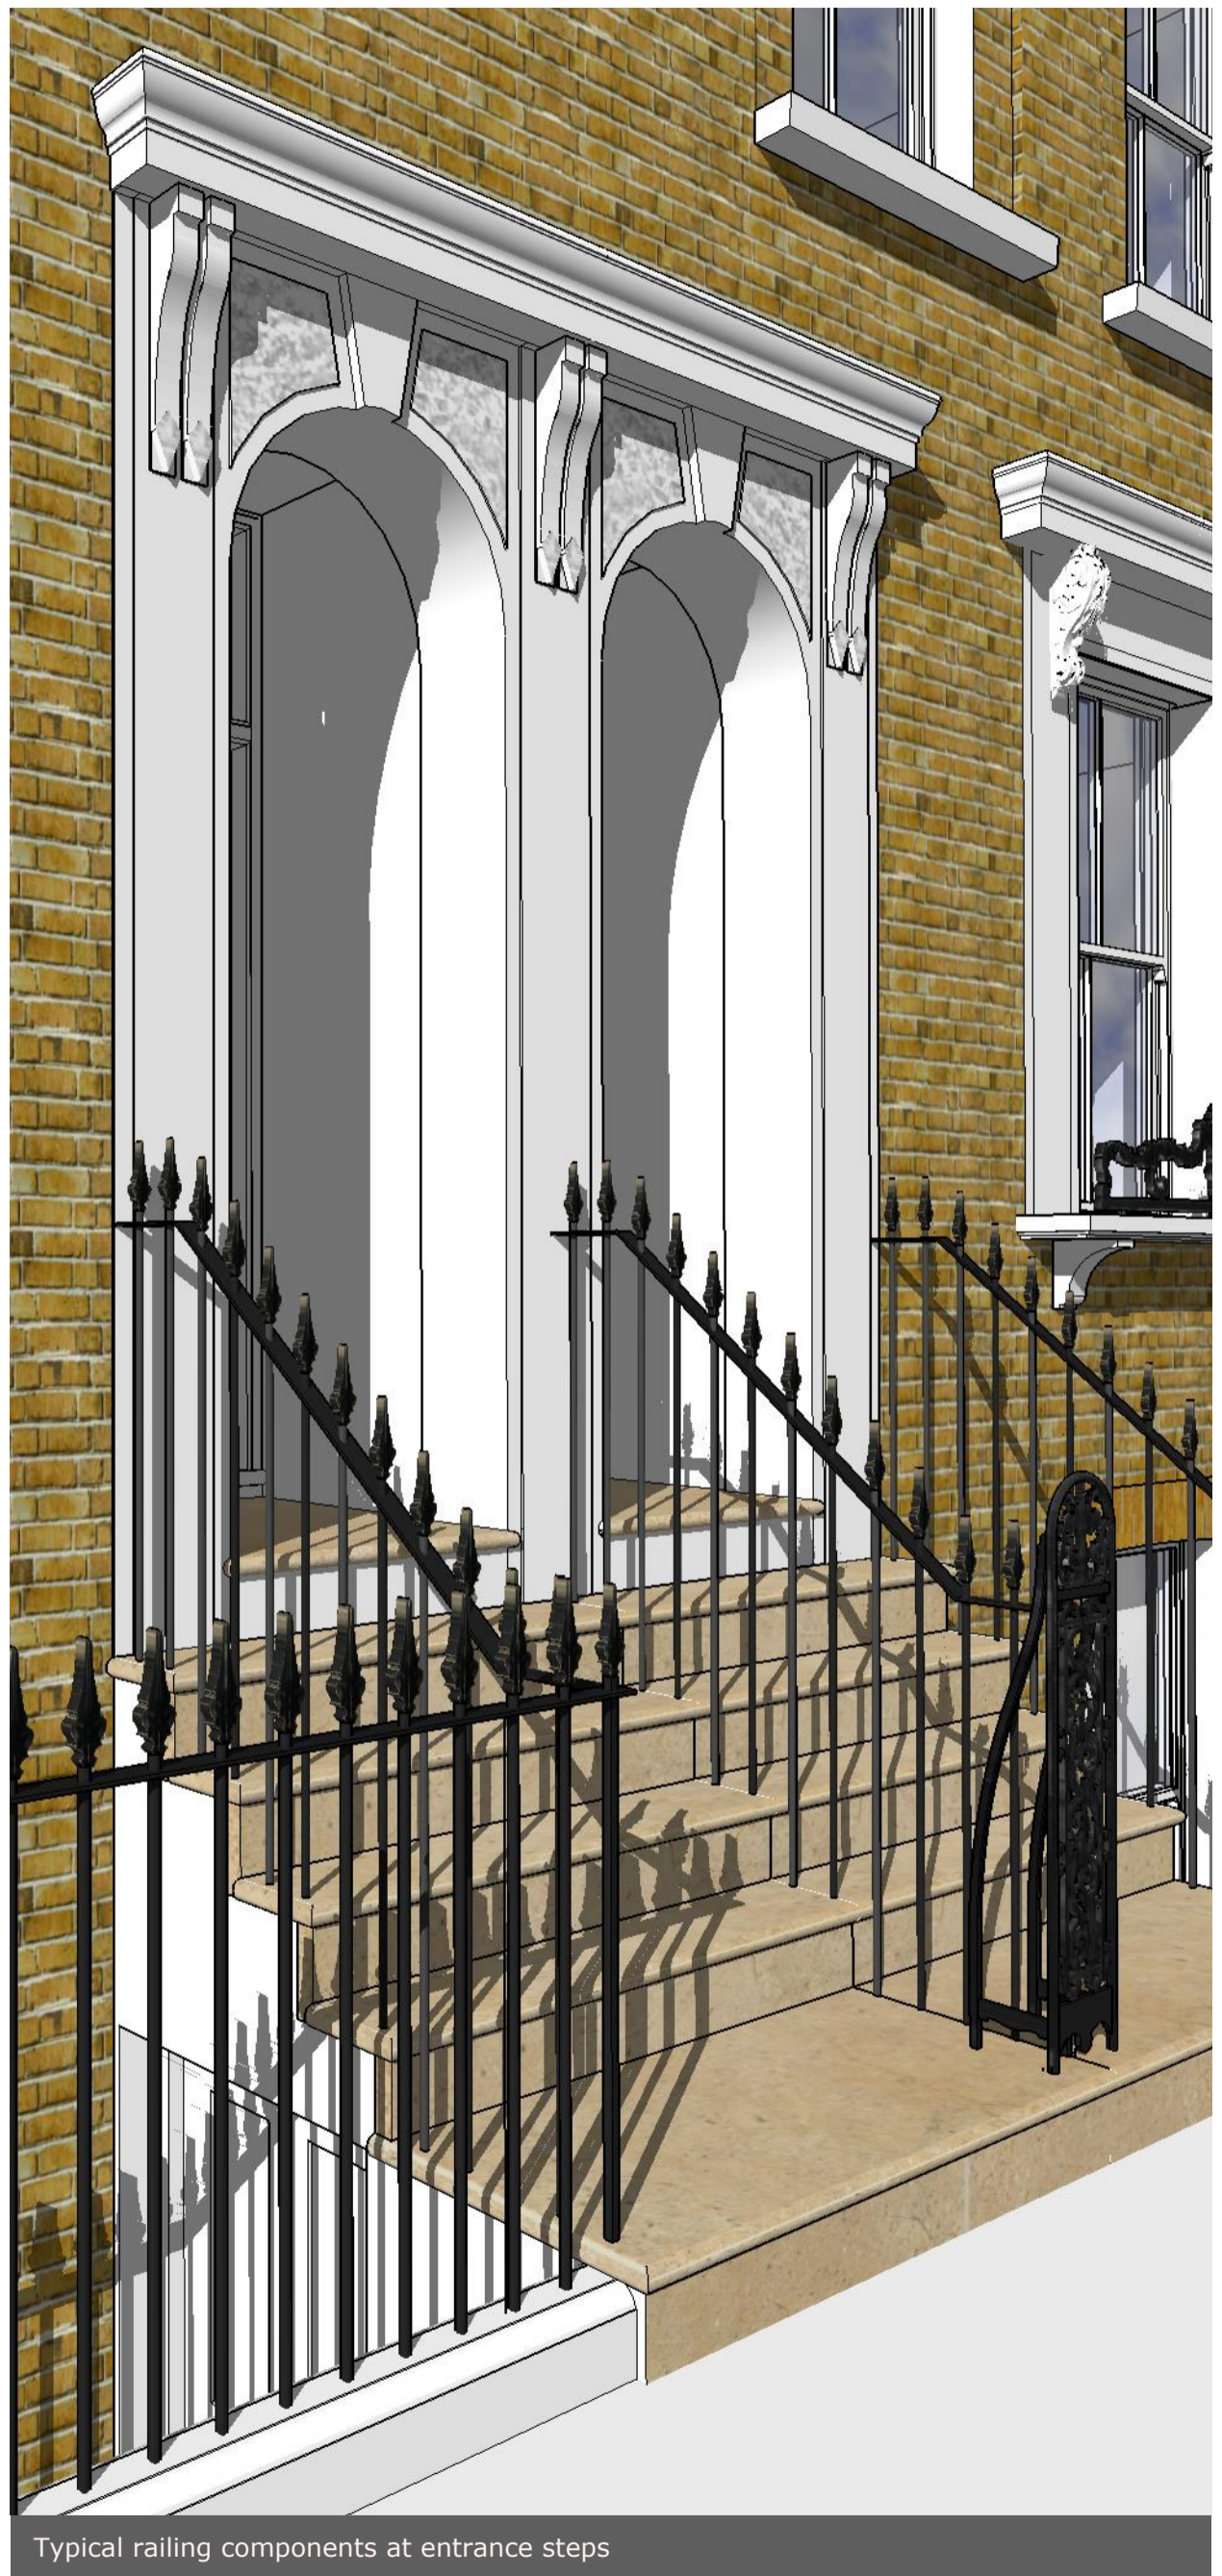
Left: Extract from James Hoyle and Son catalogue  
@jameshoyle@btconnect.com

Some properties have a cast iron 'flat back' panel between staircases, which incorporates a boot scraper. We have not identified a standard pattern number to match the original casting but the pattern on the left is the closest casting we have found, from James Hoyle and Son. Reproduction of an original would be possible by making a template of an original, by specialist metalworkers for casting by a foundry. Specialist castings may be available from Ballantine Castings, Britannia, Metalcraft, Topp & Co. or others; however we cannot vouch for any supplier or product.

Typical railing components at entrance steps

1. Plinth made of stone (some replacements are in cast stone or concrete)
2. "Flat Back" feature panel in cast iron
3. Vertical bar or palisade railing
4. Rail head or finial
5. Top rail
6. Gate stay (supporting bracket or scroll)
7. Boot scraper

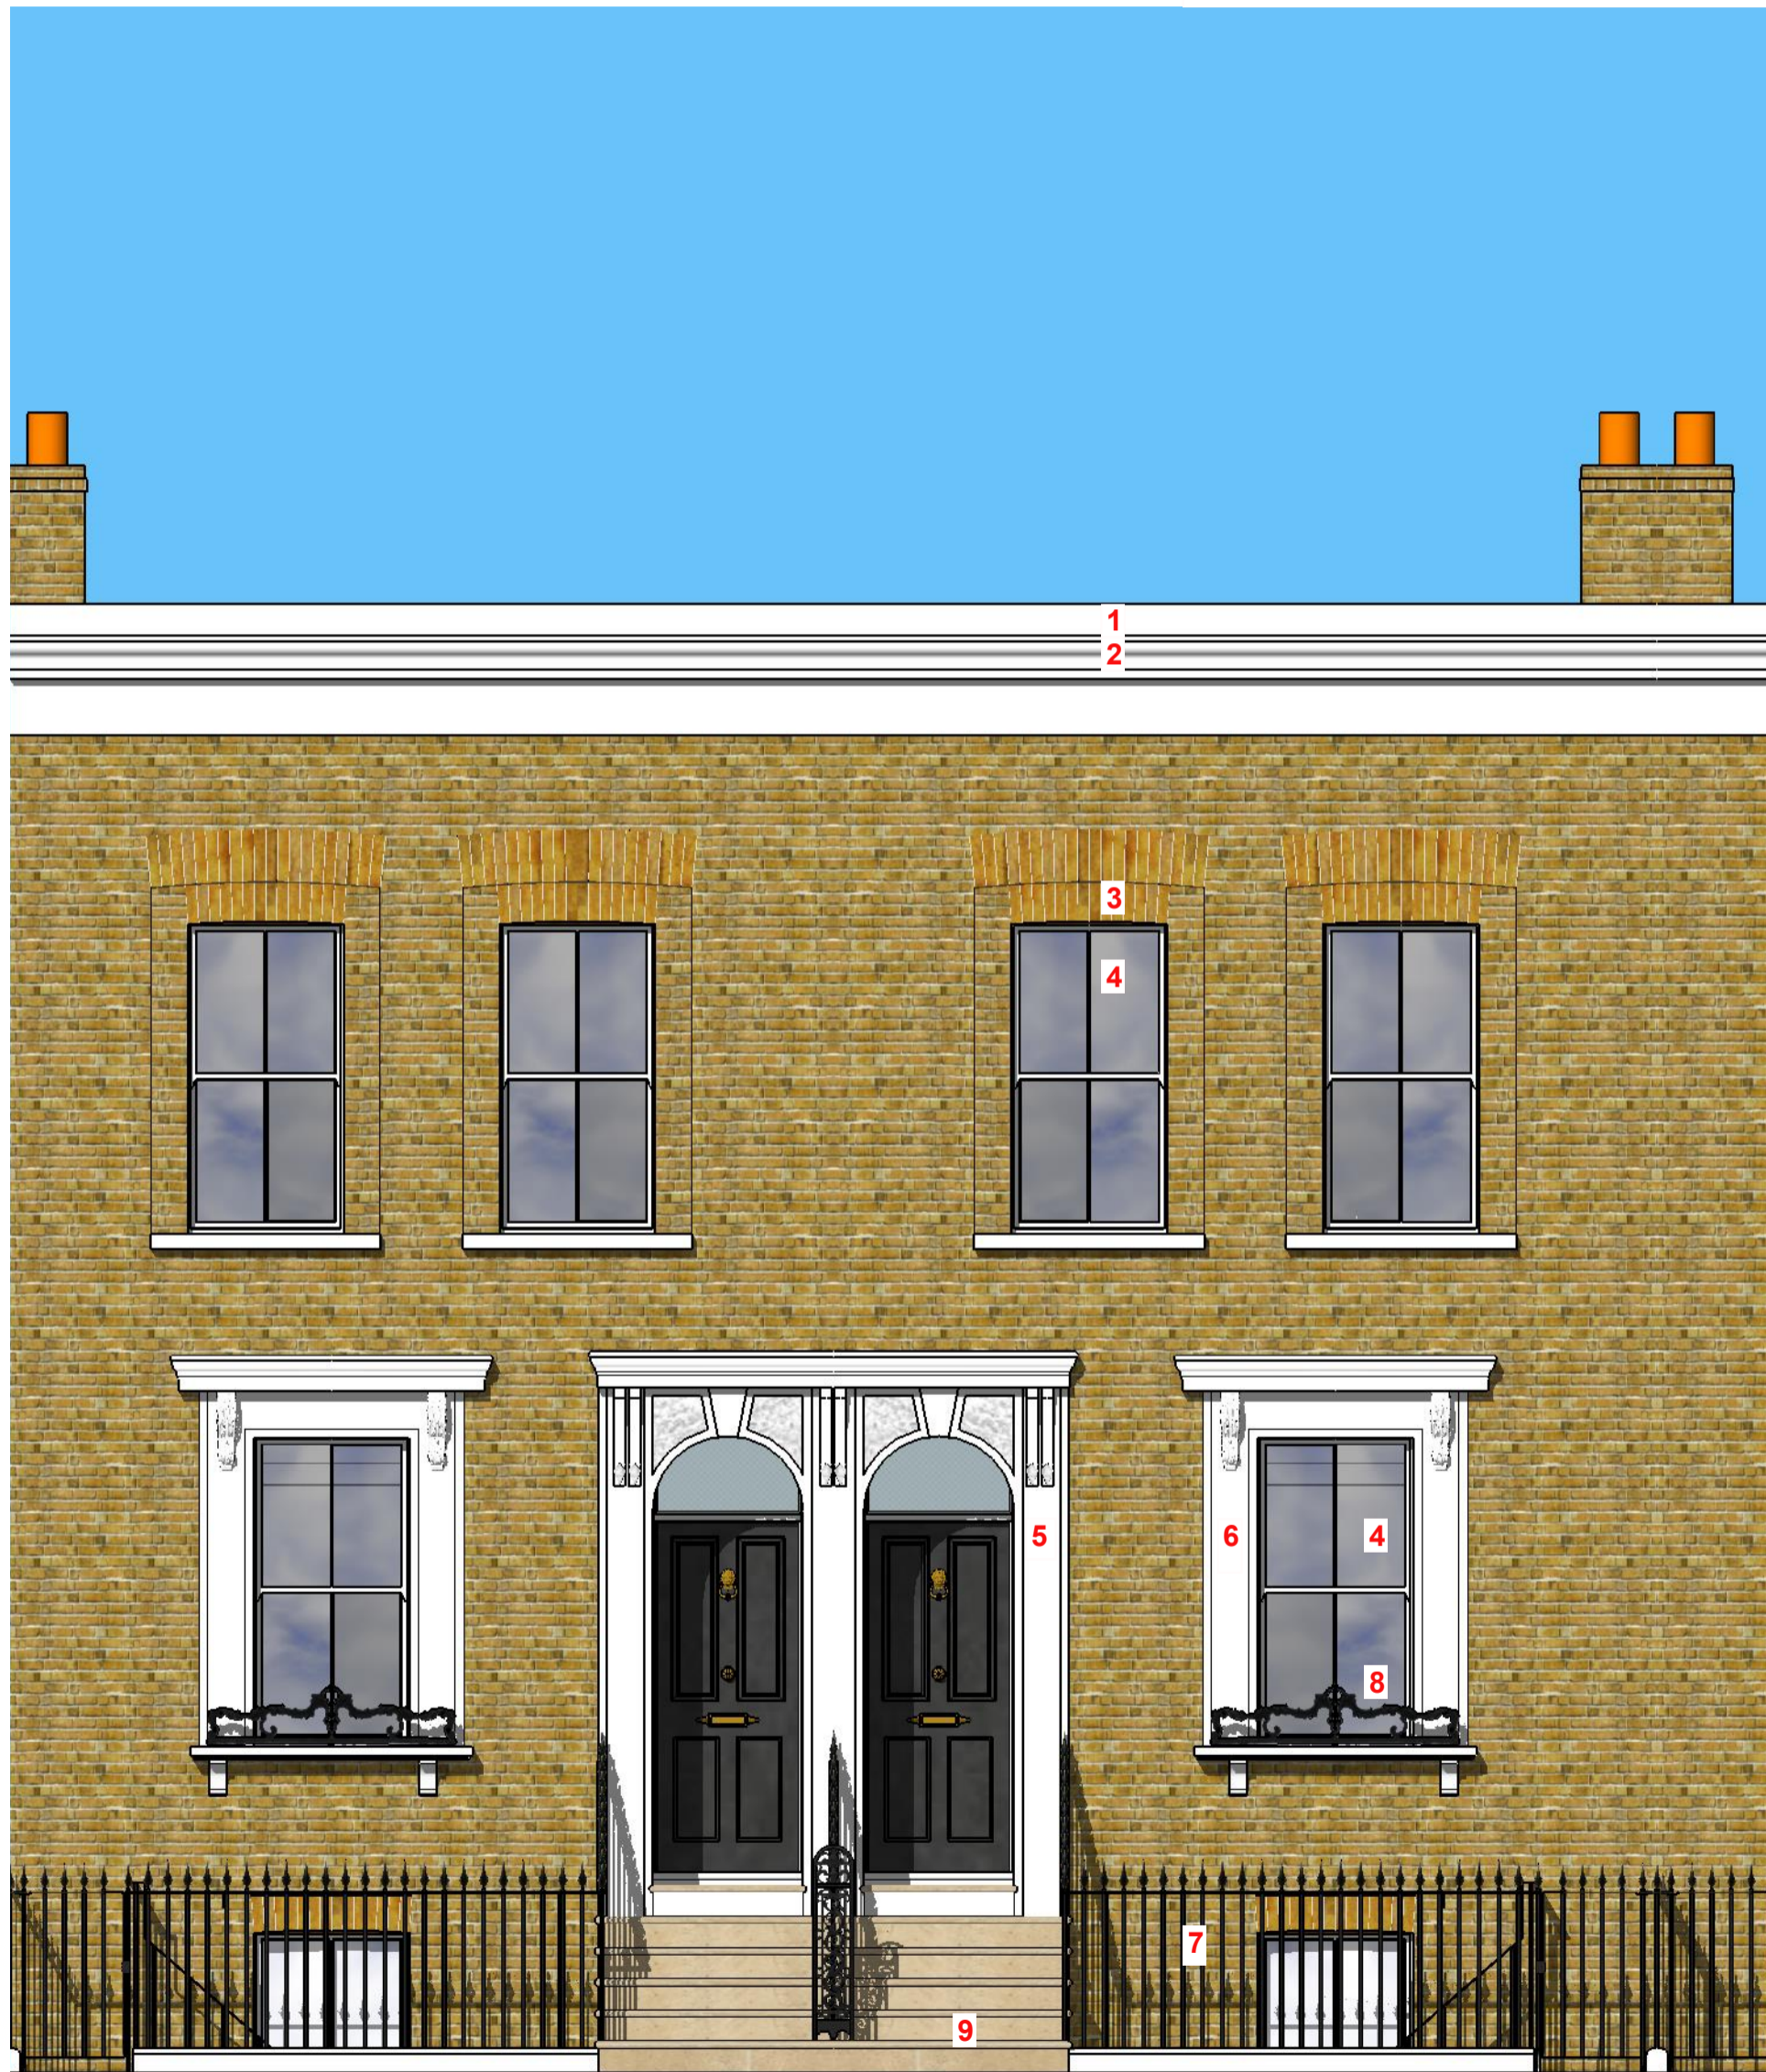
Prototype model Elevation Driffield road

- 1) Parapet wall to conceal London roof
- 2) Cornice (decorative horizontal moulding on parapet)
- 3) Mouldings or brick borders to first floor windows
- 4) Timber sash windows with delicate glazing bars
- 5) Embellished stucco surround to recessed front door
- 6) Decorative stucco surround to ground floor window (or bay window)
- 7) Cast iron railings on stone plinth
- 8) Cast iron pot guard on window sill
- 9) Stone steps

This is how a typical property in the Driffield Road Conservation Area might have looked when new
