London Borough of Tower Hamlets

# Driffield Road Conservation Area Detailed design guidance for façade enhancements

Consultation Draft April 2017

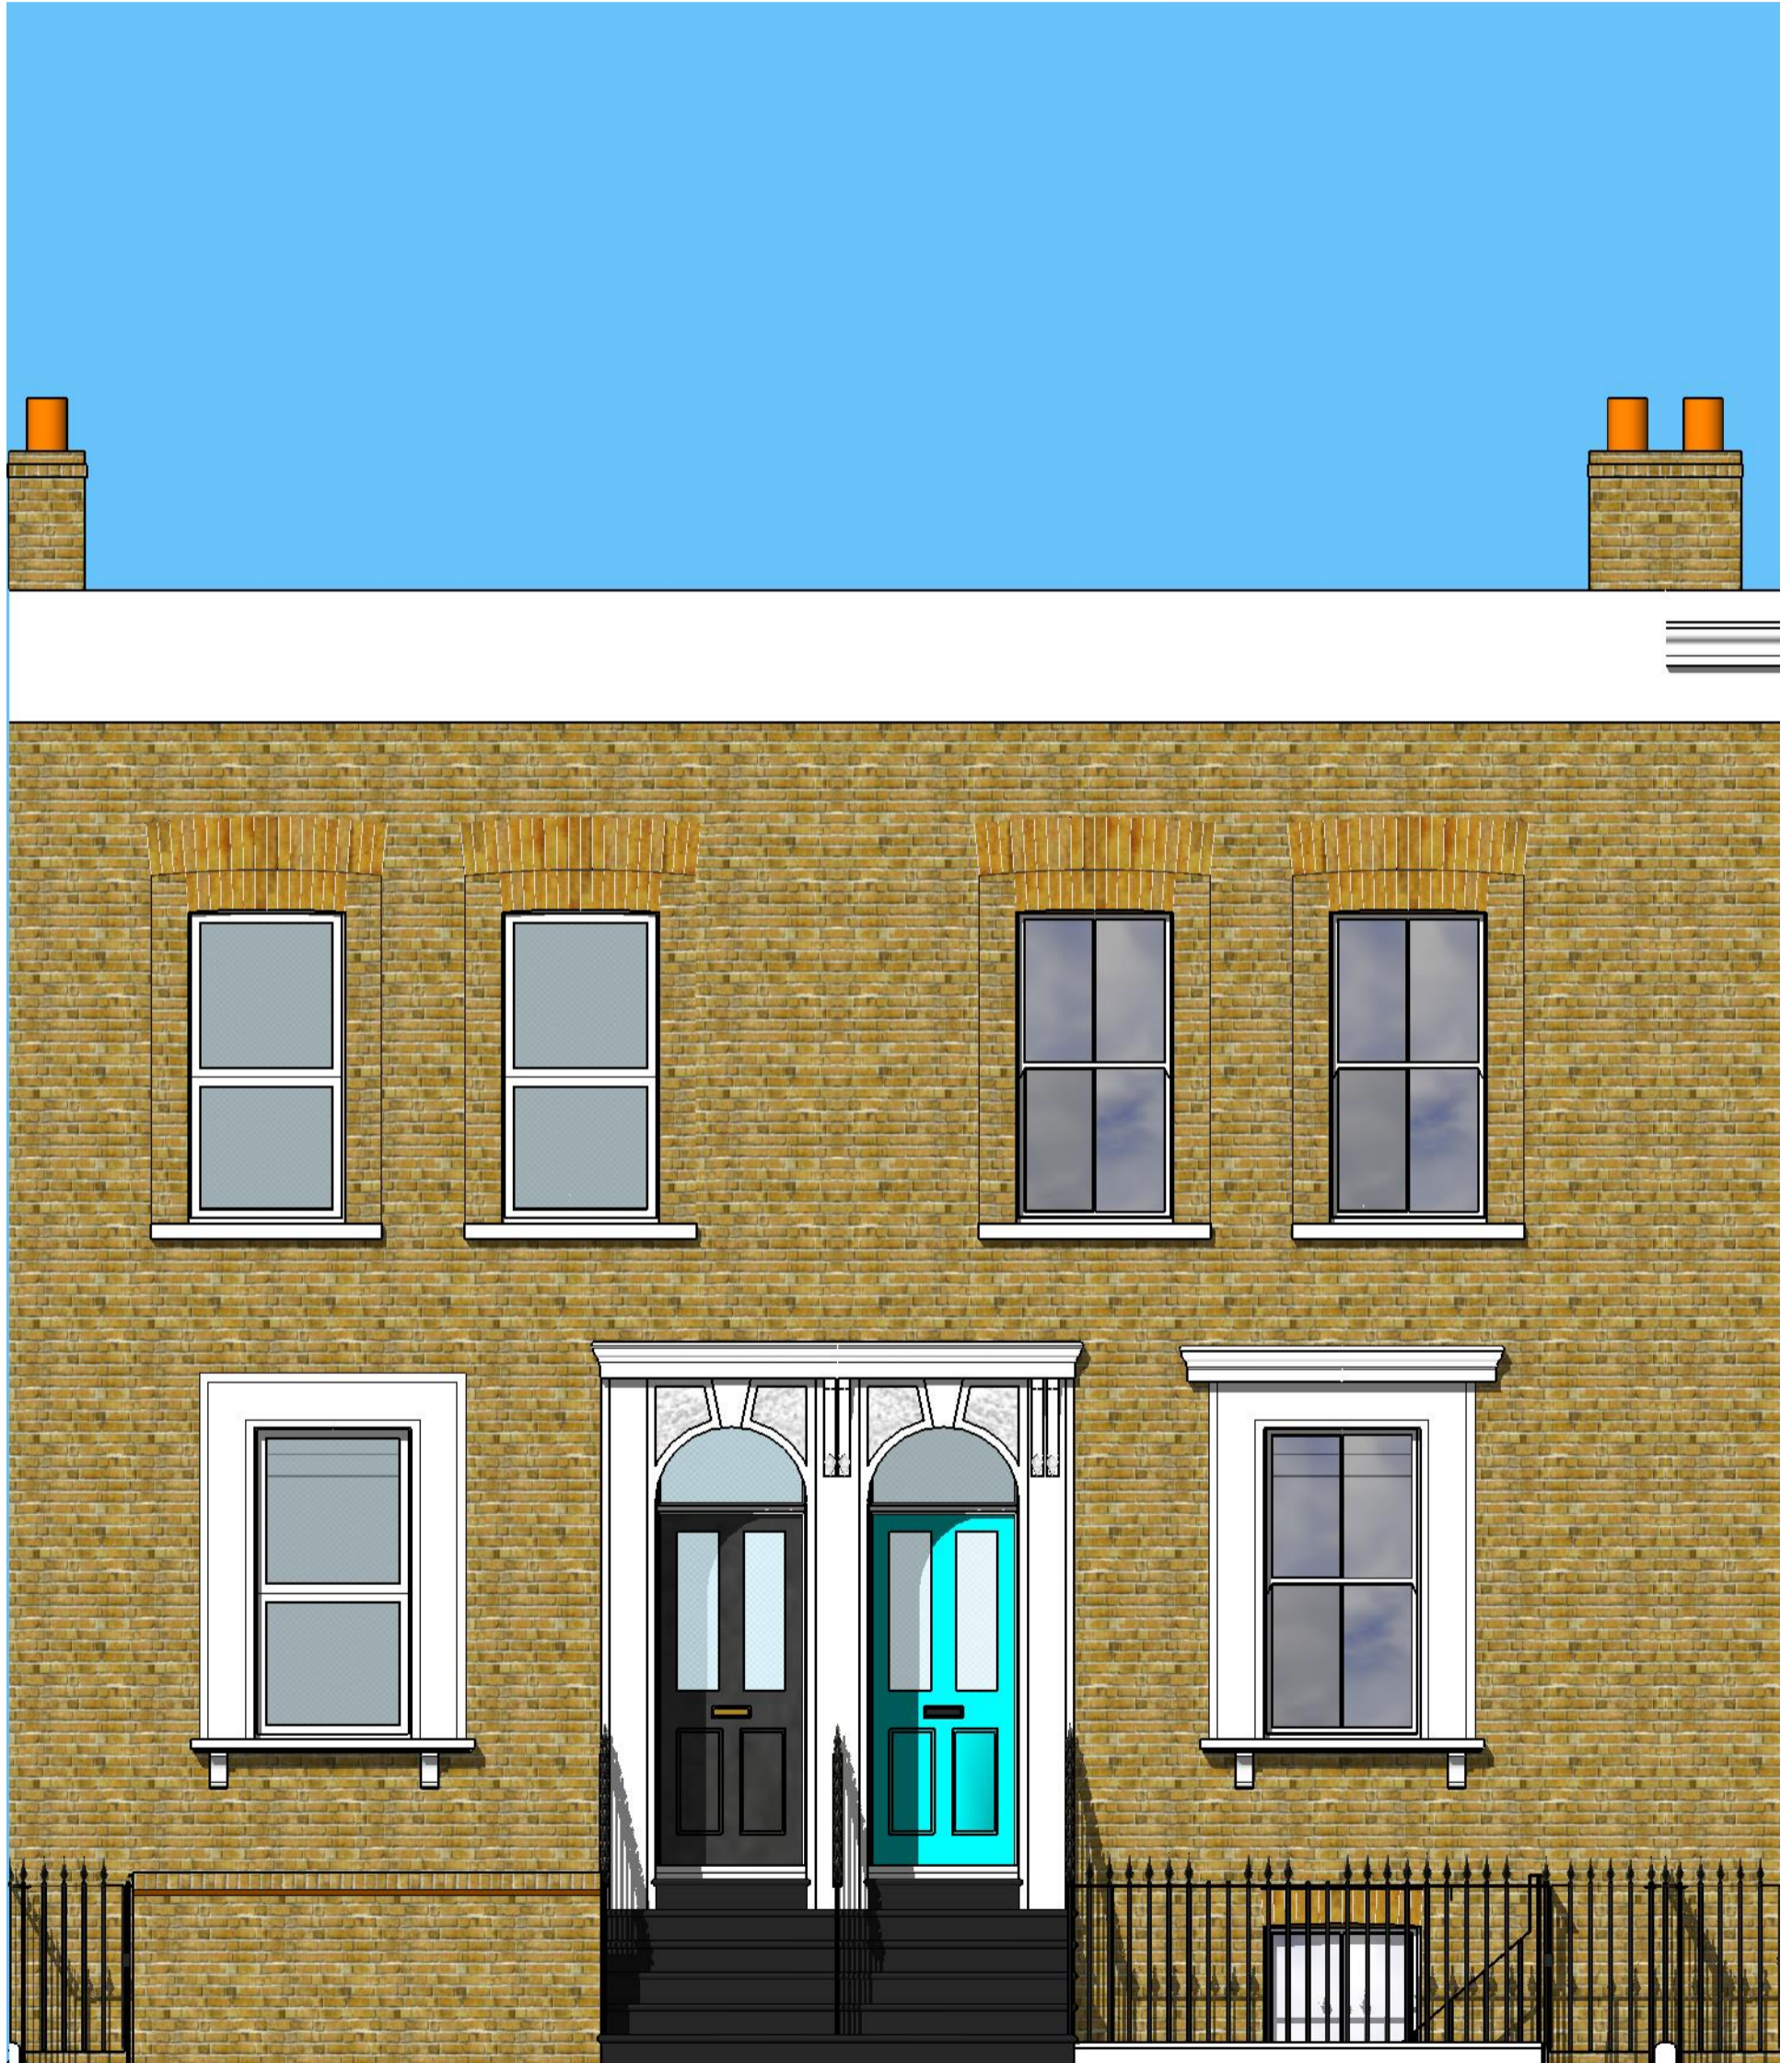
Typically properties in Driffield have lost some of their architectural features

Over time many properties in the conservation area have lost architectural features due to lack of maintenance or changing fashion. Cornices need regular redecoration and if neglected they deteriorate quickly requiring extensive repairs. Many properties have lost the cornice and some have also lost the rendered panel behind the cornice.

Replacement windows did not always match the original timber sliding sash windows and frequently top hung or casement replacement windows in timber or plastic were installed, which detract from the character of the Conservation Area. In many properties the railings have been replaced with brick walls or fences. The cumulative effect of loss of original features reduces the character and integrity of the area.

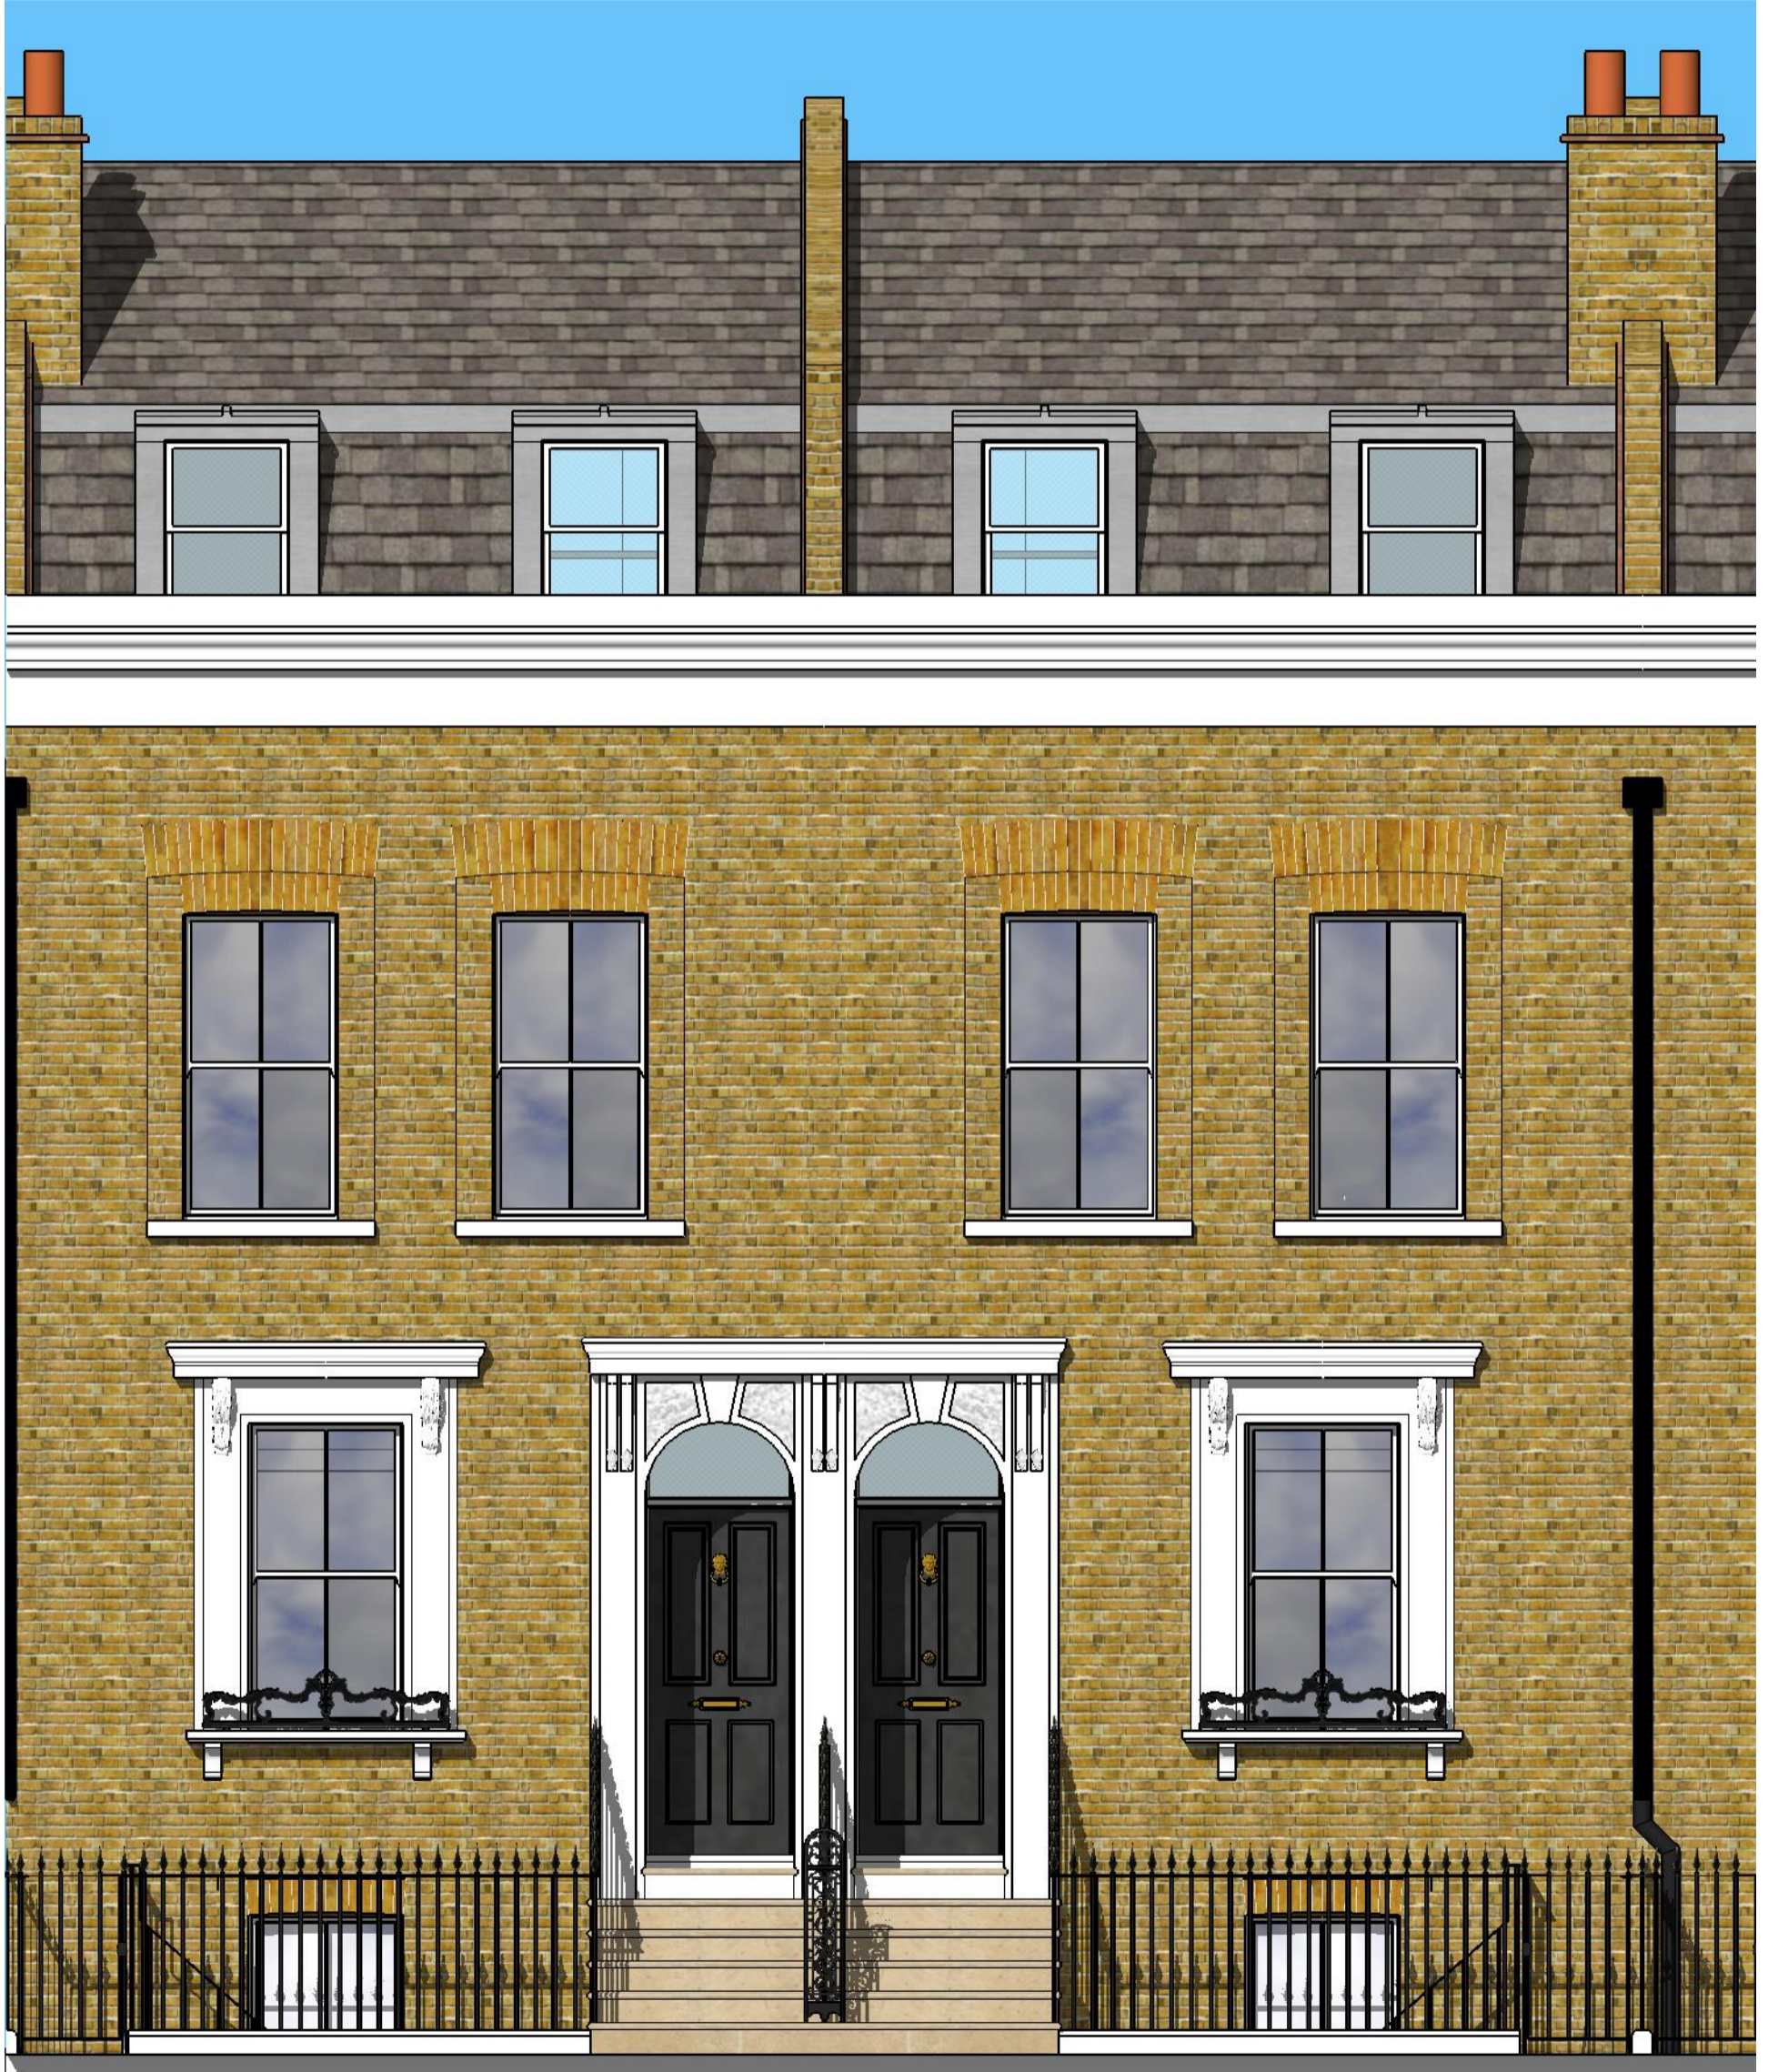
When extending properties in the Conservation Area with a mansard roof, potential harm could be offset by restoring lost architectural features as illustrated below.

Prototype elevation of typical properties in Driffield Road Conservation Area with roof extensions and architectural features reinstated

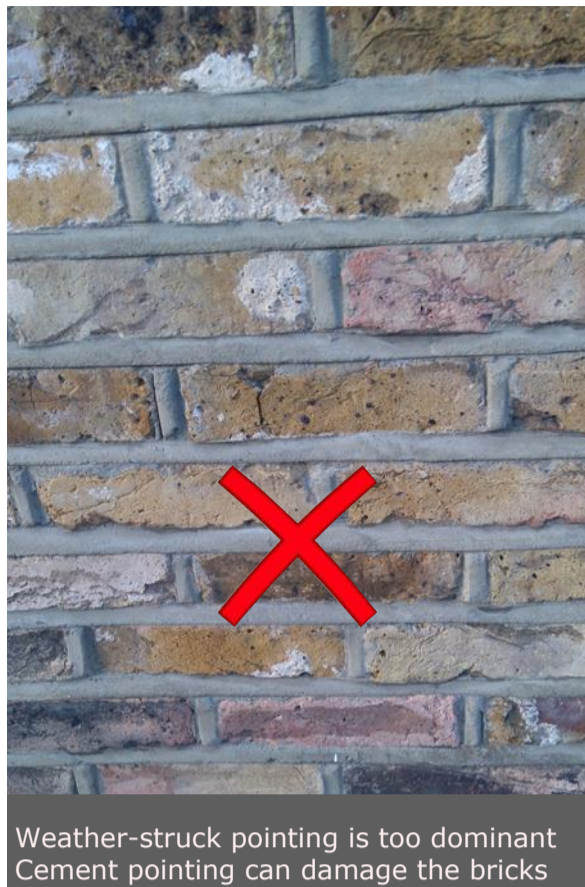
Weather-struck pointing is too dominant  
Cement pointing can damage the bricks

**Avoid cement pointing!** Many properties have suffered from inappropriate pointing in hard cementitious mortar. The problem with this is that it is harder than the soft bricks and so any moisture absorbed by the bricks cannot evaporate out through the joints. Trapped moisture builds up behind the face of the brick and frost-thaw action can accelerate deterioration of the brickwork.

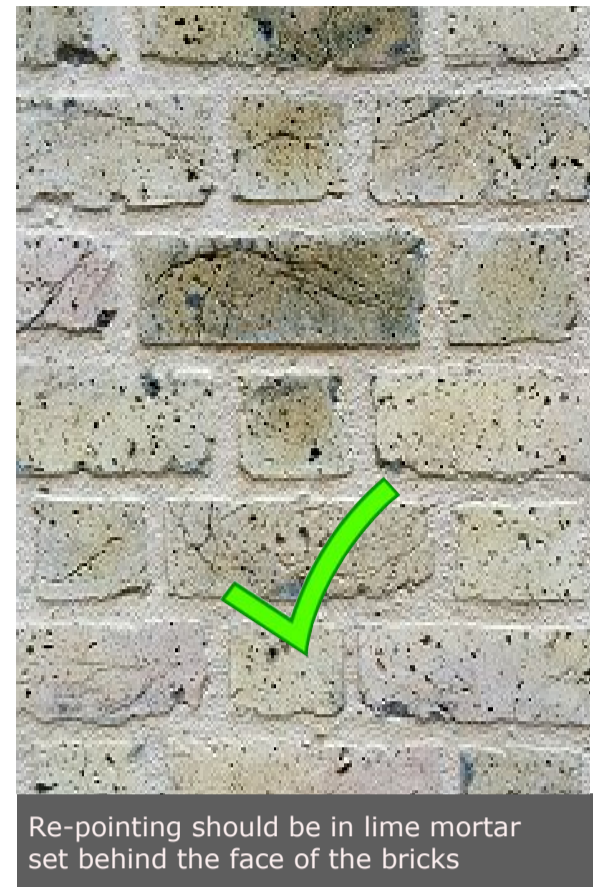
Re-pointing should be in lime mortar  
set behind the face of the bricks

The original soft London stock bricks would have been laid using lime mortar. The pointing can be susceptible to damage, particularly when bricks are cleaned, and needs periodic replacement. Most of the properties have been re-pointed using mortar that projects beyond the face of the brick. This does not match the original pointing, which was more recessive and therefore less visible than projecting mortar.

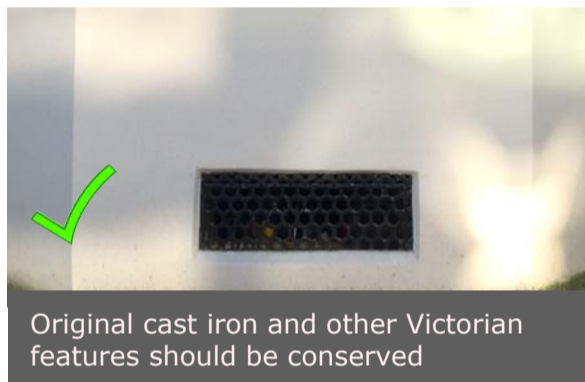
Original cast iron and other Victorian  
features should be conserved

The coal bunkers were ventilated by cast iron grilles and access covers were in cast iron. These details are characteristic of the area. Any original cast iron features should be conserved. Their retention, refurbishment, restoration and reinstatement where missing is encouraged.

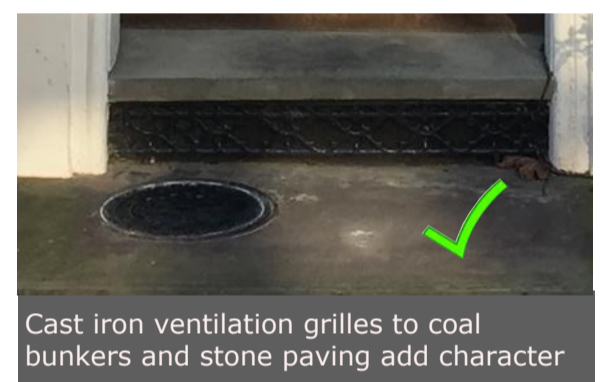
Cast iron ventilation grilles to coal  
bunkers and stone paving add character

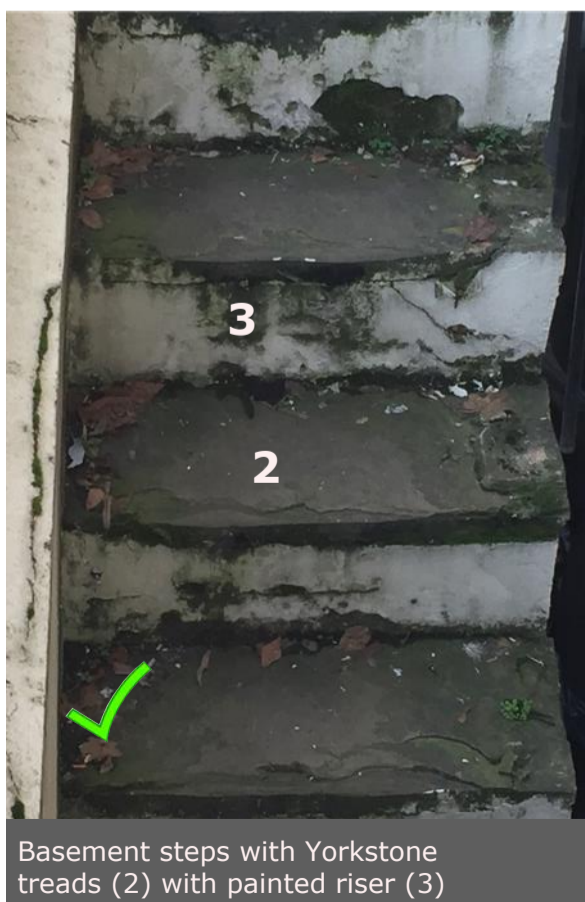
Basement steps with Yorkstone  
treads (2) with painted riser (3)

The traditional stairs down to the basement were built in stone, with a simple iron railing and handrail and a few examples remain in Driffield Road CA. Some replacements have been installed with steel or timber staircases. If renewing a staircase Yorkstone treads are preferred but simple steel stairs painted black are also considered to be appropriate.

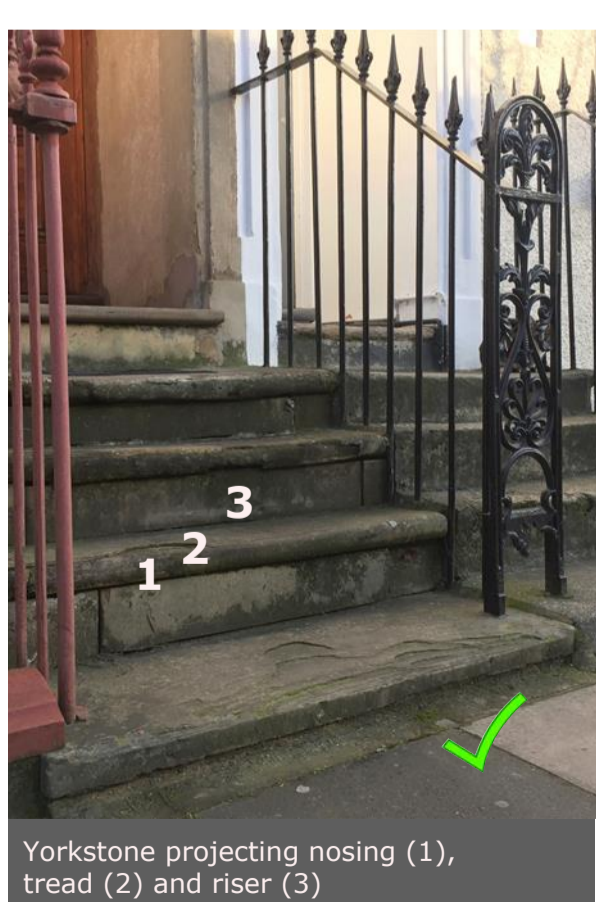
Yorkstone projecting nosing (1),  
tread (2) and riser (3)

The original paving and steps are likely to have been riven Yorkstone with a projecting nosing. The top riser in some cases was an iron grille as described above. Conservation of original features is encouraged. The flagstones inside the front area and on the steps were large and sourcing replacements of a similar scale can be problematic, but it is still possible, and piecing in repairs can be carried out by stonemasons. Smaller slabs would be acceptable.

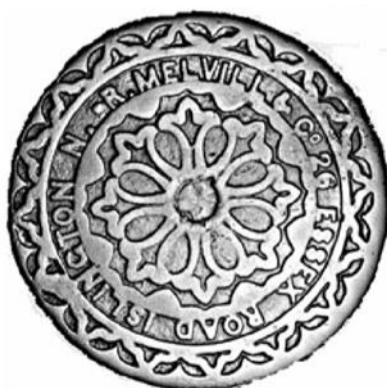
**YHCC4**  
P77  
Coal hole cover  
320 DIA  
50 DEEP  
COLLAR  
248 DIA  
42 DEEP  
5.20kg

Above: Extract from James Hoyle and Son catalogue @jameshoyle@btconnect.com
